## Coastal Adaptation Study

# MARINO CLIFFS

By Integrated Coasts

Review date 1 December 2022

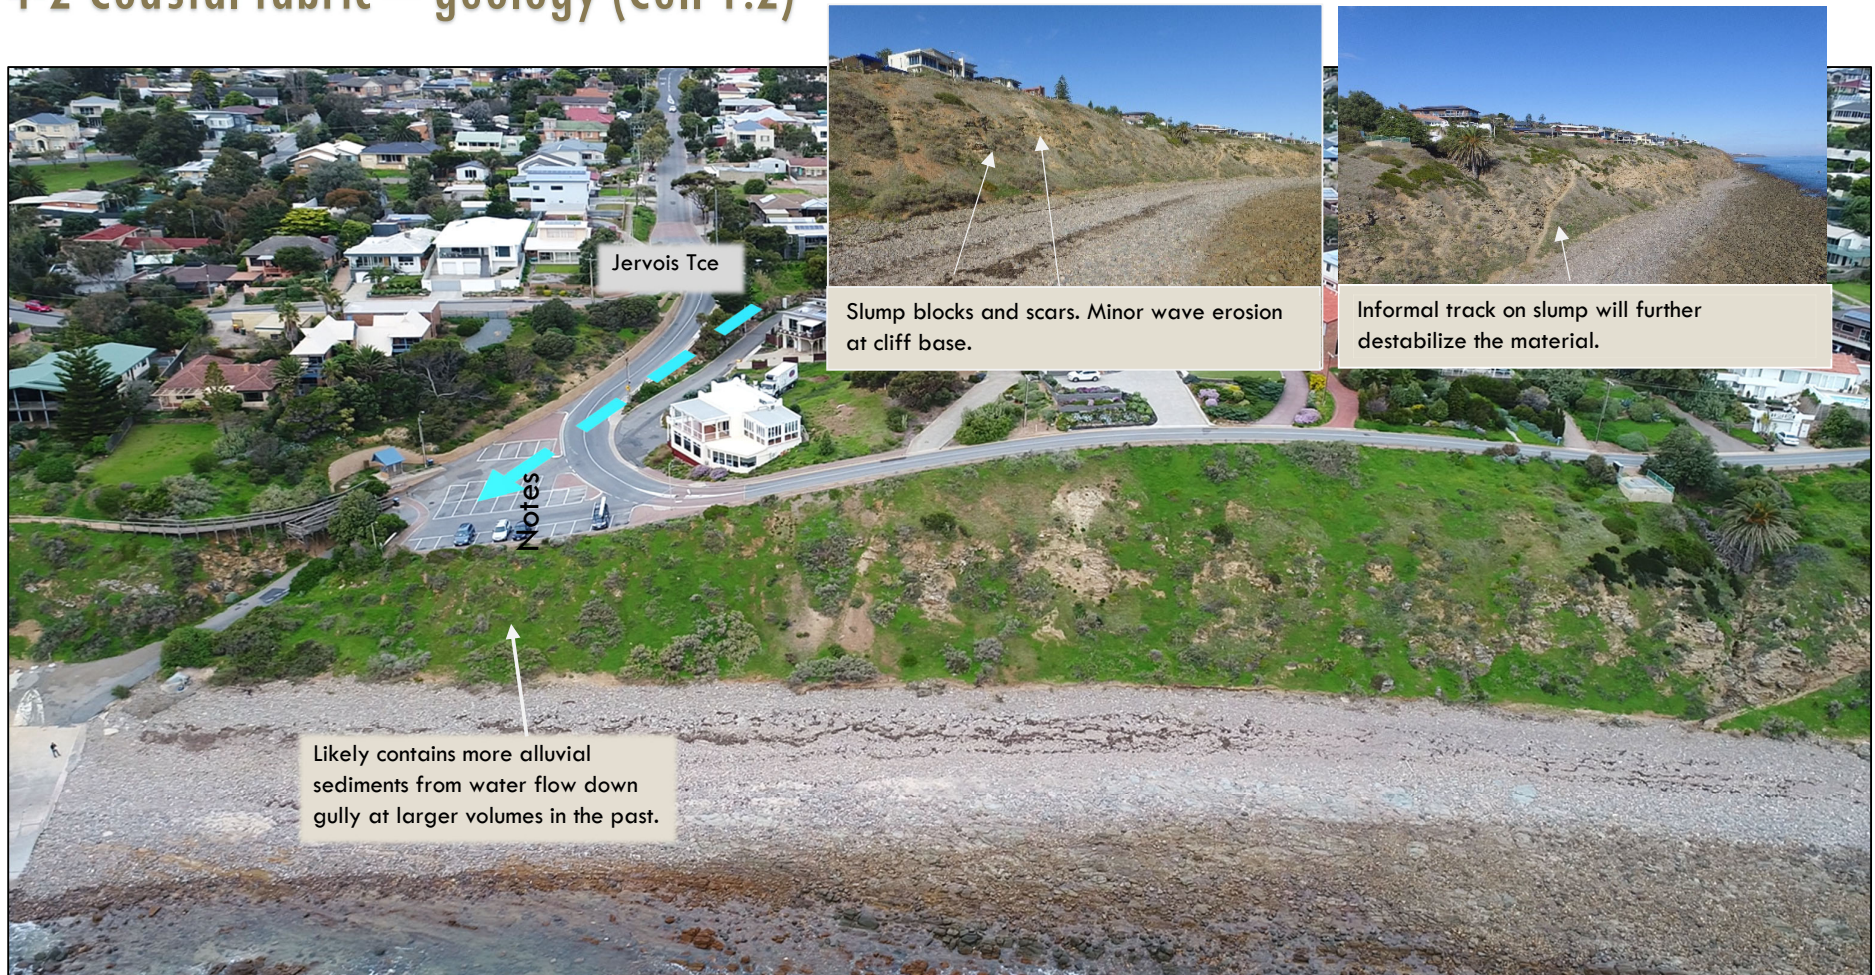
## 4-2 Coastal fabric — geology (Cell 1.2)

This section is composed of the Neo-Proterozoic Marino Arkose formation, which is a resistant material but is covered by undifferentiated material. Cliff morphology suggests that subaerial erosion is currently more significant than wave-driven erosion. There is undercutting (scars) at cliff top and slumping material, nonetheless, vegetated suggesting the movement is not recent. Rocky beach reduces ocean impacts, but sea level rise of 1m will cause major recession of toe.

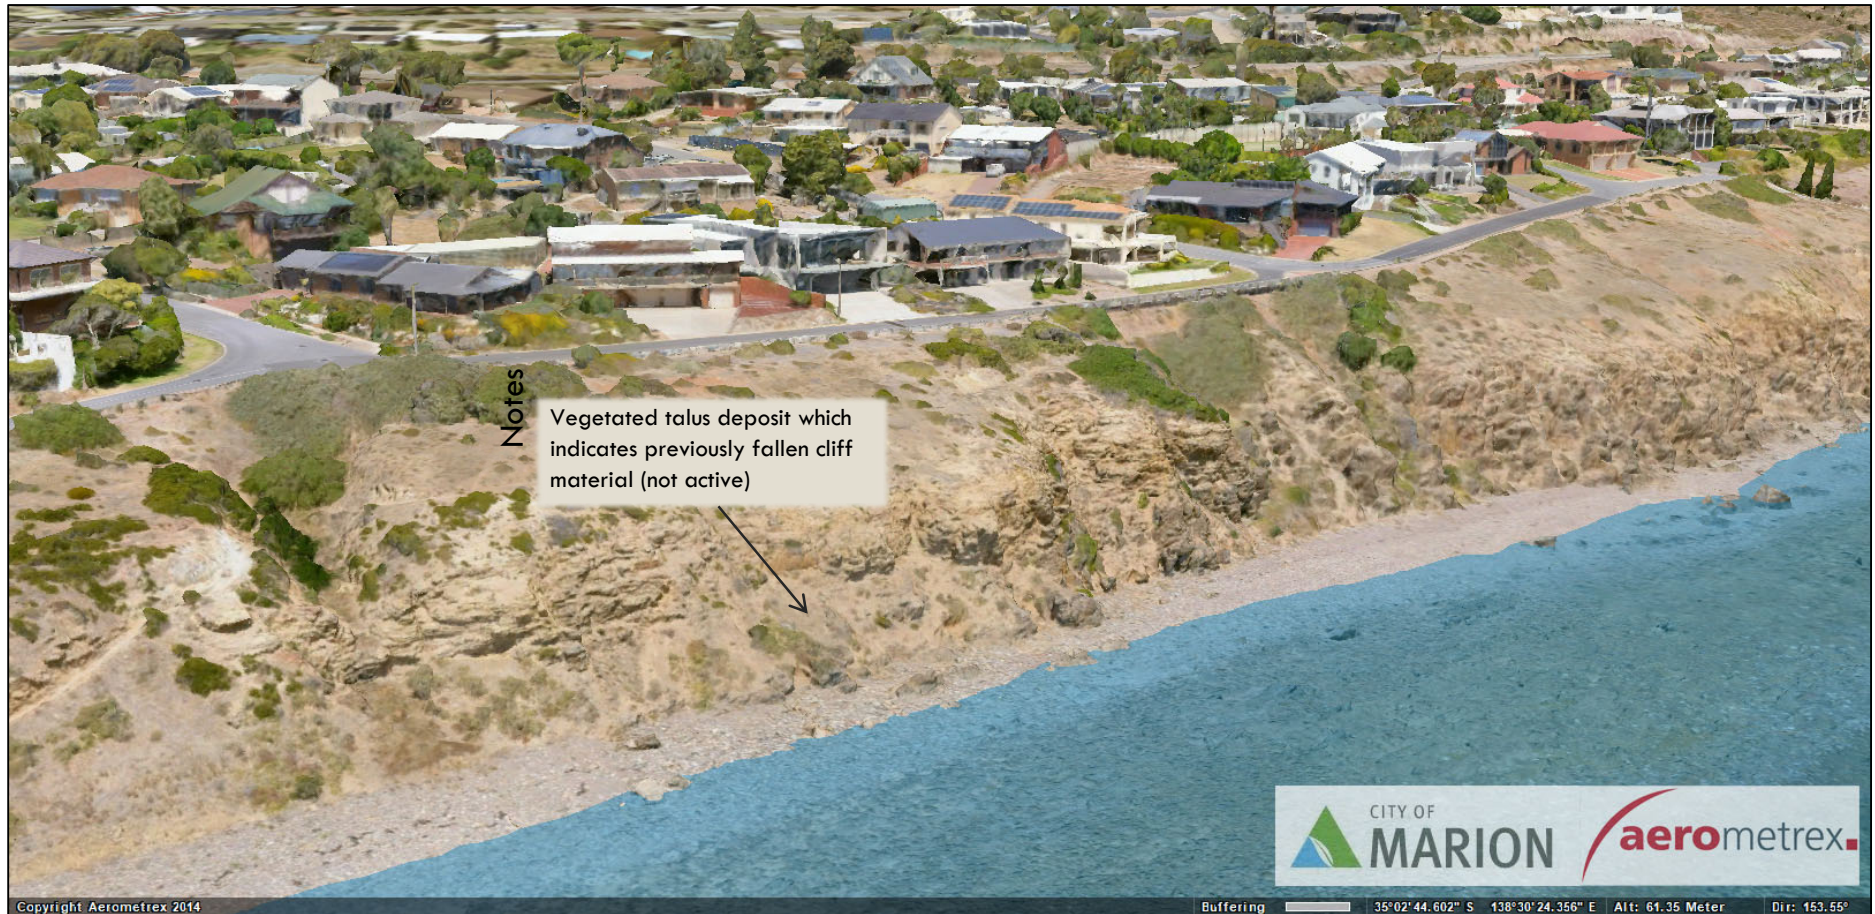
## 4-2 Coastal fabric — geology (Cell 1.3)

This section is composed of the Neo-Proterozoic Marino Arkose formation, which is a resistant, lime-cemented sandstone rich in feldspar. Some slump material but cliff face mostly exposed. The narrower intertidal rock platform also indicates less cliff recession over the last 7000 yrs in comparison to northerly sections. Hence more wave impact. Sea-level rise of 1m will impact cliff toe with potential for significantly increased rate of erosion (noting it is resistant rock here).

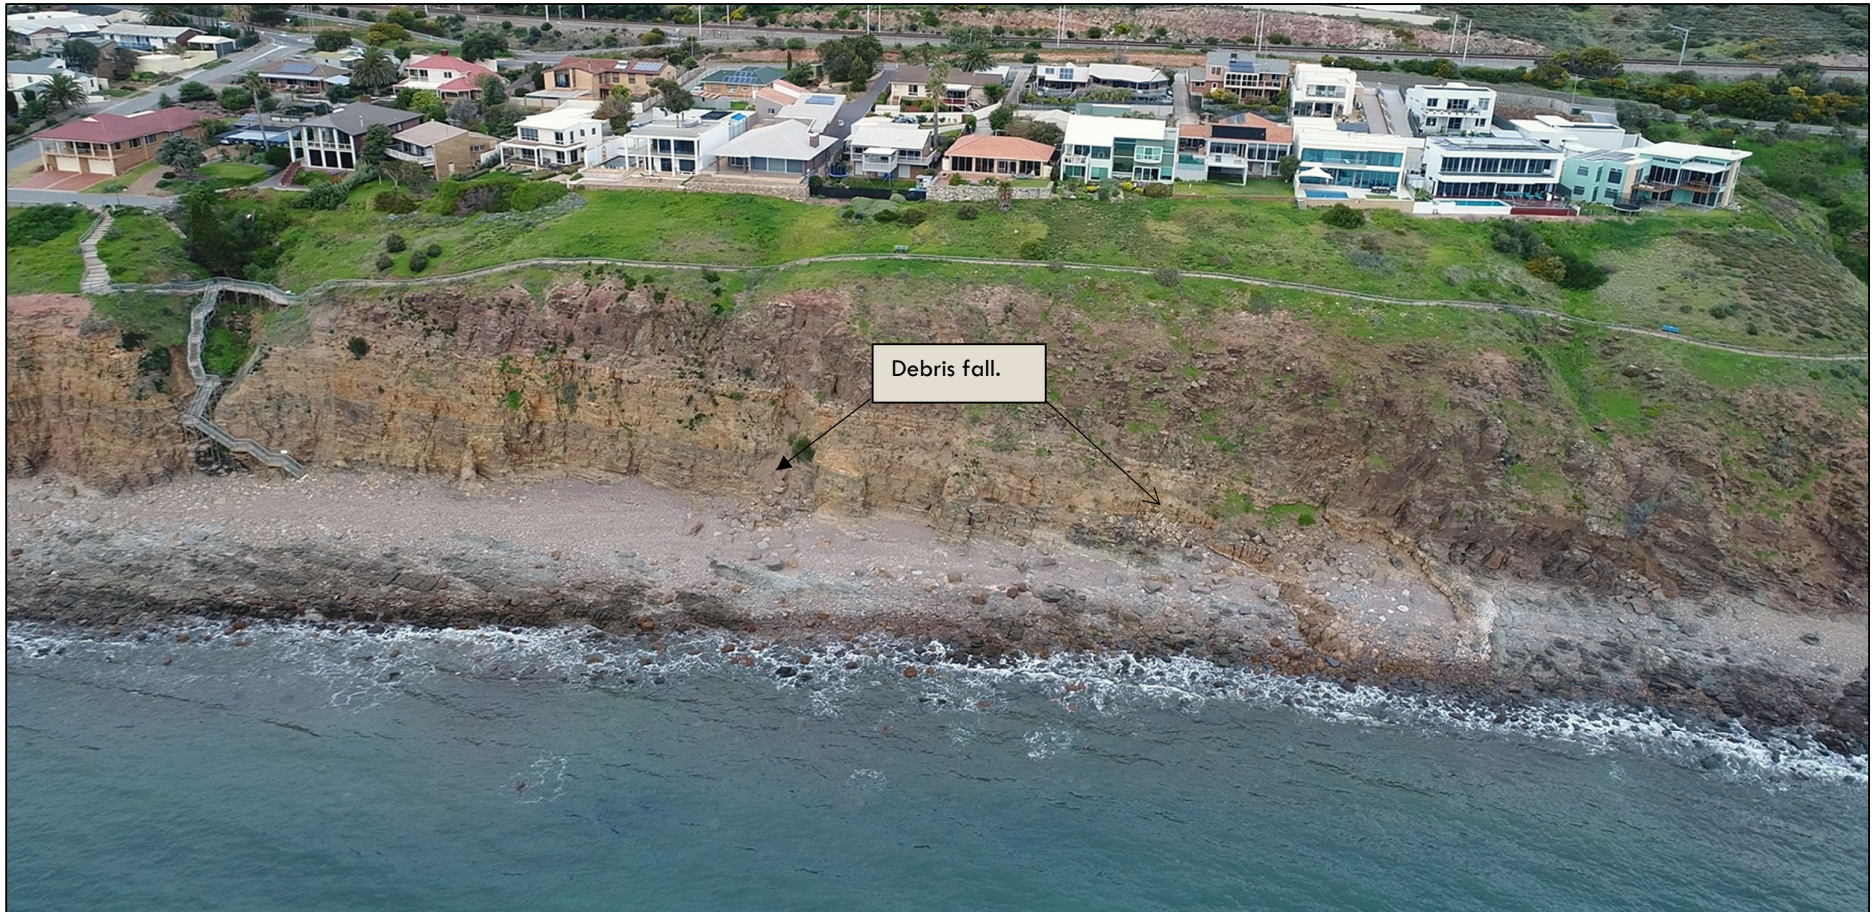
## 4-2 Coastal fabric — geology (Cell 1.4)

Heterogeneous cliff with sandstone and siltstone members of the Wilmington Formation overlying the Marino Arkose (relatively resistant rock types). The gully where the staircase is located is an area of concern. Rock falls at some places. Well-developed storm ridge will offer protection, however narrow rock platform will decrease potential for wave energy dissipation. Sea-level rise will increasingly undermine the base of the cliff (but rock types are 'resistant').

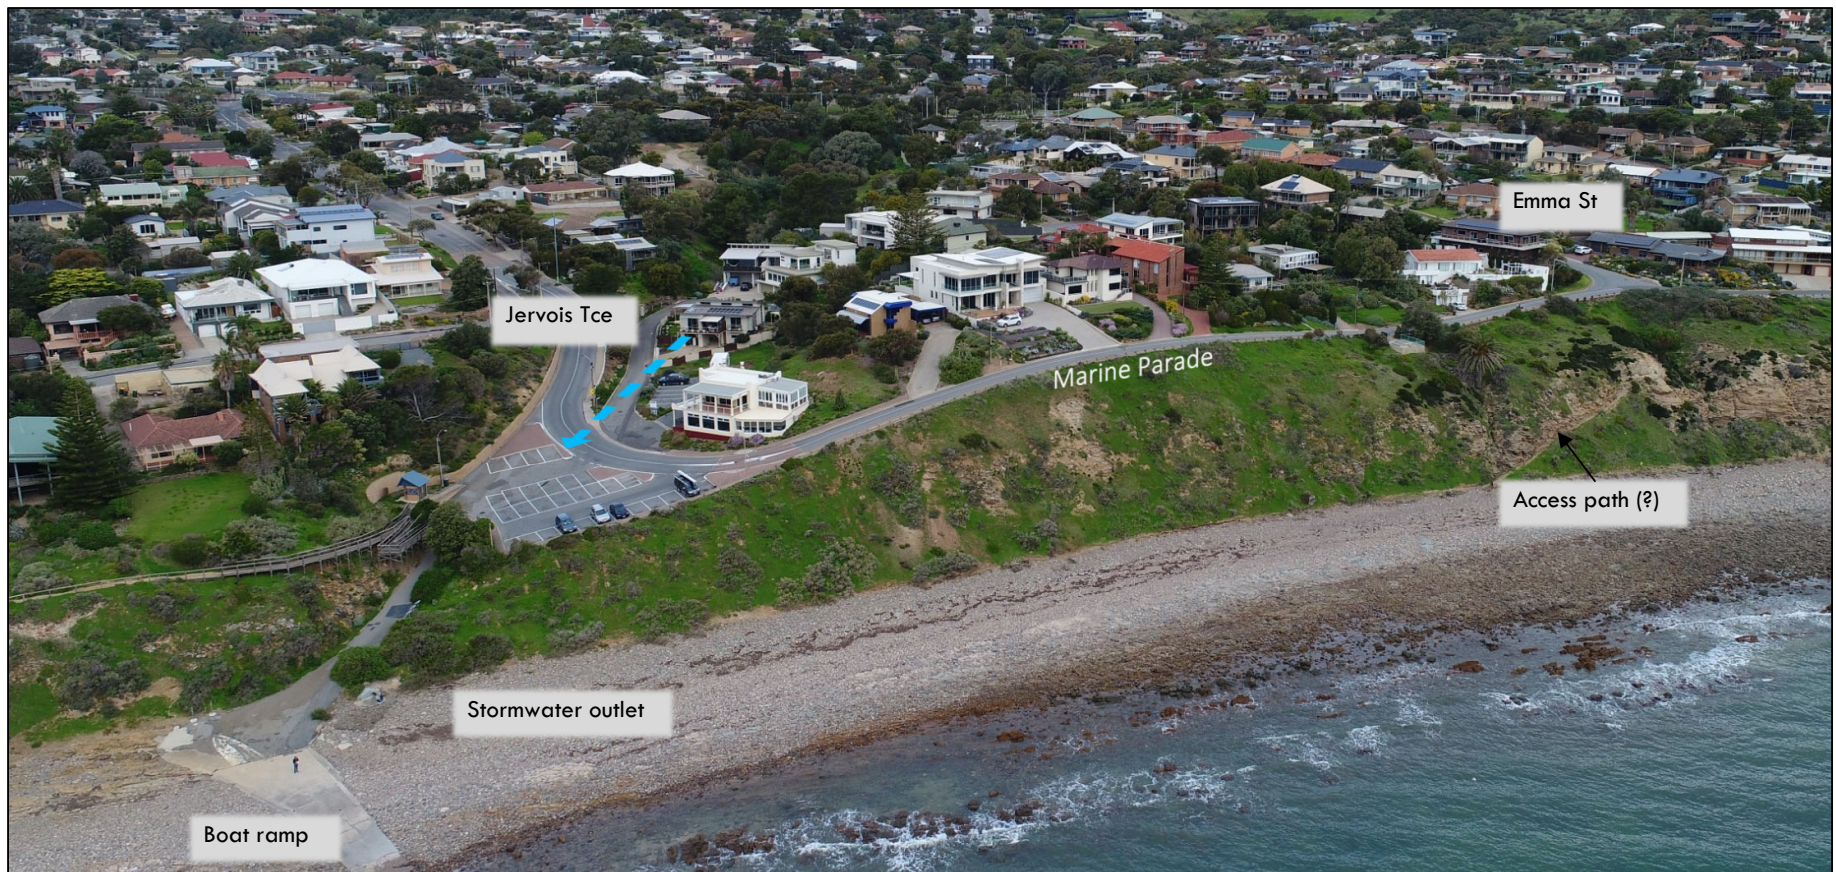
## 4-5 Coastal fabric — human intervention (Cell 1.3)

**Modifications:** Marine Parade has been constructed close to the top of the cliff which places a 'hold point' at the top of the cliff and would come under threat if the cliff receded. Dwellings and other private infrastructure are positioned landward of Marine Parade. The geology analysis noted it was composed of the Neo-Proterozoic Marino Arkose formation which is resistant to erosion.

**Protection items:** Nil

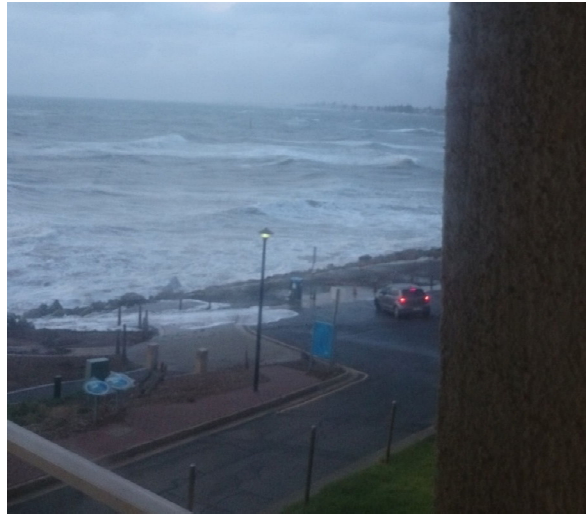
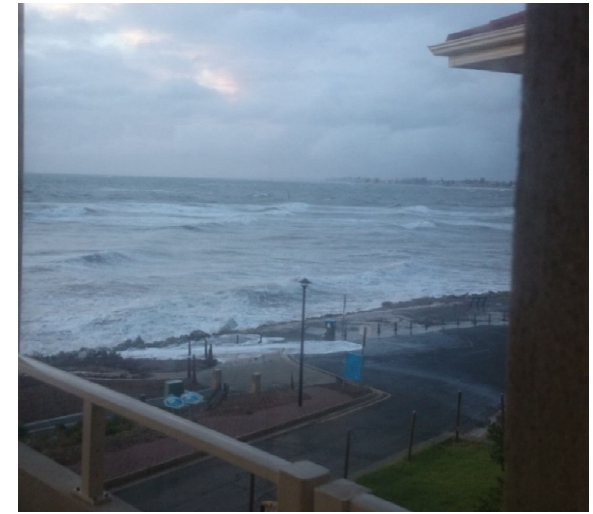
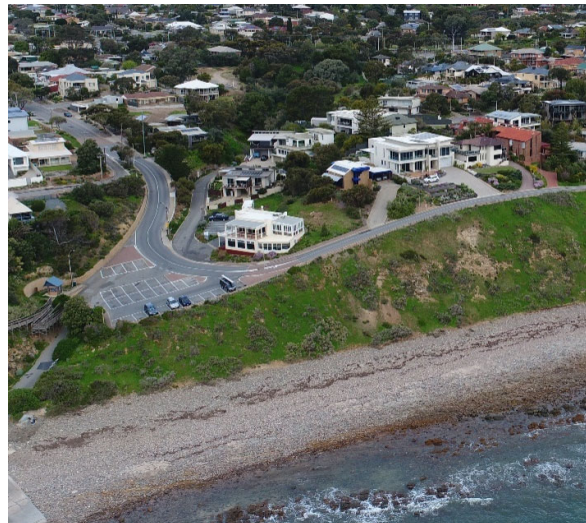
Figures a. & b. Photographs taken at 17.20, 9 May 2016 by Bill and Glenys Summersides, residents on The Esplanade at Marino (used with permission).

Figure c. Minor scarping and erosion were observed at the base of the cliff under the Marino Rocks carpark as a result of the 9 May 2016 storm.

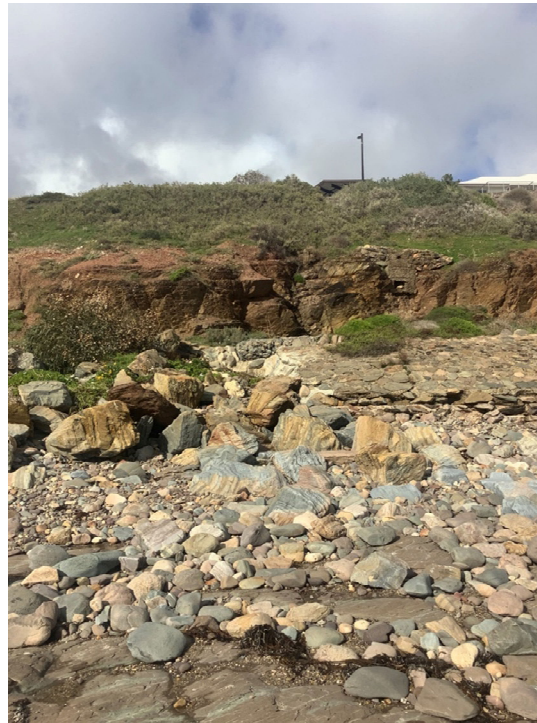
Figures (a) Stormwater flows down cliff (1.2), under footpath and under the old seawall causing it to collapse.

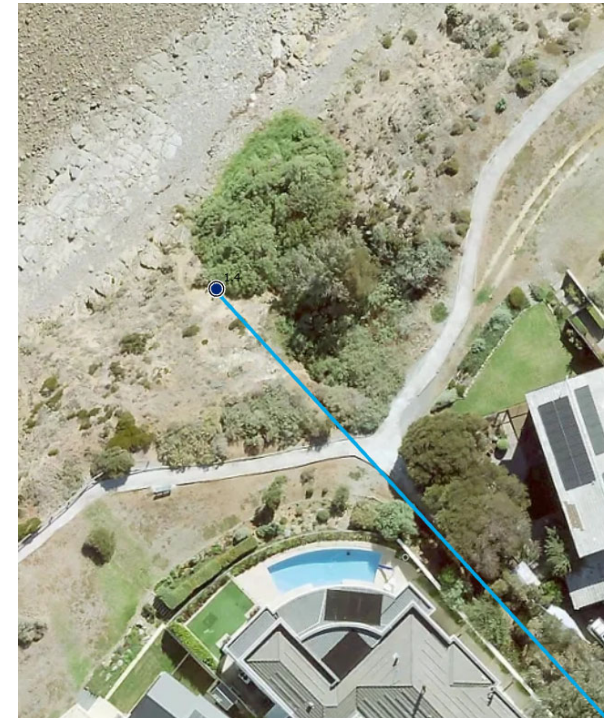
Figures (b) This is a friable cliff but volume of storm water may be low. Piping at the top is in poor repair and undercut.
