Coastal Adaptation Study

## HALLETT COVE CLIFFS NORTH

Cell 2

Review date 1 December 2022

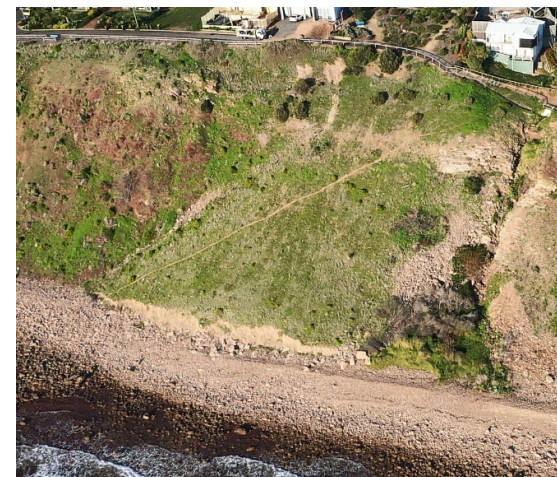
Figure a: Cliff slump in 1996. The slope of the coastal cliff was mechanically lowered, and two houses demolished.

A cliff slump occurred in 1996 at the Esplanade which resulted in demolition of two houses and purchase of the allotments by Council. The slope of the cliff was mechanically lowered. The cause of the slump was not deemed due to coastal processes but more likely due to storm water runoff.

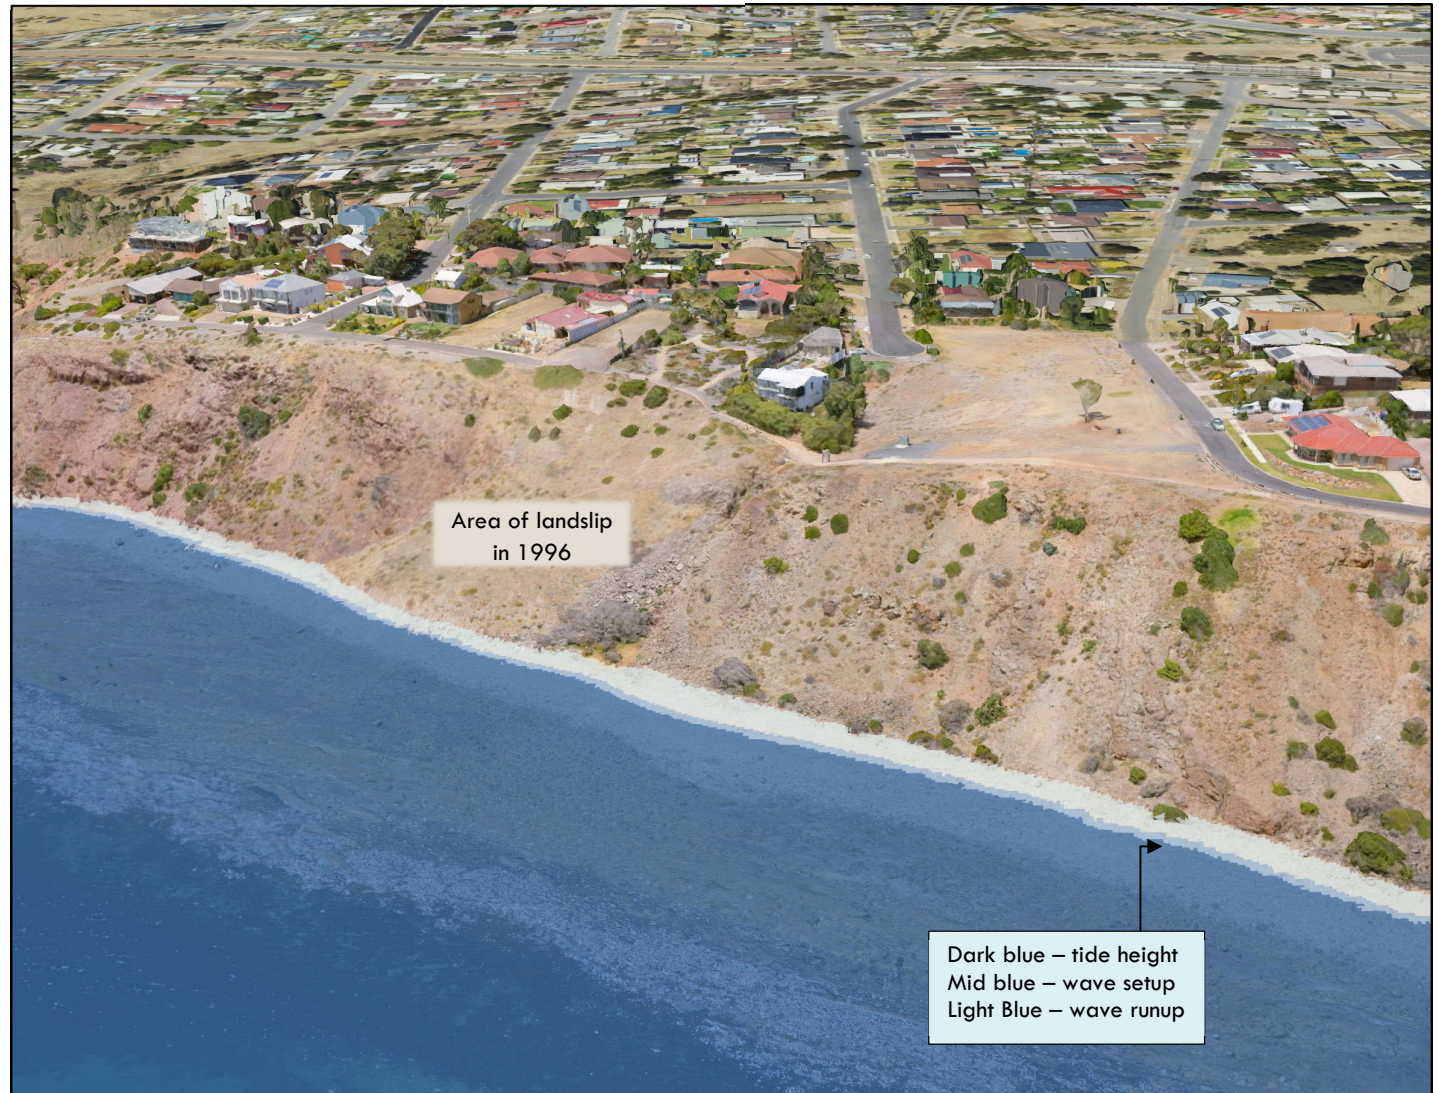
This is a rare event similar to 9 May 2016 and is likely to cause scarping at the base of the sloping cliffs, especially in the location where the slope was mechanically lowered in the 1980s after a landslide. However, there doesn't appear to be any threat to the stability of the slope from this event.

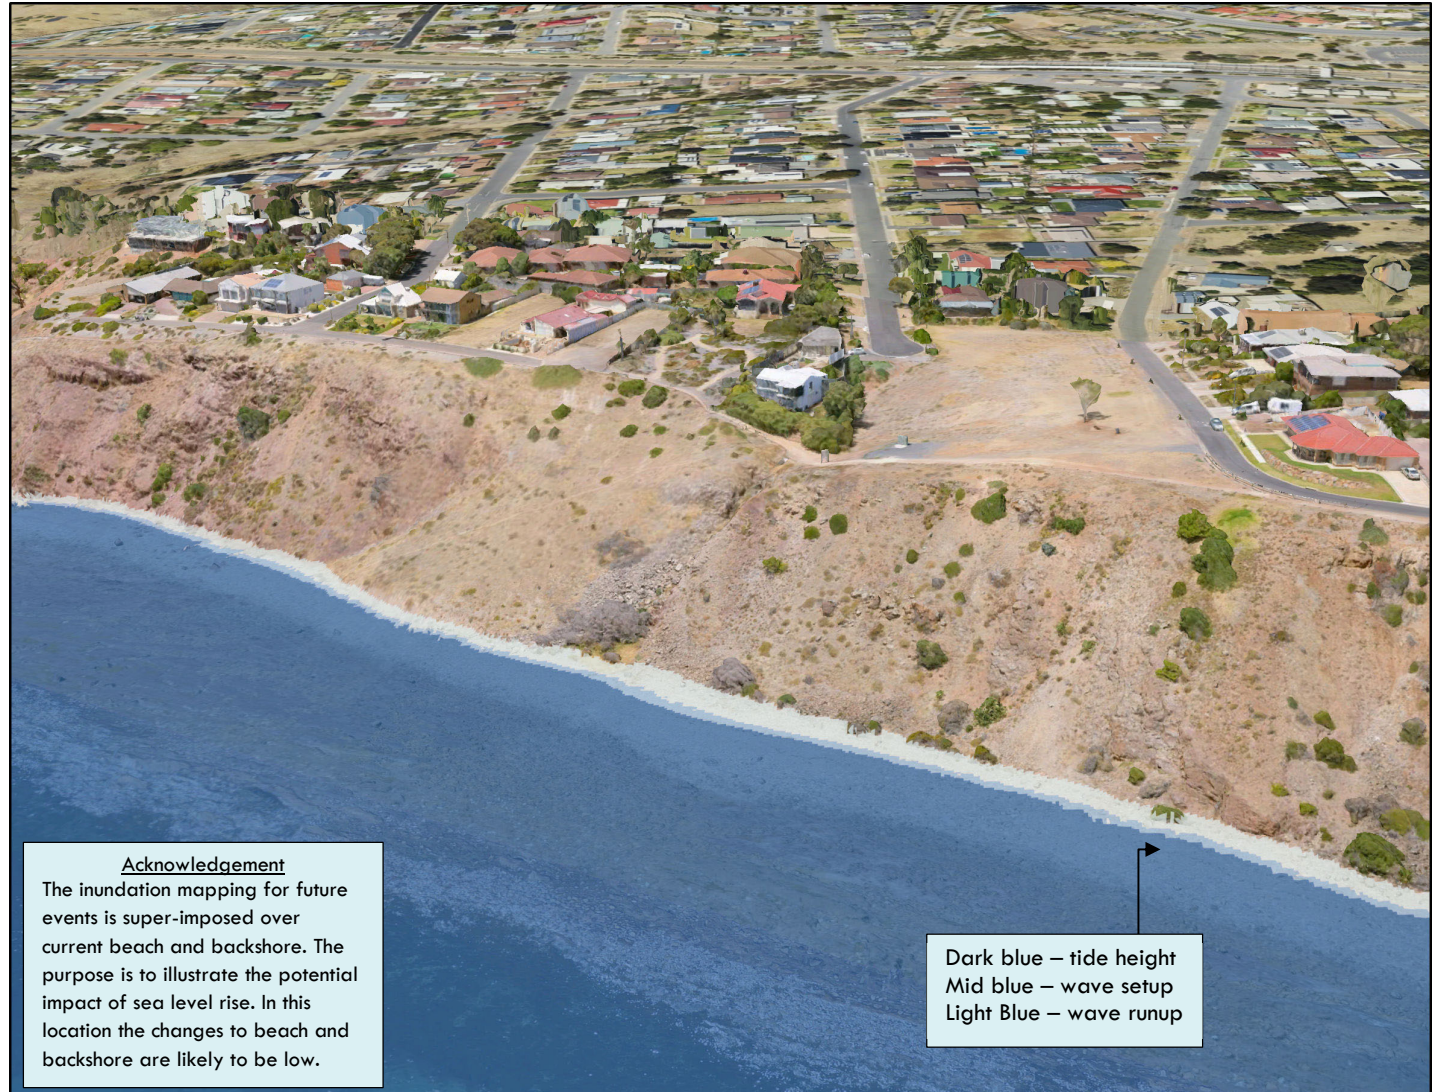
This would be a rare event and is likely to cause scarping at the base of the sloping cliffs, especially in the location where the slope was mechanically lowered in the 1980s after a landslide.

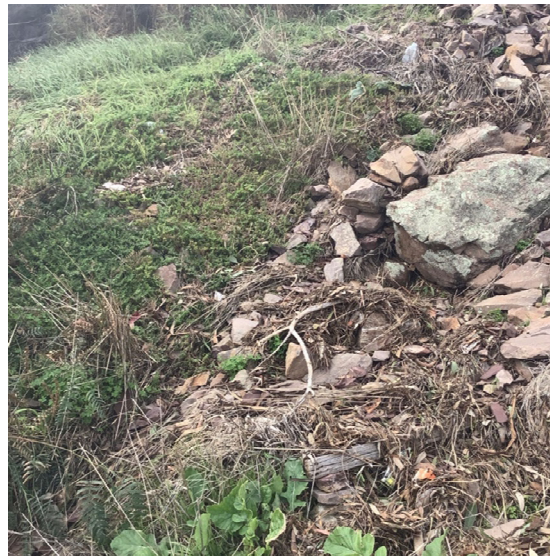
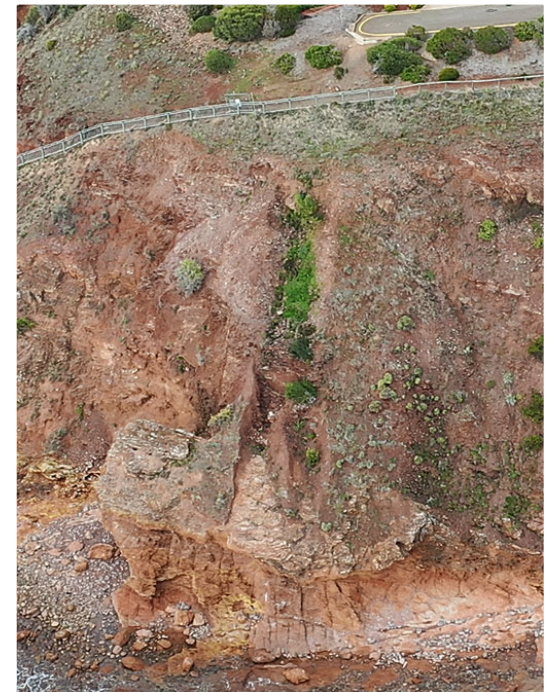
increased flooding would be considered. This cell is elevated above any risk of confluence of events.

Figures (a) It is recommended that further drone review establish whether appropriate end control has been installed and what impact is occurring on this cliff.
