Coastal Adaptation Study

HALLETT COVE BEACH

Cell 3

By Integrated Coasts
Review date 1 December 2022

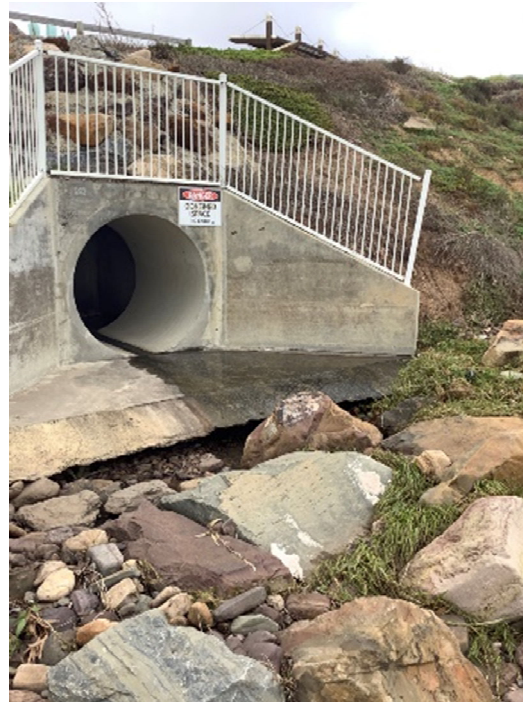
Figure (a) Outlet 3.1. Under the concrete base has been eroded away in recent storm events. Suggest fill.
