Aleppo Pine Management Plan – Cormorant Drive Reserve, Hallett Cove

Mr. Jock Conlon
Coordinator Biodiversity
City of Marion
August 2020

Sam Cassar

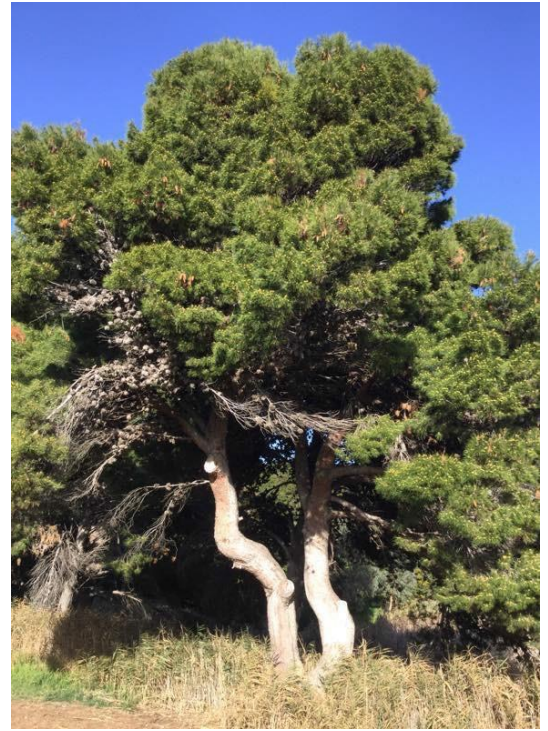
Tree ID	1
Species	Pinus halepensis
Height	10-20m
Health	Fair
Structure	Fair
Circumference	1.75 & 1.64m
Removal Program	2 yr
Comments	Die back due overshadowing southern side, crown in contact ground, crown requires lifting. 30% overall crown is dead.

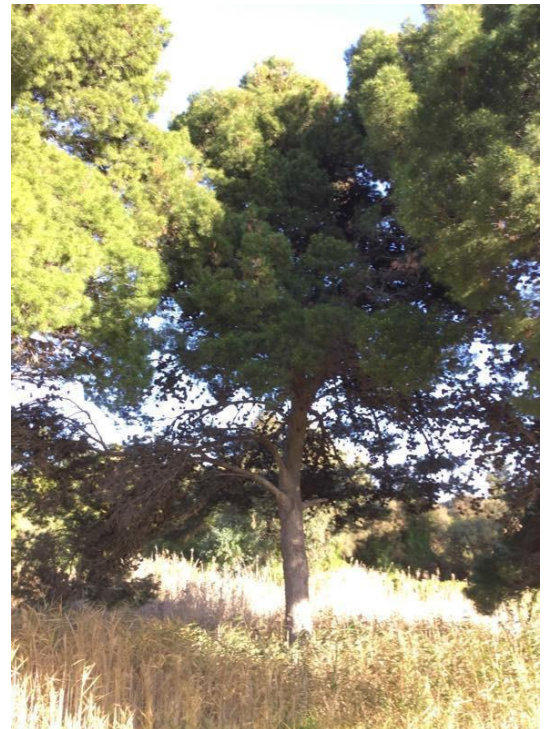
Tree ID	2
Species	Pinus halepensis
Height	10-20m
Health	Poor
Structure	Fair
Circumference	1.52m
Removal Program	1 yr
Comments	History of branch failure. Die back southwest side due overshadowing.

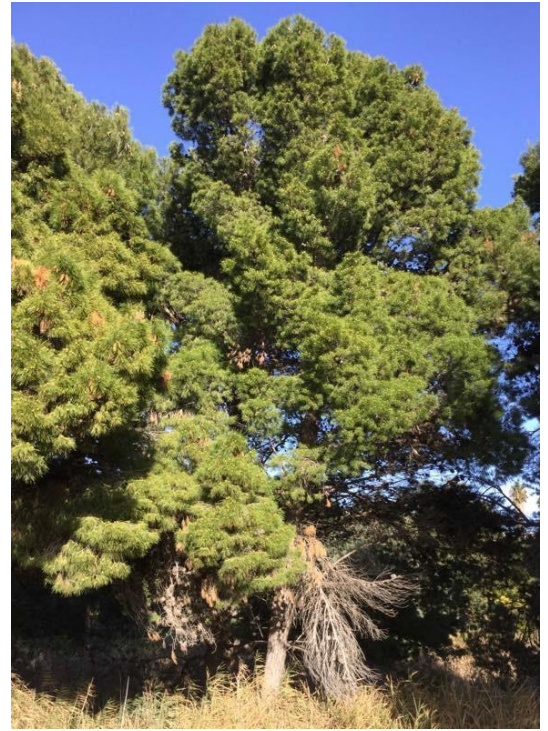
Tree ID	3
Species	Pinus halepensis
Height	10-20m
Health	Poor
Structure	Fair
Circumference	1.25m
Removal Program	1 yr
Comments	Approximately 50% crown dieback apparent. Crown bias west.

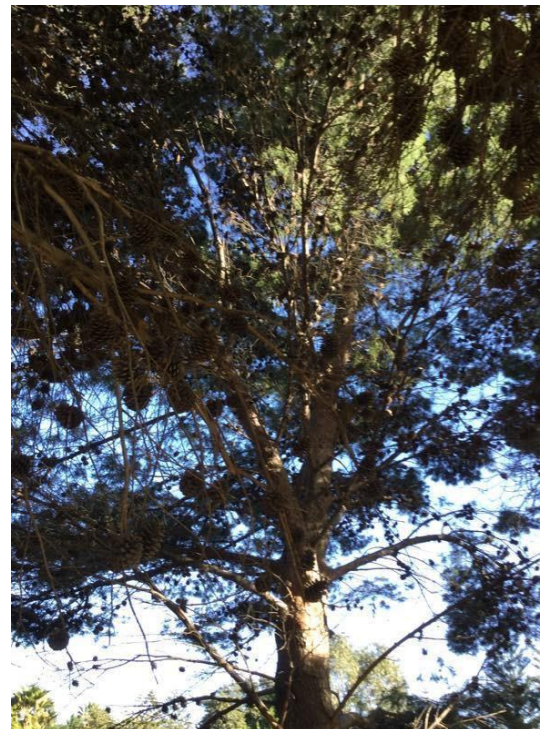
Tree ID	4
Species	Pinus halepensis
Height	10-20m
Health	Fair
Structure	Fair
Circumference	1.75m
Removal Program	3 yr
Comments	Crown lift required to 3 metres.

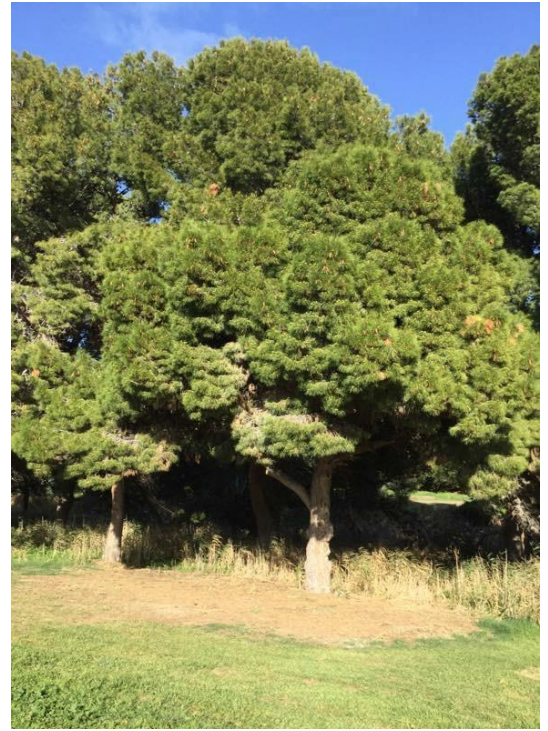
Tree ID	5
Species	Pinus halepensis
Height	5-10m
Health	Fair
Structure	Poor
Circumference	1.56m
Removal Program	2 yr
Comments	History branch failure, 50% crown dieback southern side. Tree stunted overshadowed by larger tree to southeast.

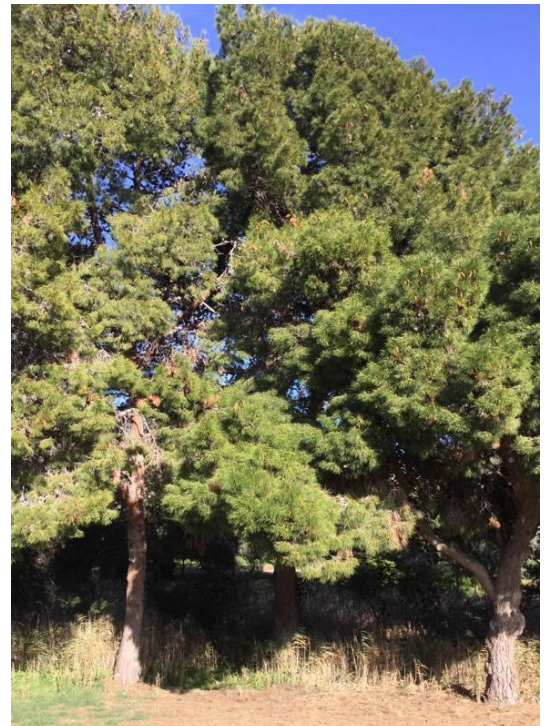
Tree ID	6
Species	Pinus halepensis
Height	10-20m
Health	Fair
Structure	Fair
Circumference	2.42m
Removal Program	4 yr
Comments	Approximately 20% crown dieback due to overshadowing. Crown lift to 3 metres.

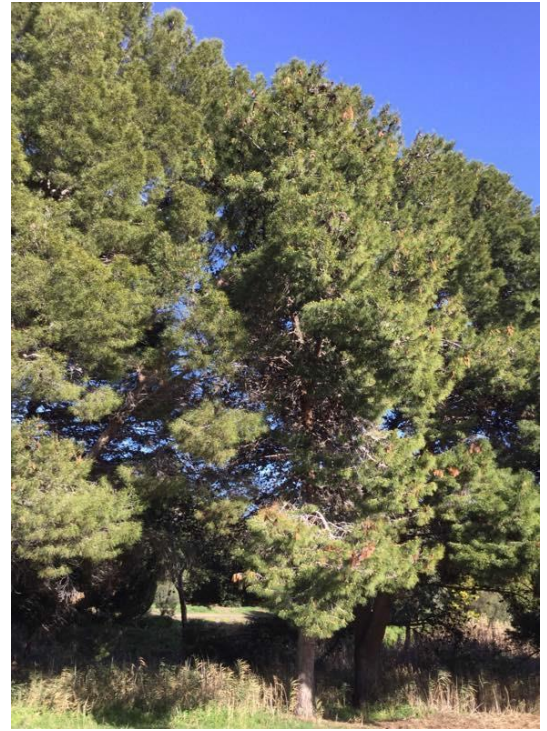
Tree ID	7
Species	Pinus halepensis
Height	10-20m
Health	Poor
Structure	Fair
Circumference	1.33m
Removal Program	1 yr
Comments	Approximately 50% crown dieback due overshadowing. Crown bias northeast. Crown lift to 3 metres required.

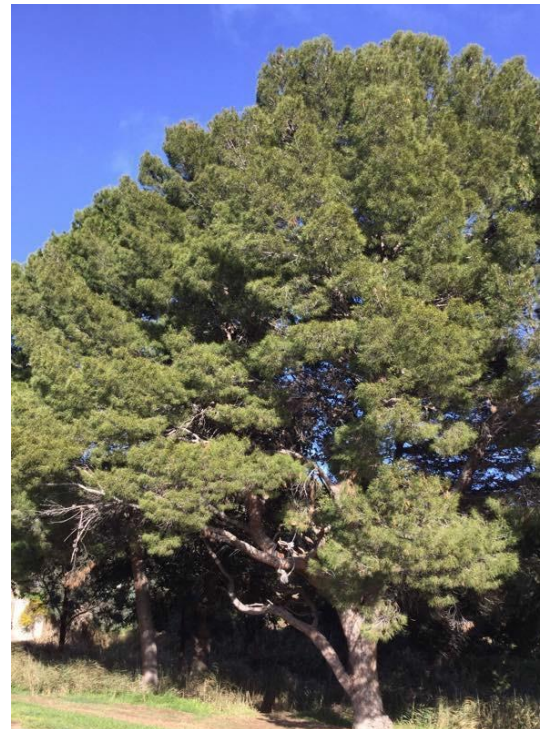
Tree ID	8
Species	Pinus halepensis
Height	10-20m
Health	Fair
Structure	Fair
Circumference	2.26m
Removal Program	4 yr
Comments	Crown bias towards the northeast. Broad spreading. 30% crown dieback due to overshadowing. Used as swing. Remove lower southeastern dead lateral to main branching framework.

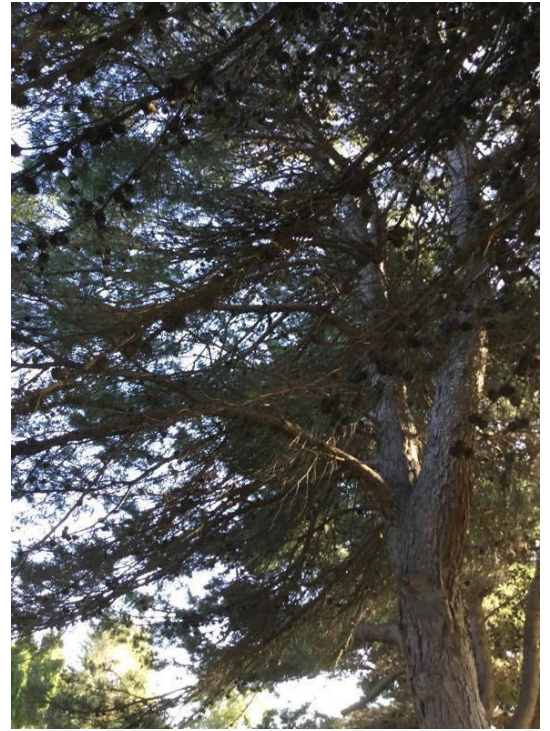
Tree ID	9
Species	Pinus halepensis
Height	10-20m
Health	Fair
Structure	Fair
Circumference	1.96m
Removal Program	4 yr
Comments	Approximately 40% dieback by overshadowing. Crown lift to 3 metres. Crown bias south.

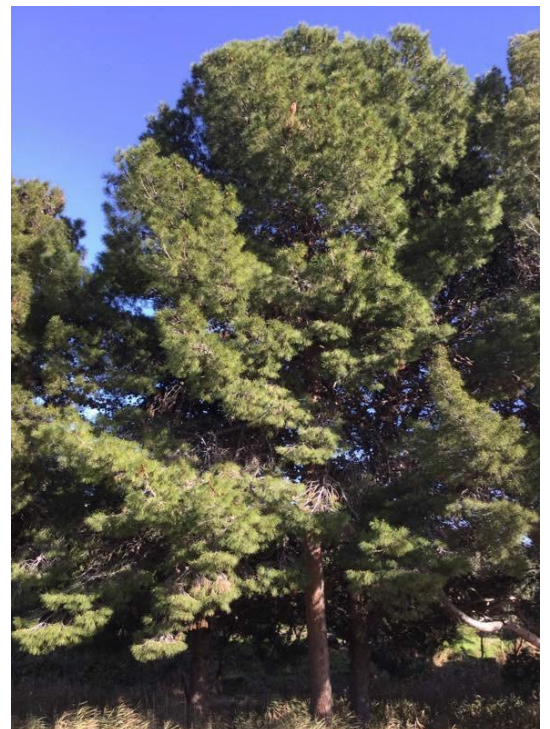
Tree ID	10
Species	Pinus halepensis
Height	10-20m
Health	Fair
Structure	Fair
Circumference	1.45m
Removal Program	3 yr
Comments	Approximately 50% overall crown is dead southern side due to overshadowing. Crown bias towards northeast. Minor history of branch failure.

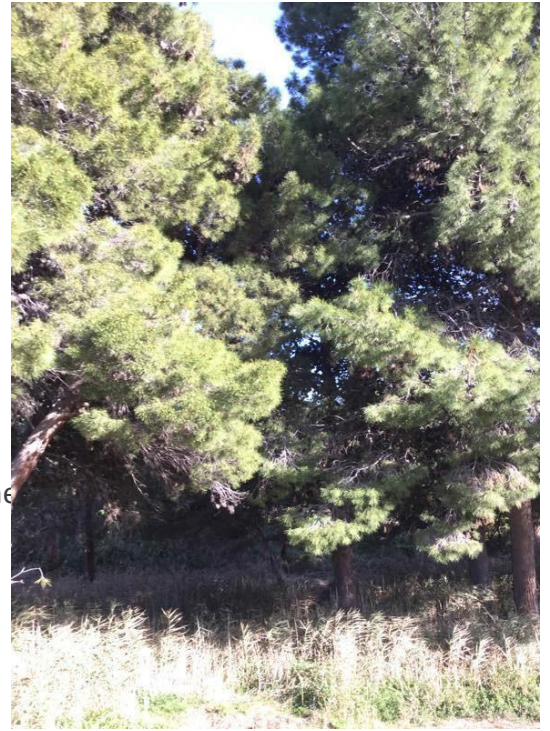
Tree ID	11
Species	<i>Pinus halepensis</i>
Height	10-20m
Health	Fair
Structure	Fair
Circumference	1.89m
Removal Program	3 yr
Comments	Approximately 50% crown dieback, northern exposure. Crown lift to 3 metres.

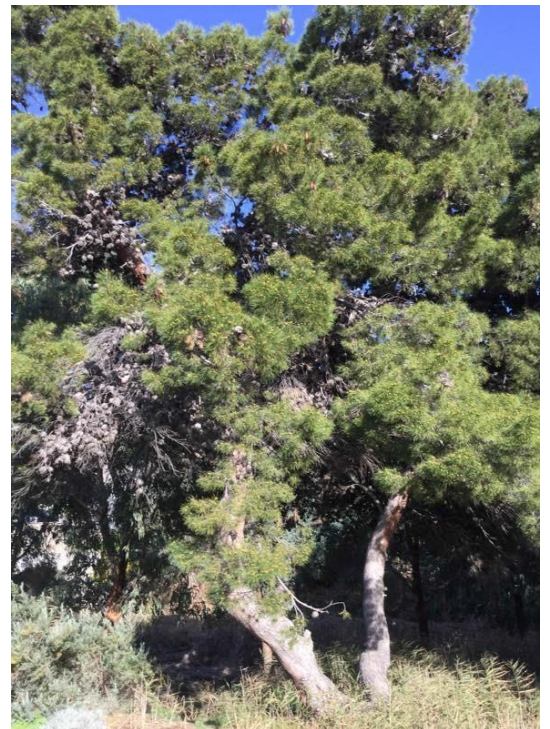
Tree ID	12
Species	<i>Pinus halepensis</i>
Height	10-20m
Health	Fair
Structure	Poor
Circumference	1.51, & 1.45 m
Removal Program	1 yr
Comments	Poor form 50% crown dieback.

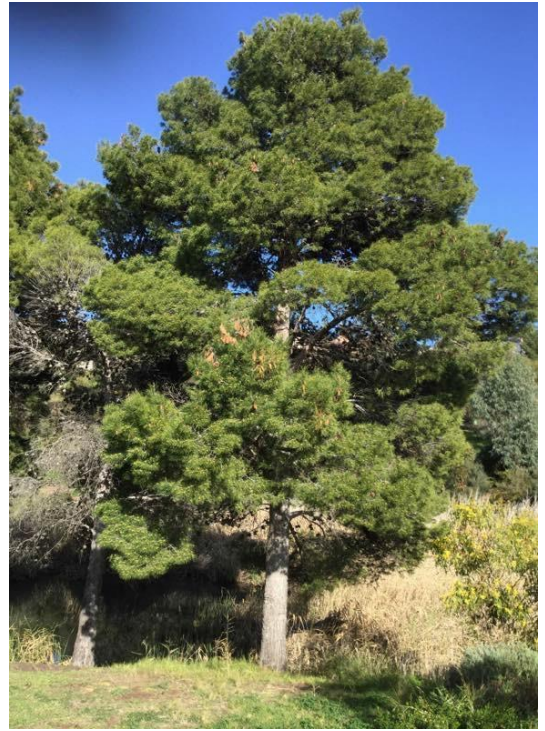
Tree ID	13
Species	Pinus halepensis
Height	10-20m
Health	Good
Structure	Good
Circumference	1.36m
Removal Program	5 yr
Comments	Moderate volumes of dead wood inner crown. Crown lift to 3 metres all sides.

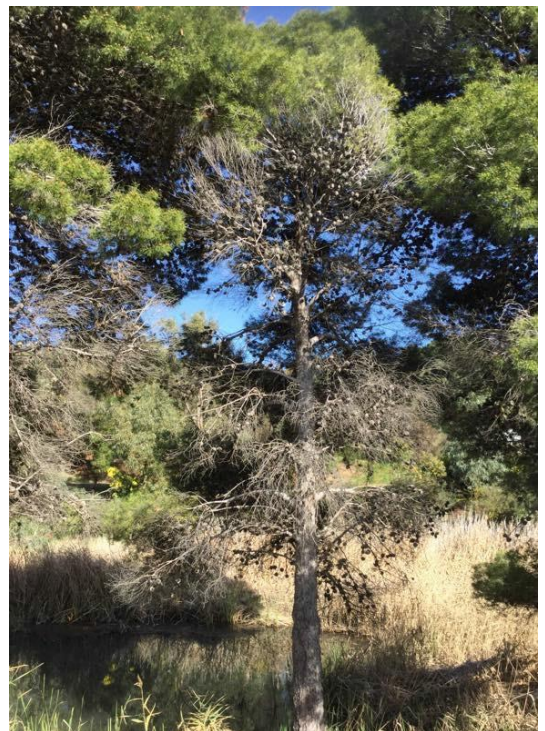
Tree ID	14
Species	Pinus halepensis
Height	10-20m
Health	Poor
Structure	Fair
Circumference	1.32m
Removal Program	1 yr
Comments	80% overall crown is dead.

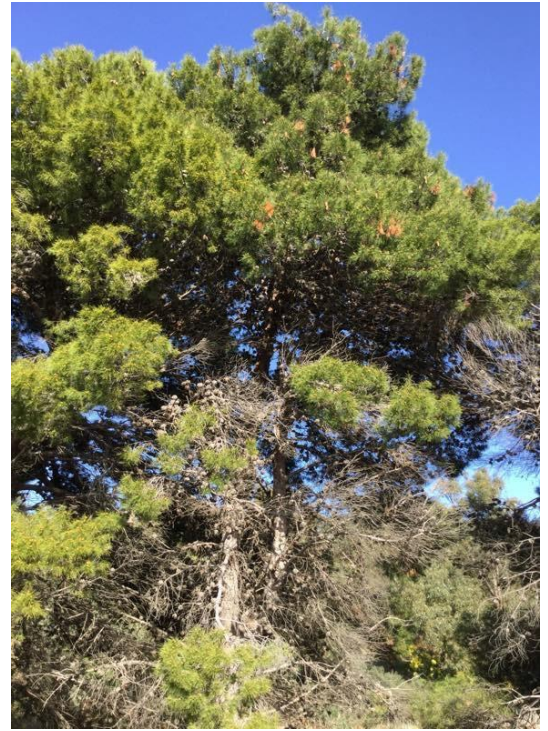
Tree ID	15
Species	<i>Pinus halepensis</i>
Height	10-20m
Health	Fair
Structure	Poor
Circumference	1.33m
Removal Program	1 yr
Comments	Twin leader poor form, 30% overall crown dieback.

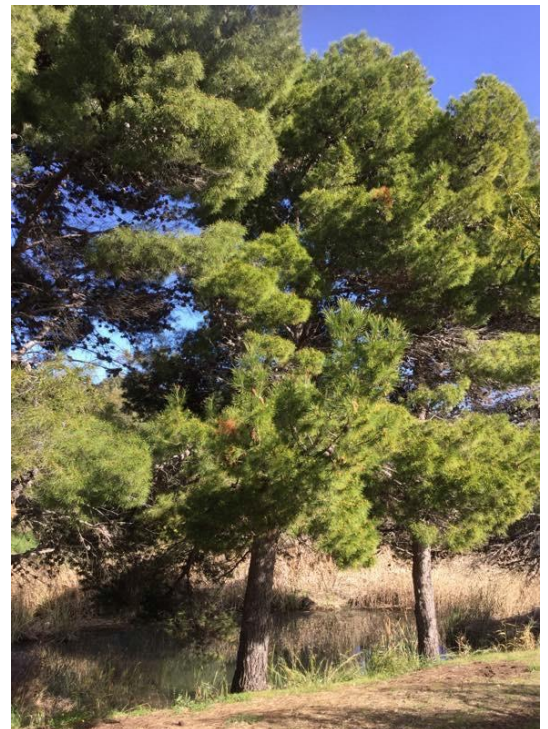
Tree ID	16
Species	<i>Pinus halepensis</i>
Height	10-20m
Health	Fair
Structure	Fair
Circumference	1.66m
Removal Program	4 yr
Comments	Crown lift to 3 metres. Crown bias towards the west.

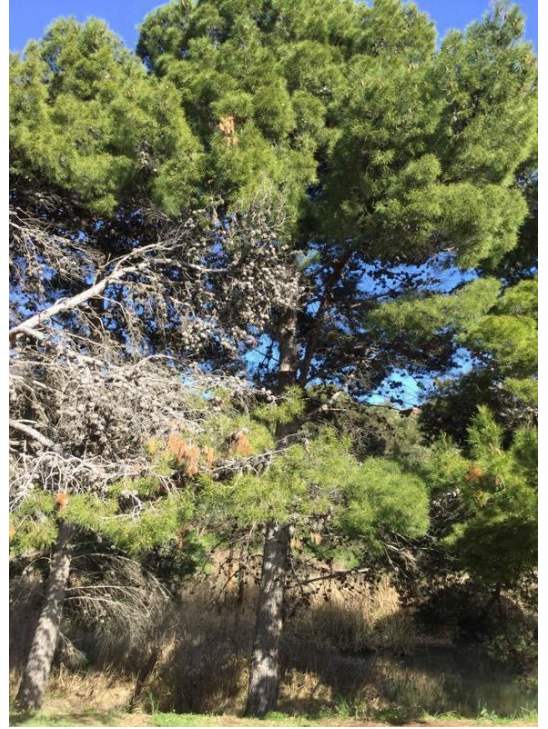
Tree ID	17
Species	Pinus halepensis
Height	10-20m
Health	Fair
Structure	Fair
Circumference	1.66m
Removal Program	3 yr
Comments	Poor form, no canopy 3/4 trunk northeastern side. Crown lift 3 metres.

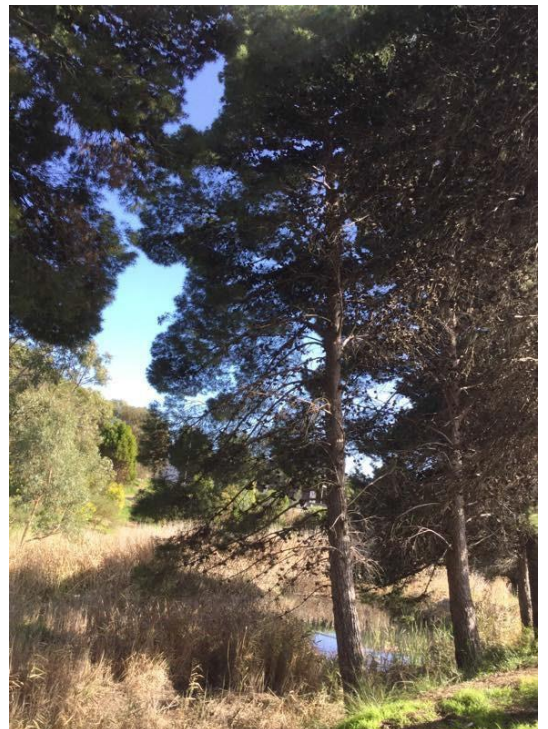
Tree ID	18
Species	Pinus halepensis
Height	10-20m
Health	Poor
Structure	Poor
Circumference	1.55m
Removal Program	1 yr
Comments	Tall upright form no canopy majority of the northeastern side. poor tree

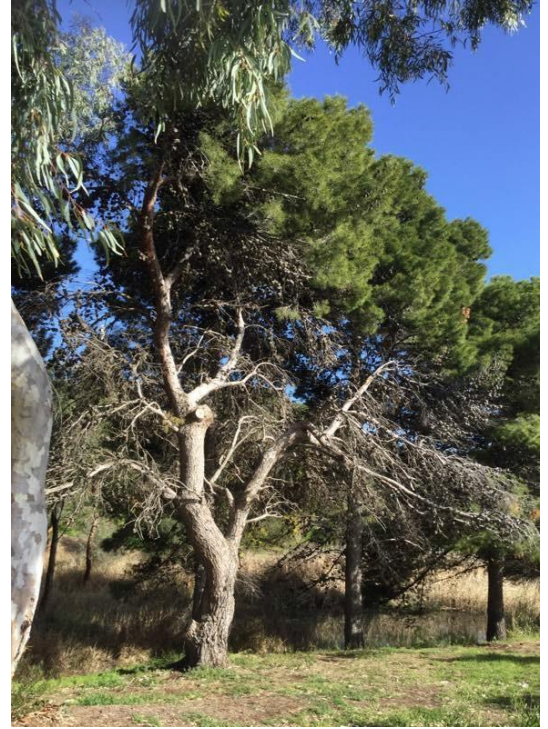
Tree ID	19
Species	Pinus halepensis
Height	10-20m
Health	Poor
Structure	Poor
Circumference	2.14m
Removal Program	1 yr
Comments	Approximately 50% crown dieback, poor form crown bias west, heavily pruned in past.

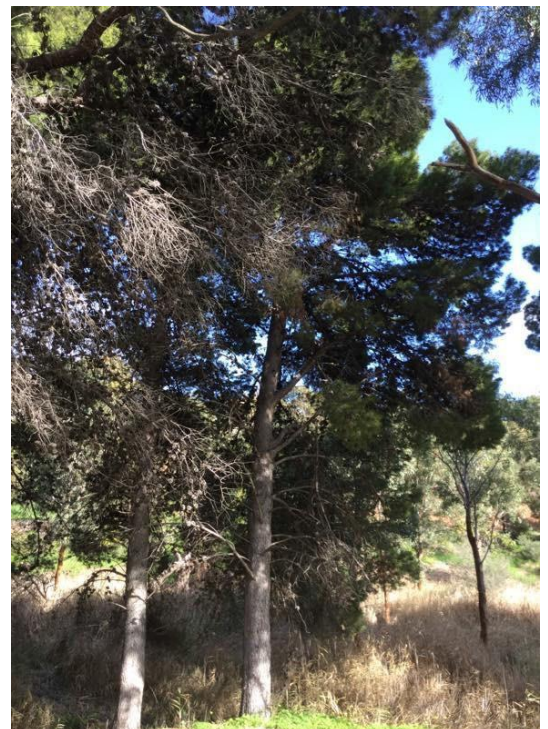
Tree ID	20
Species	Pinus halepensis
Height	10-20m
Health	Fair
Structure	Fair
Circumference	1.65m
Removal Program	3 yr
Comments	Approximately 40% dieback northeastern side due to overshadowing. Crown lift to 3 metres.

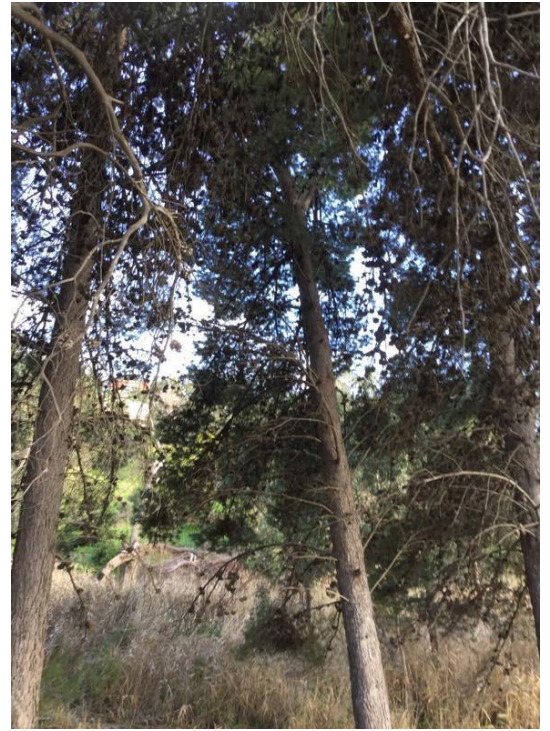
Tree ID	21
Species	Pinus halepensis
Height	10-20m
Health	Fair
Structure	Poor
Circumference	1.7m
Removal Program	2 yr
Comments	Approximately 50% of overall crown dieback. Trunk leans towards the southwest.

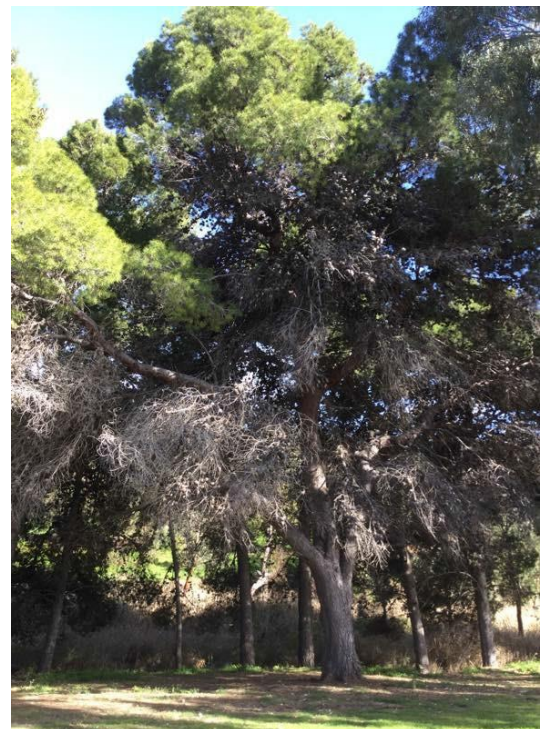
Tree ID	22
Species	Pinus halepensis
Height	10-20m
Health	Fair
Structure	Fair
Circumference	3.18m
Removal Program	5 yr
Comments	Entire lower crown approximately 50% dead. Prune lower dead branches to 5 metres.

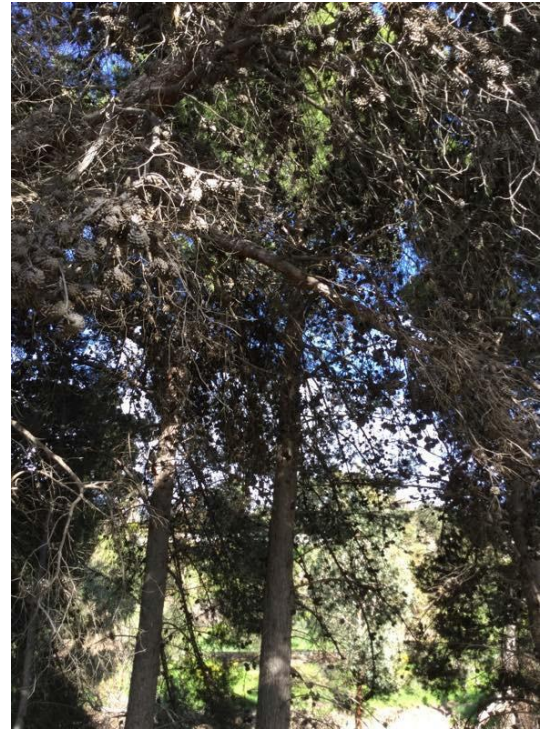
Tree ID	23
Species	<i>Pinus halepensis</i>
Height	10-20m
Health	Fair
Structure	Poor
Circumference	1.83m
Removal Program	2 yr
Comments	Approximately 50% overall crown is dead due to overshadowing.

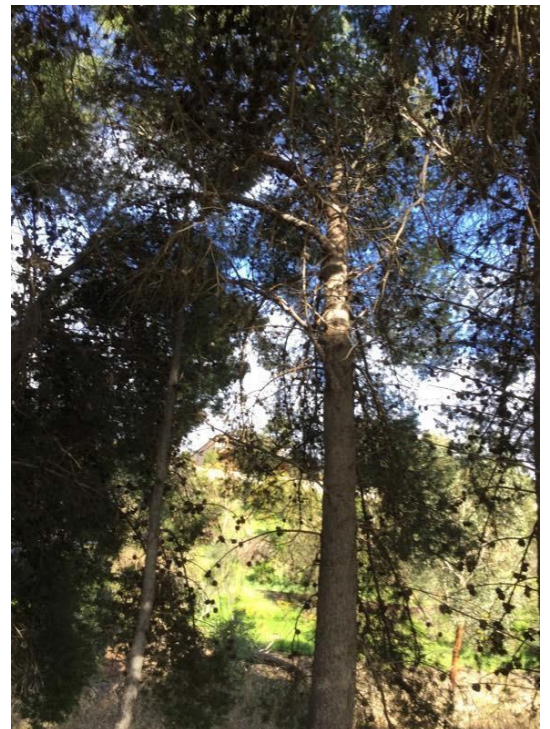
Tree ID	24
Species	<i>Pinus halepensis</i>
Height	10-20m
Health	Poor
Structure	Fair
Circumference	1.8m
Removal Program	2 yr
Comments	Approximately 60% overall crown is dead due to overshadowing. Crown bias towards the southeast.

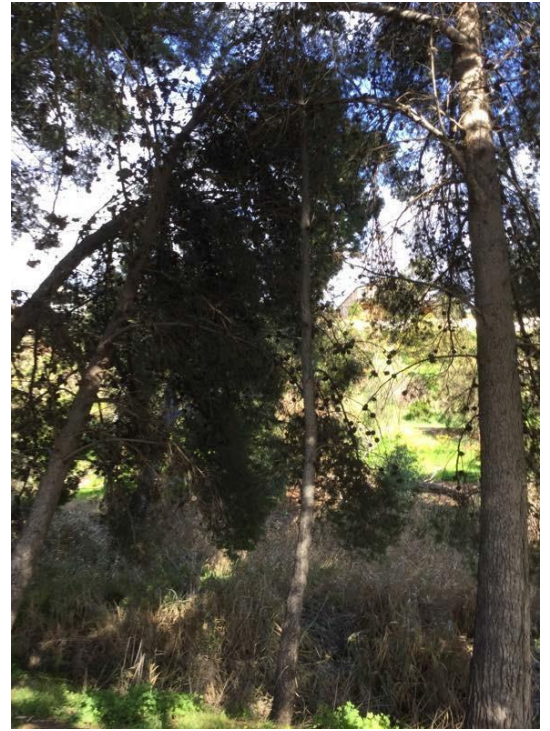
Tree ID	25
Species	<i>Pinus halepensis</i>
Height	5-10m
Health	Poor
Structure	Poor
Circumference	0.65m
Removal Program	1 yr
Comments	Only a tuft of foliage end of trunk.

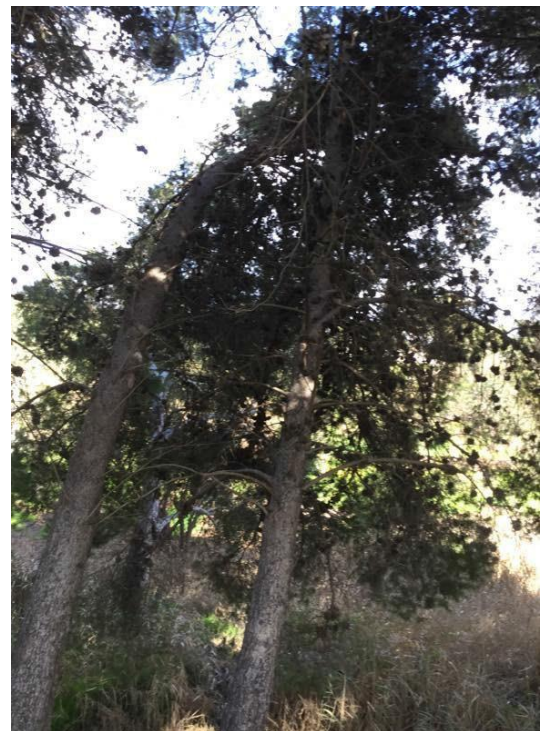
Tree ID	27
Species	<i>Pinus halepensis</i>
Height	5-10m
Health	Poor
Structure	Poor
Circumference	1.2m
Removal Program	1 yr
Comments	Approximately 80% overall crown is dead, crown bias towards southwest. Stunted growth.

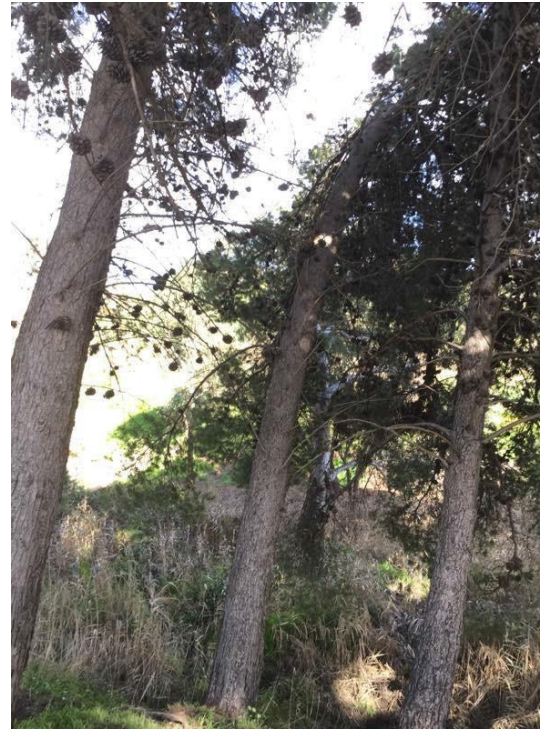
Tree ID	28
Species	<i>Pinus halepensis</i>
Height	5-10m
Health	Poor
Structure	Poor
Circumference	1.25m
Removal Program	1 yr
Comments	Poor form 80% overall crown is dead. Crown bias towards the southwest.

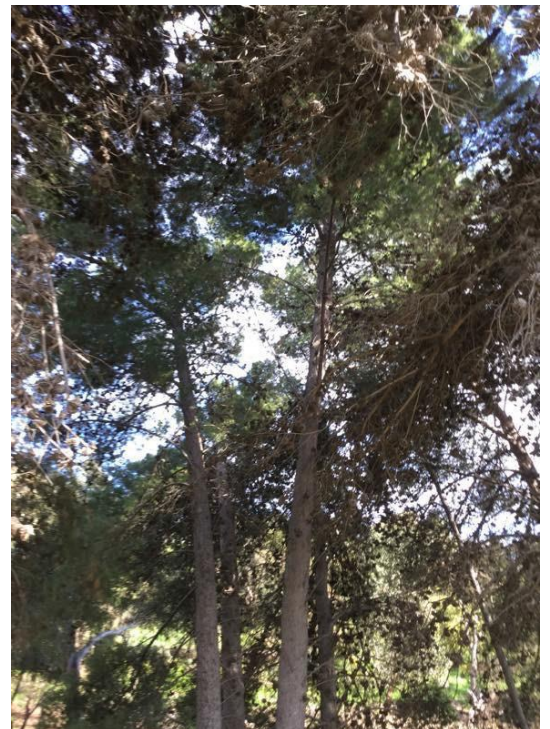
Tree ID	29
Species	<i>Pinus halepensis</i>
Height	10-20m
Health	Fair
Structure	Fair
Circumference	1.36m
Removal Program	2 yr
Comments	Upright crown, approximately 50% crown dieback.

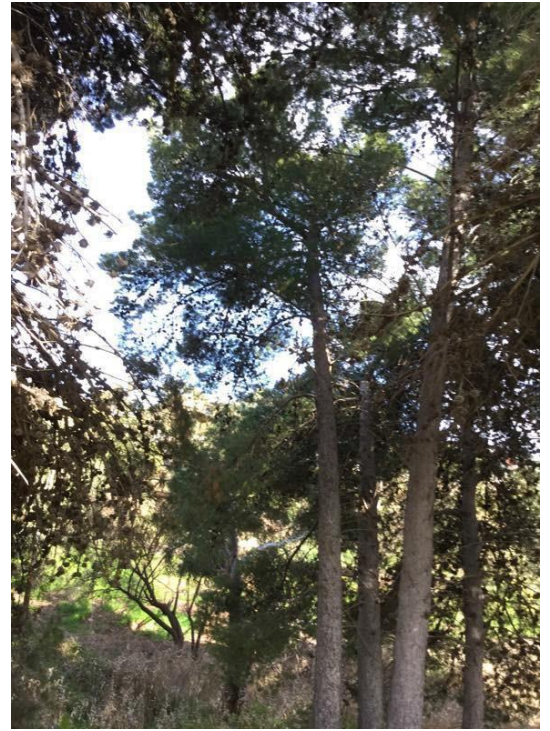
Tree ID	30
Species	<i>Pinus halepensis</i>
Height	10-20m
Health	Fair
Structure	Fair
Circumference	1.23m
Removal Program	2 yr
Comments	Crown bias towards the southeast 50% overall crown is dead.

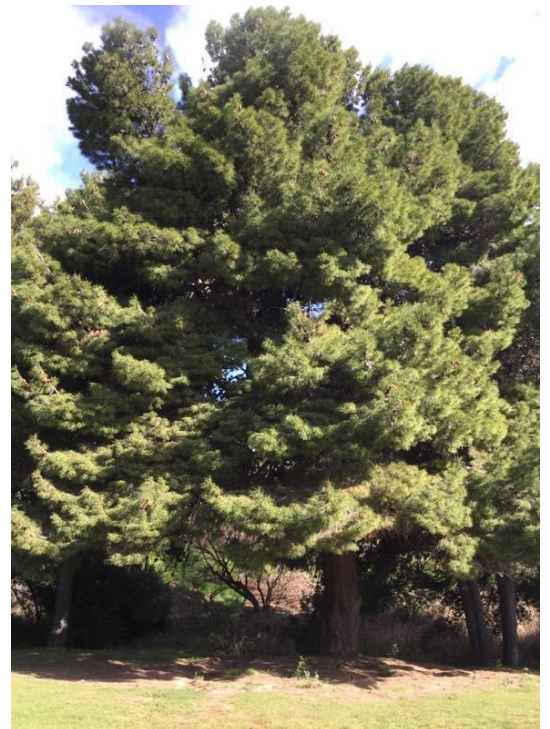
Tree ID	31
Species	<i>Pinus halepensis</i>
Height	10-20m
Health	Fair
Structure	Fair
Circumference	3.83m
Removal Program	6 yr
Comments	Largest tree, moderate volumes of dead wood inner crown. Crown lift to 3 metres all sides.

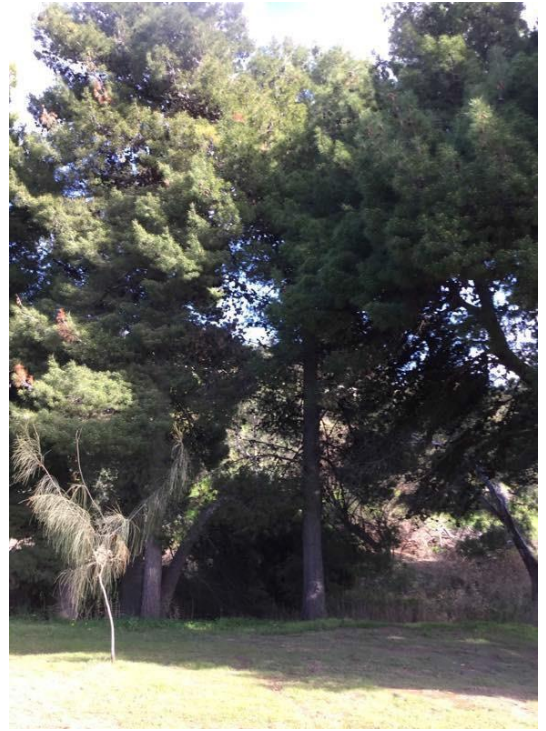
Tree ID	32
Species	<i>Pinus halepensis</i>
Height	10-20m
Health	Fair
Structure	Fair
Circumference	1.95m
Removal Program	3 yr
Comments	Some deadwood inner crown, crown lift 3 metres

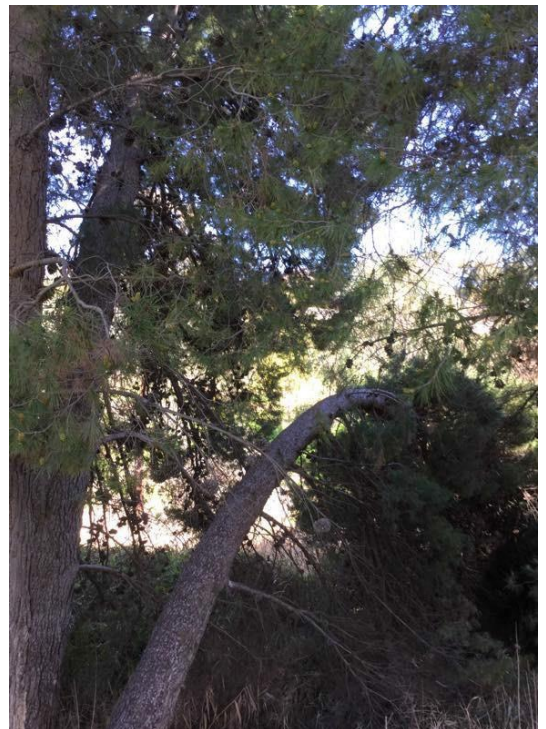
Tree ID	33
Species	<i>Pinus halepensis</i>
Height	10-20m
Health	Fair
Structure	Poor
Circumference	1.95, 1.32m
Removal Program	1 yr
Comments	Heavy bias to west, in contact with creek, bifurcation primary union.

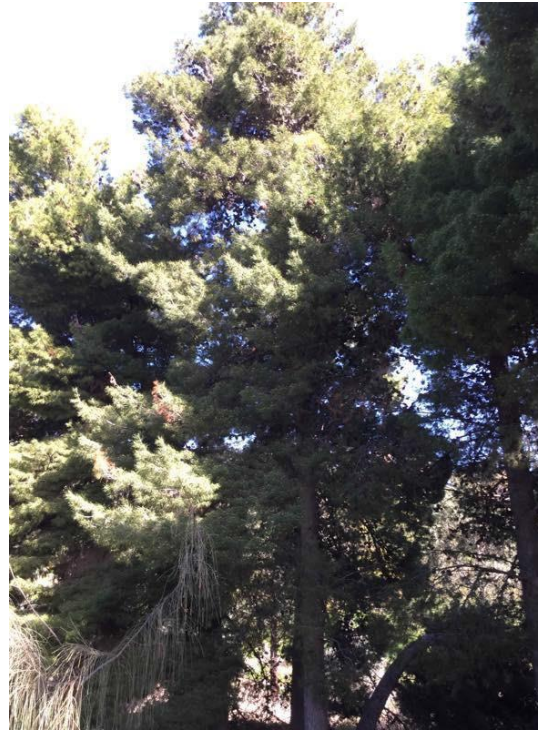
Tree ID	34
Species	Pinus halepensis
Height	10-20m
Health	Fair
Structure	Fair
Circumference	1.45m
Removal Program	2 yr
Comments	Crown dieback southern southwestern sides approximately 50%.

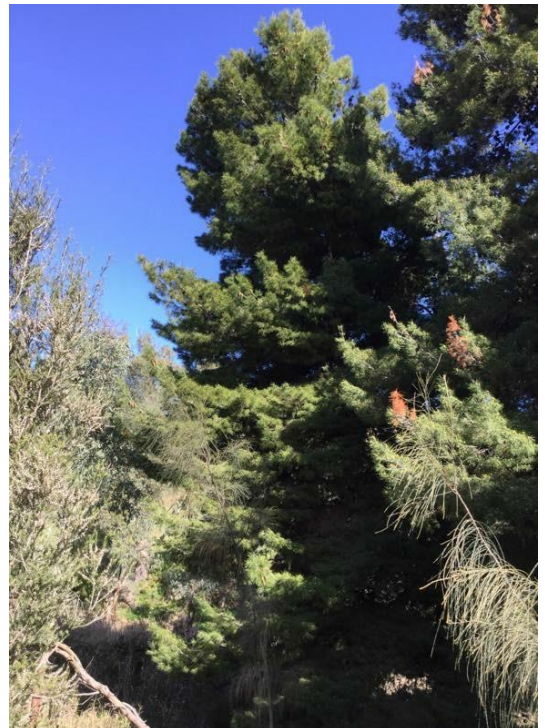
Tree ID	35
Species	Pinus halepensis
Height	10-20m
Health	Fair
Structure	Fair
Circumference	1.93m
Removal Program	2 yr
Comments	Approximately 50% crown dieback western side, removed earlier due to prevailing winds.
