Coastal Adaptation Study

HALLETT COVE CLIFFS SOUTH

Cell 4

By Integrated Coasts

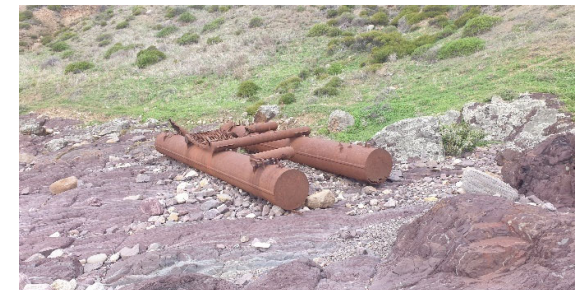
Due to evaluated coastal terrain and general inaccessibility to the beach, very few coastal structures have been installed to the beach area apart from a few posts. Debris from previous work operations remain on the beach or have floated into these locations from elsewhere (Figure b). The walking trail installed in the 1990s is primarily constructed along the natural ground and fenced on the seaward side. Some parts of the trail, particularly access ways from the surrounding roads, have been covered with a thin layer of gravel (Figure c).

Figure b. Debris from a previous era (function unknown).

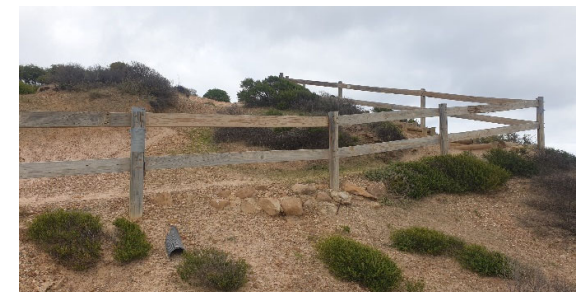
Figure c. Walking trail (predominantly a natural surface).

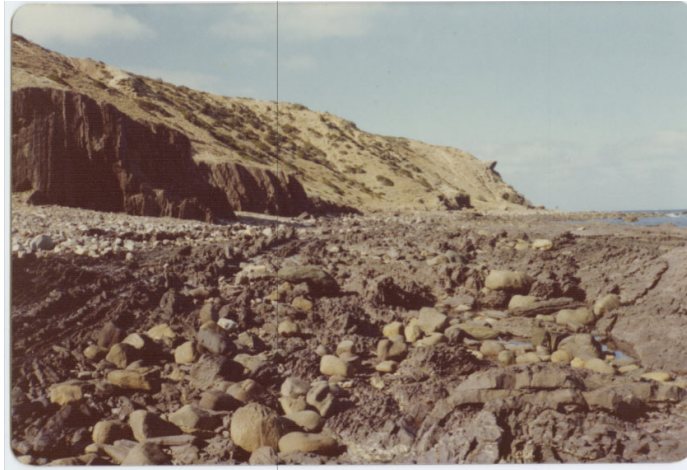
100 Years of Coastal Change.

No changes are observed in the backshores. In particular, there is no increased tidal action below the cliff.

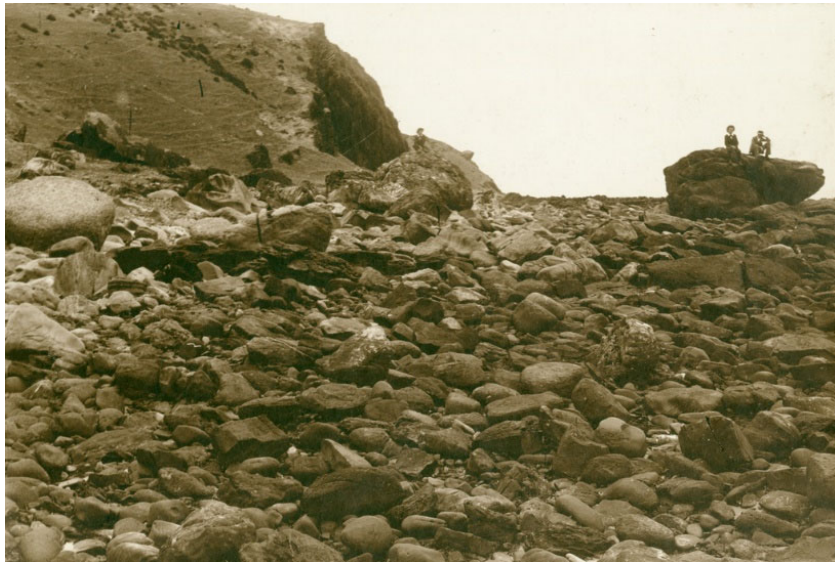
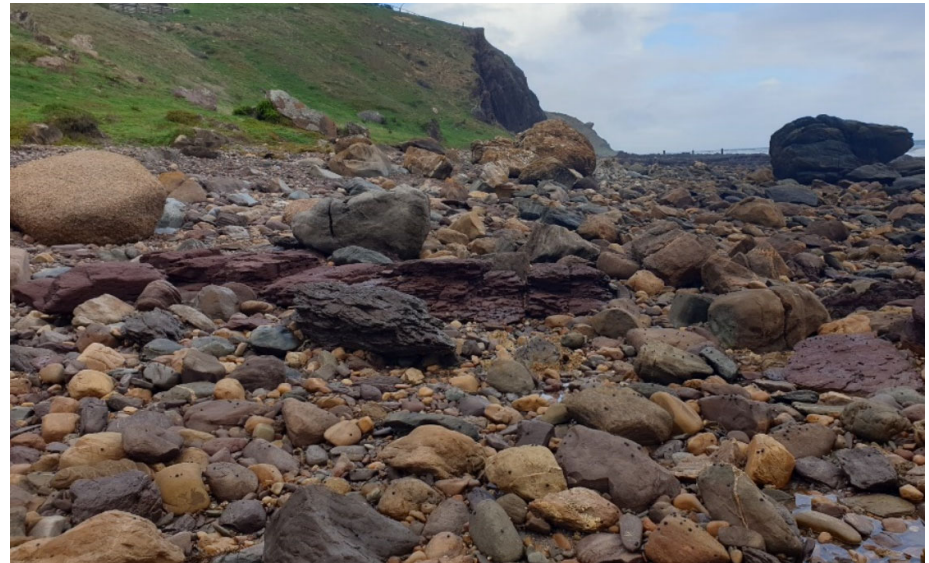
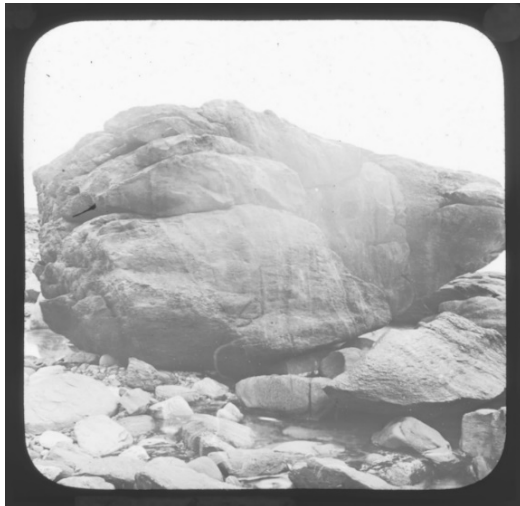
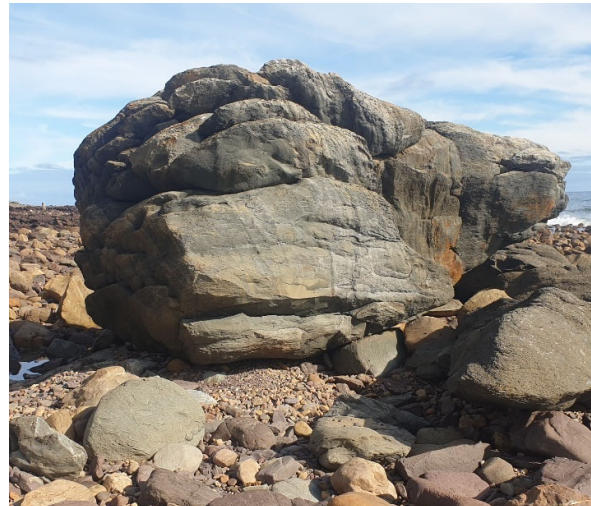
100 Years of Coastal Change

Assessment of photographs needs to consider different camera perspectives and the poorer resolution of older photographs.

Minor changes are observed to the rock situated about 100m south of Field River. The rock in 2022 appears more weathered and fissured. This analysis provides a context to consider the rate of erosion of rock within a tidal zone. Photograph c, 1900, State Library of SA, B77127-60-85, Photograph d, M. Western, June 2022.

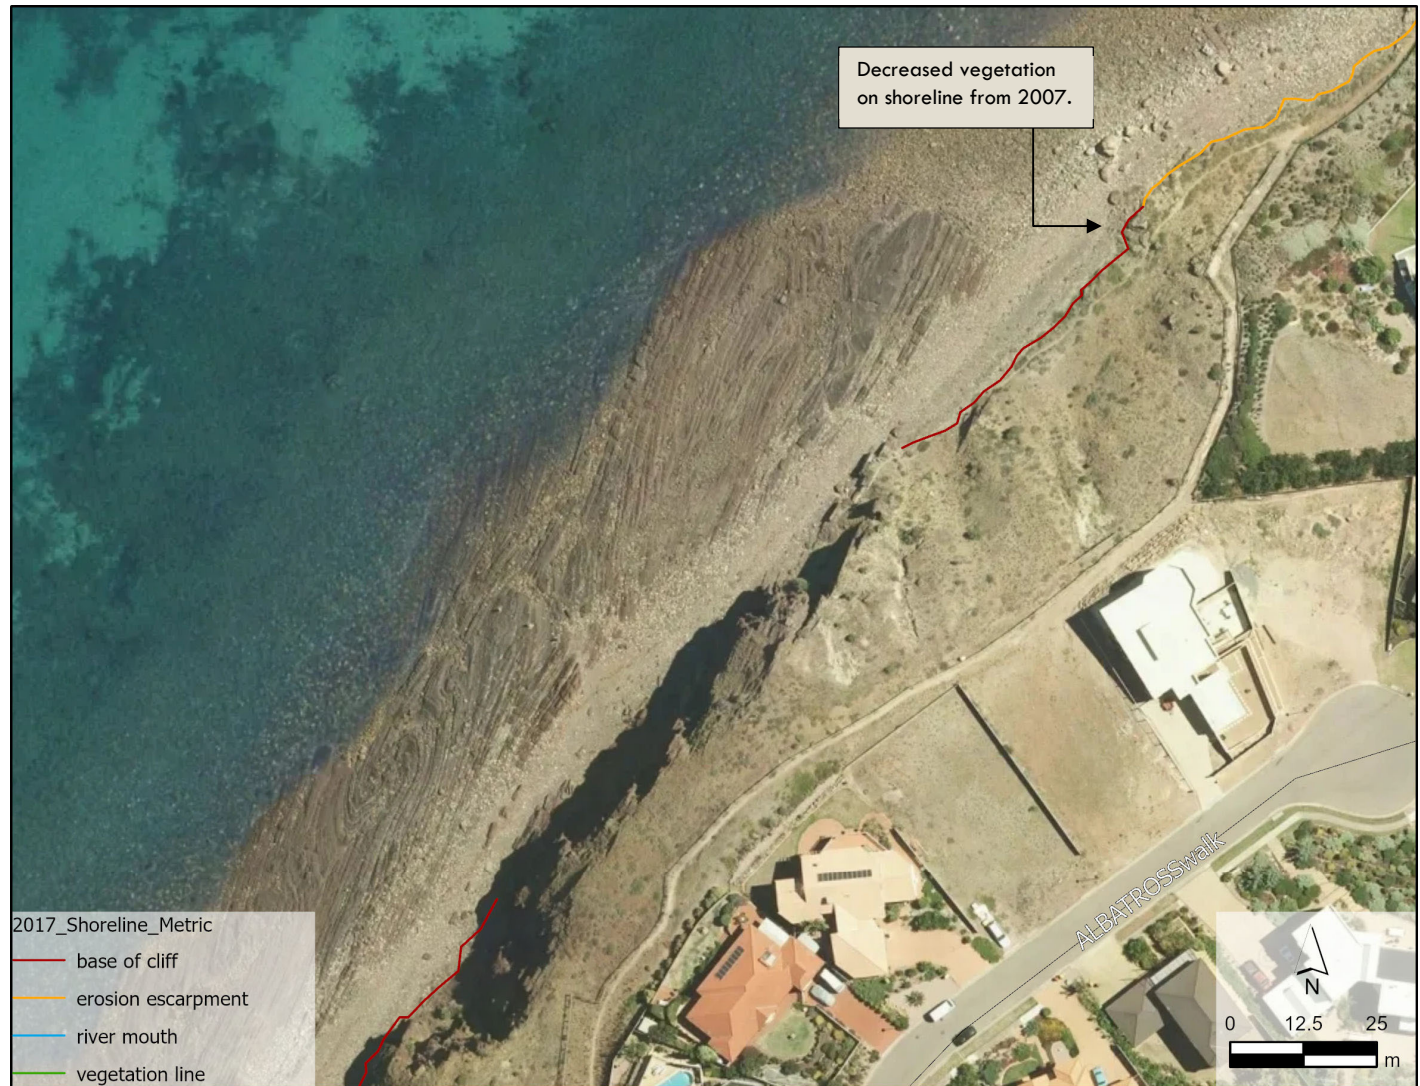
4-3 Coastal fabric — shoreline changes (Summary)

Very few changes observed apart from possible recession where shown on 1949 photograph.

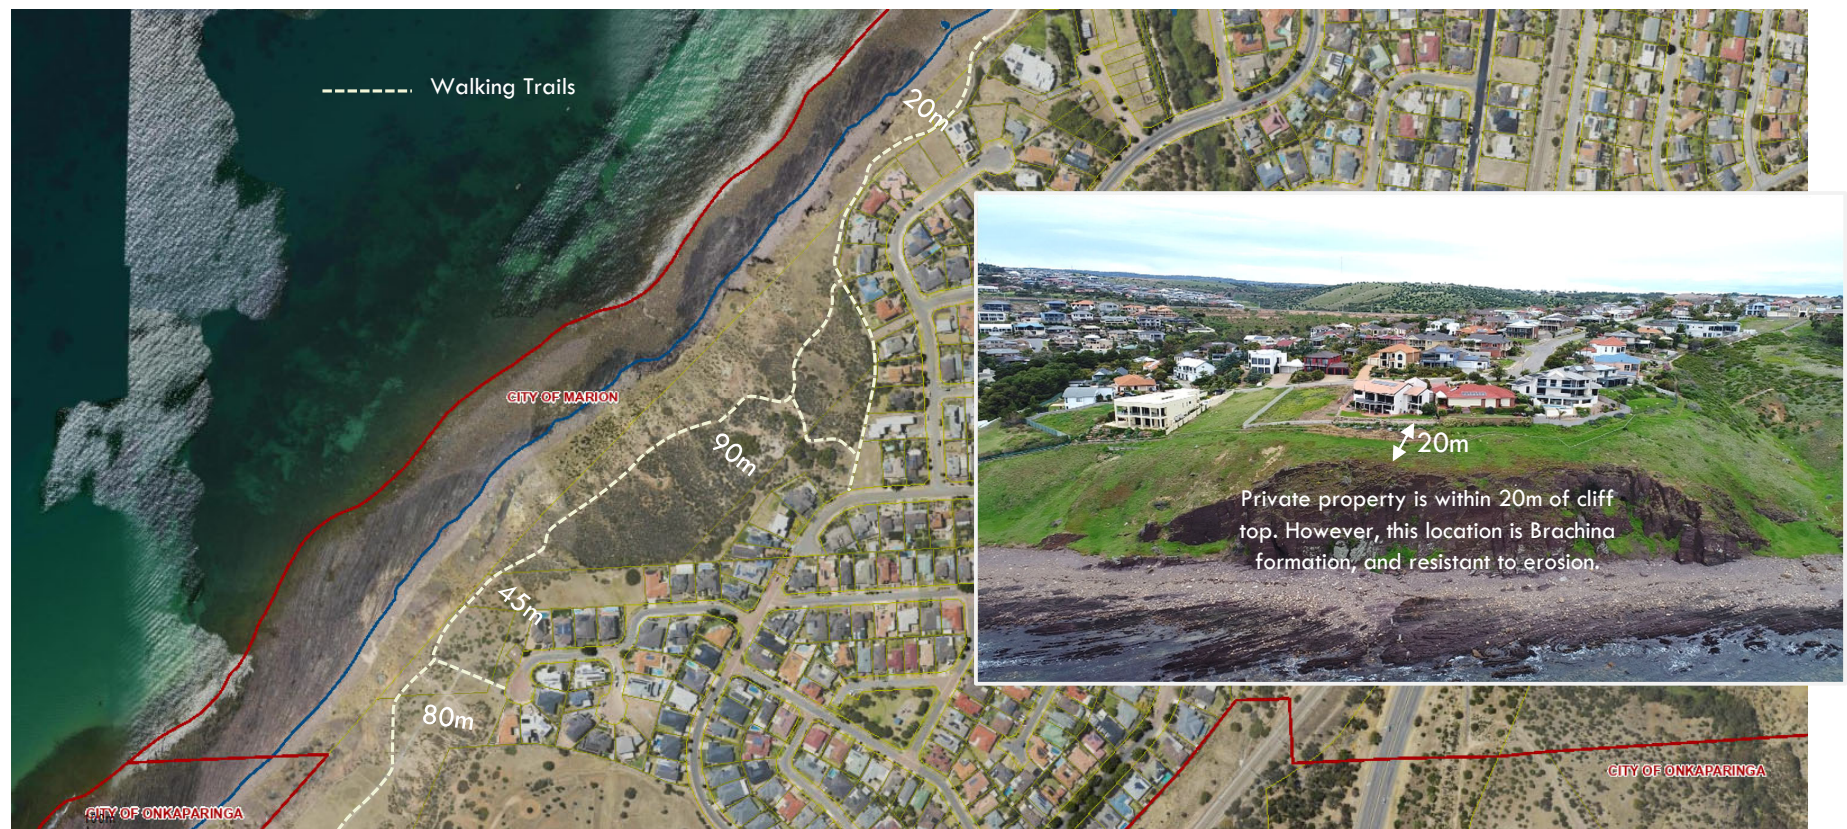
4-5 Coastal fabric — human intervention (Cell 4)

Urban settlements placed too close to the top of cliffs may be threatened if cliffs are not appropriately resistant to erosion (from wave attack, rain water, or aeolian impact). Hallett Cove Cliffs (South) was established in the 1990s and due care was undertaken to position residential development at appropriate distances from the cliff top. The development in most areas of this cell is well set back except for development on Albatross Walk, but this section of cliff is Brachina Formation and resistant to erosion (See inset photo). The only other human intervention in this cell is the coastal walking trail which is predominantly constructed on natural ground and with a fence positioned on the seaward side.

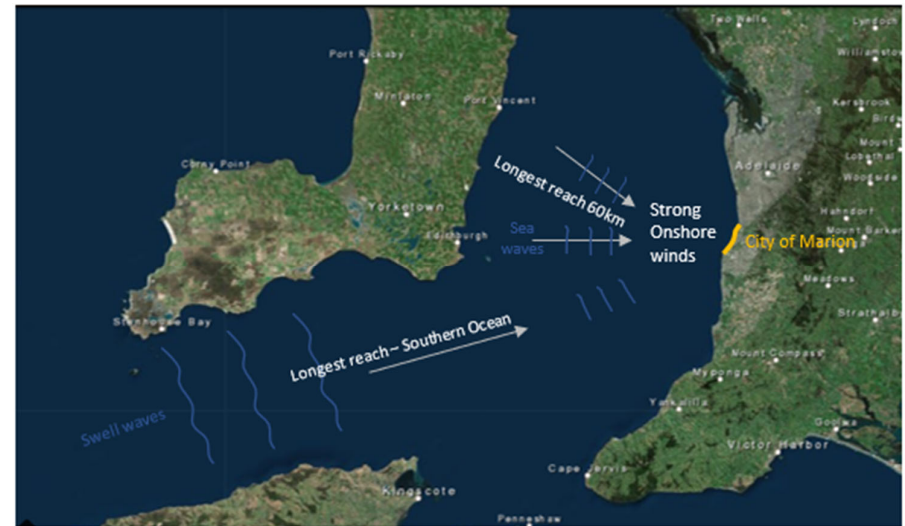
Figure a. The orientation of the City of Marion coastline to wave energy (M. Western, 2018)

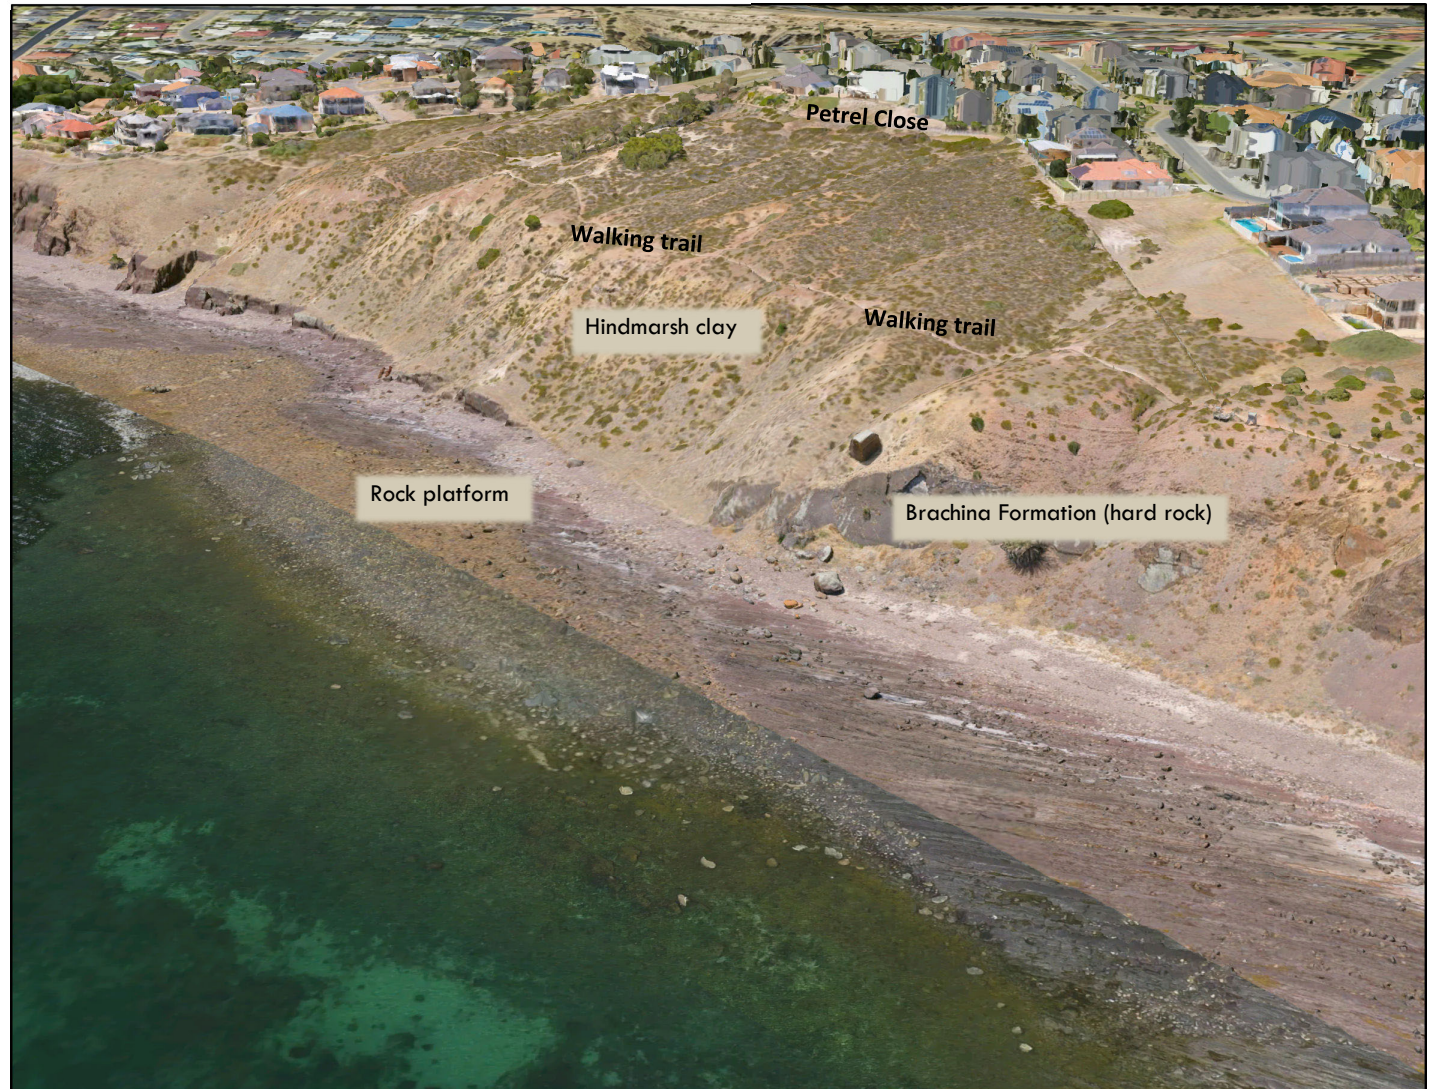
5. Coastal exposure – routine high water (2020)

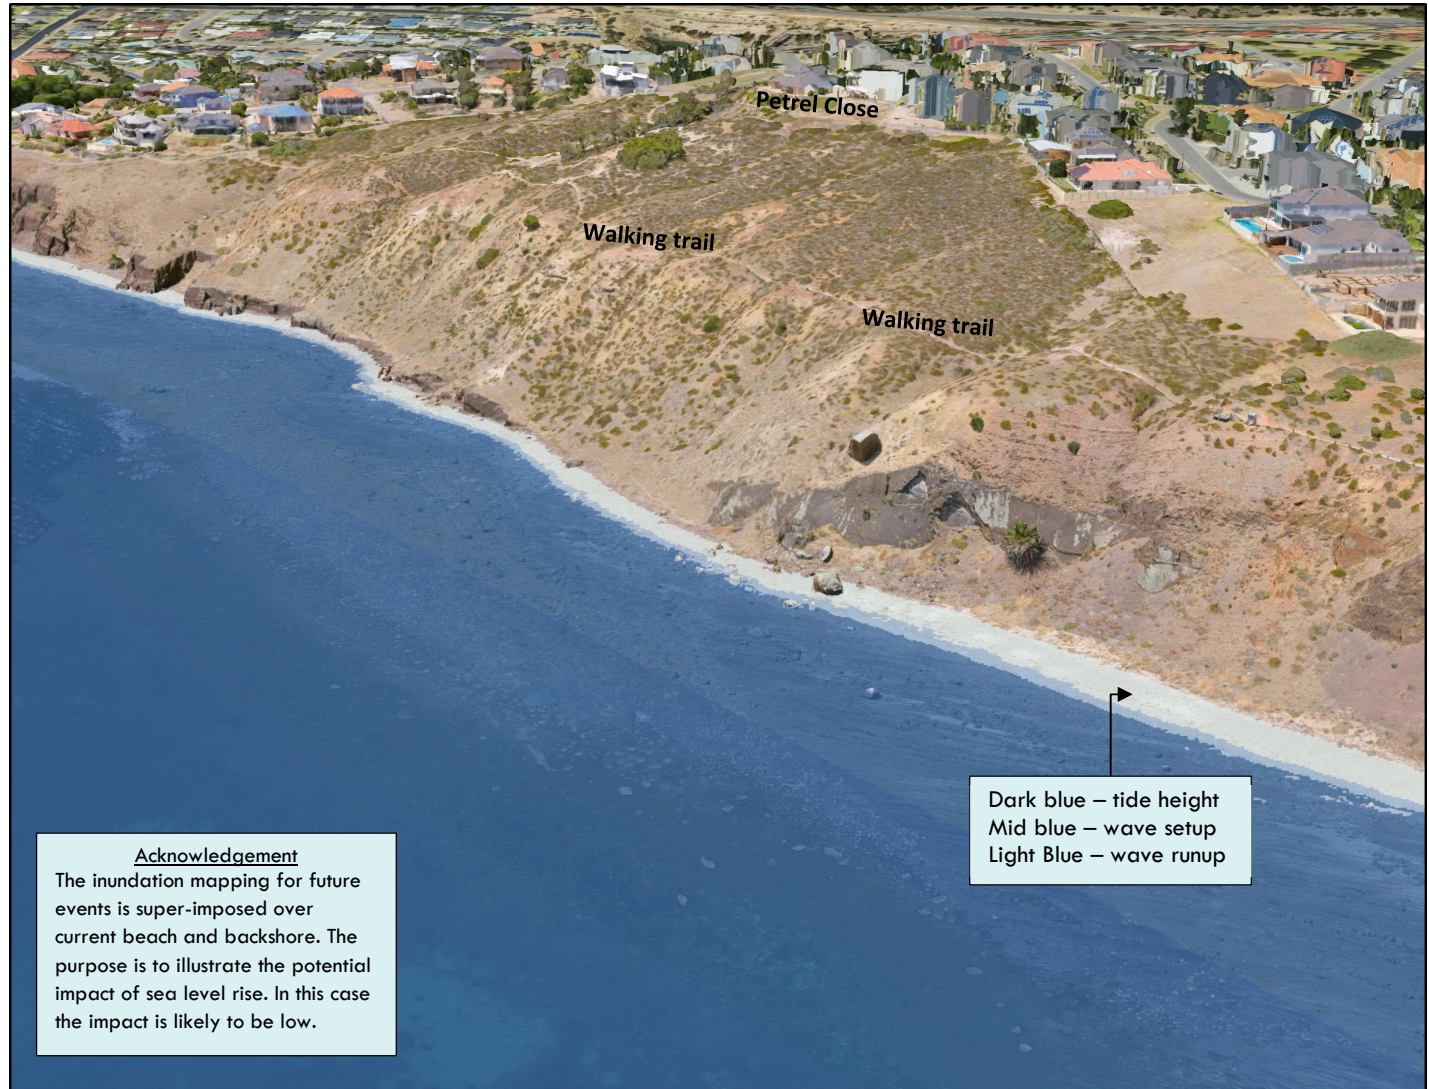
5. Coastal exposure – routine high water (2050)

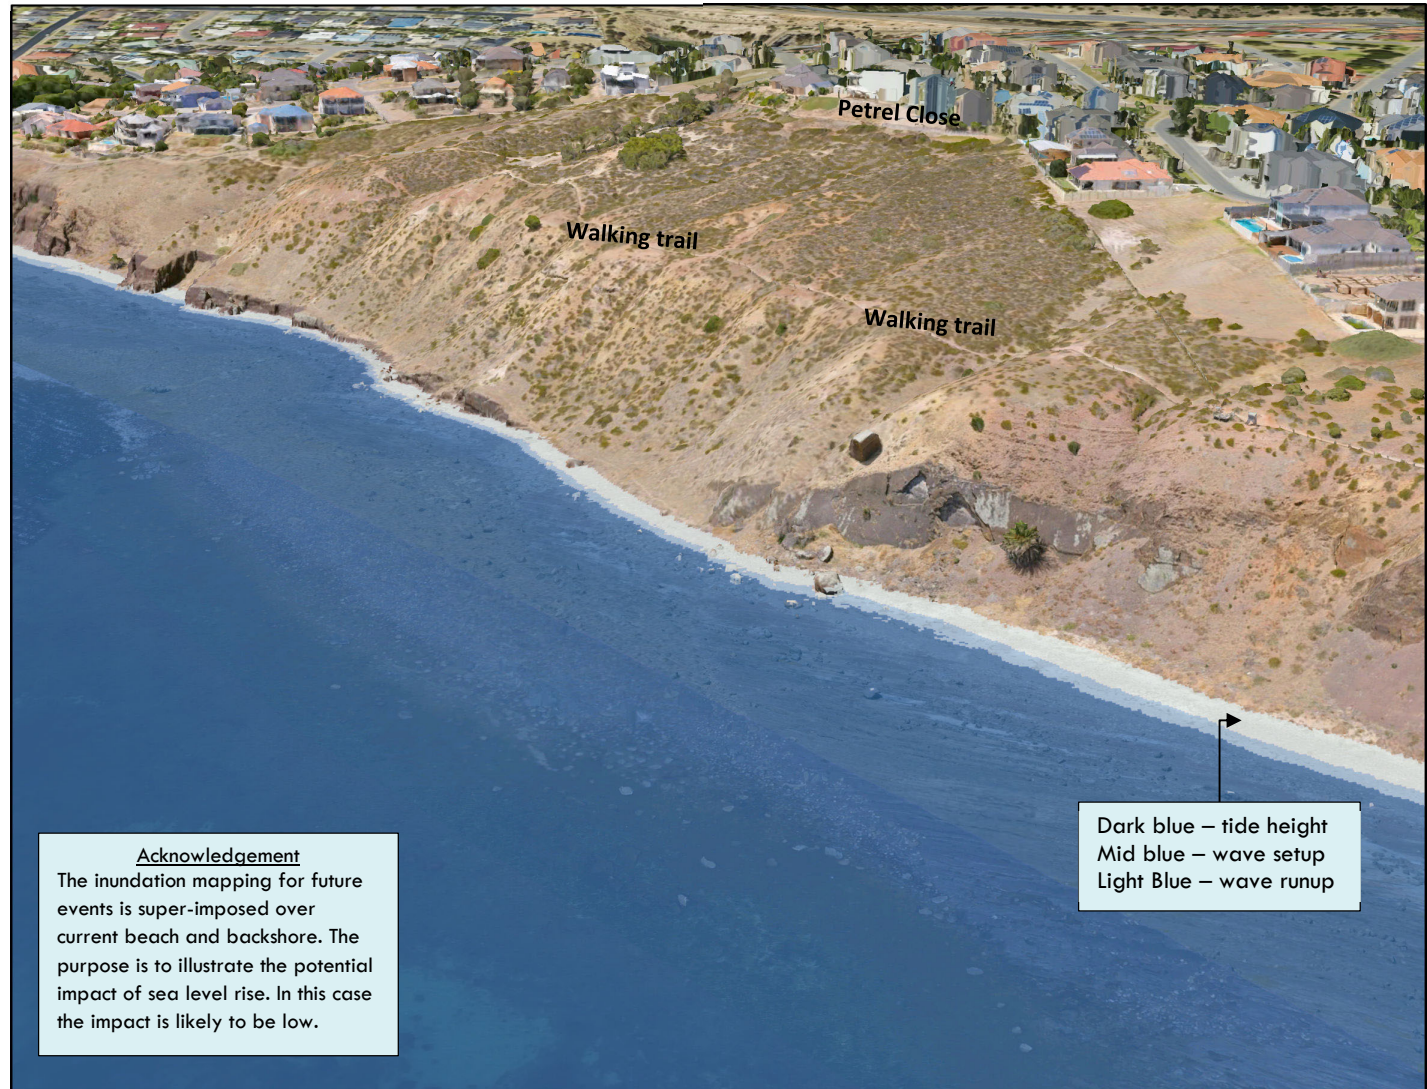
5. Coastal exposure – routine high water (2100)

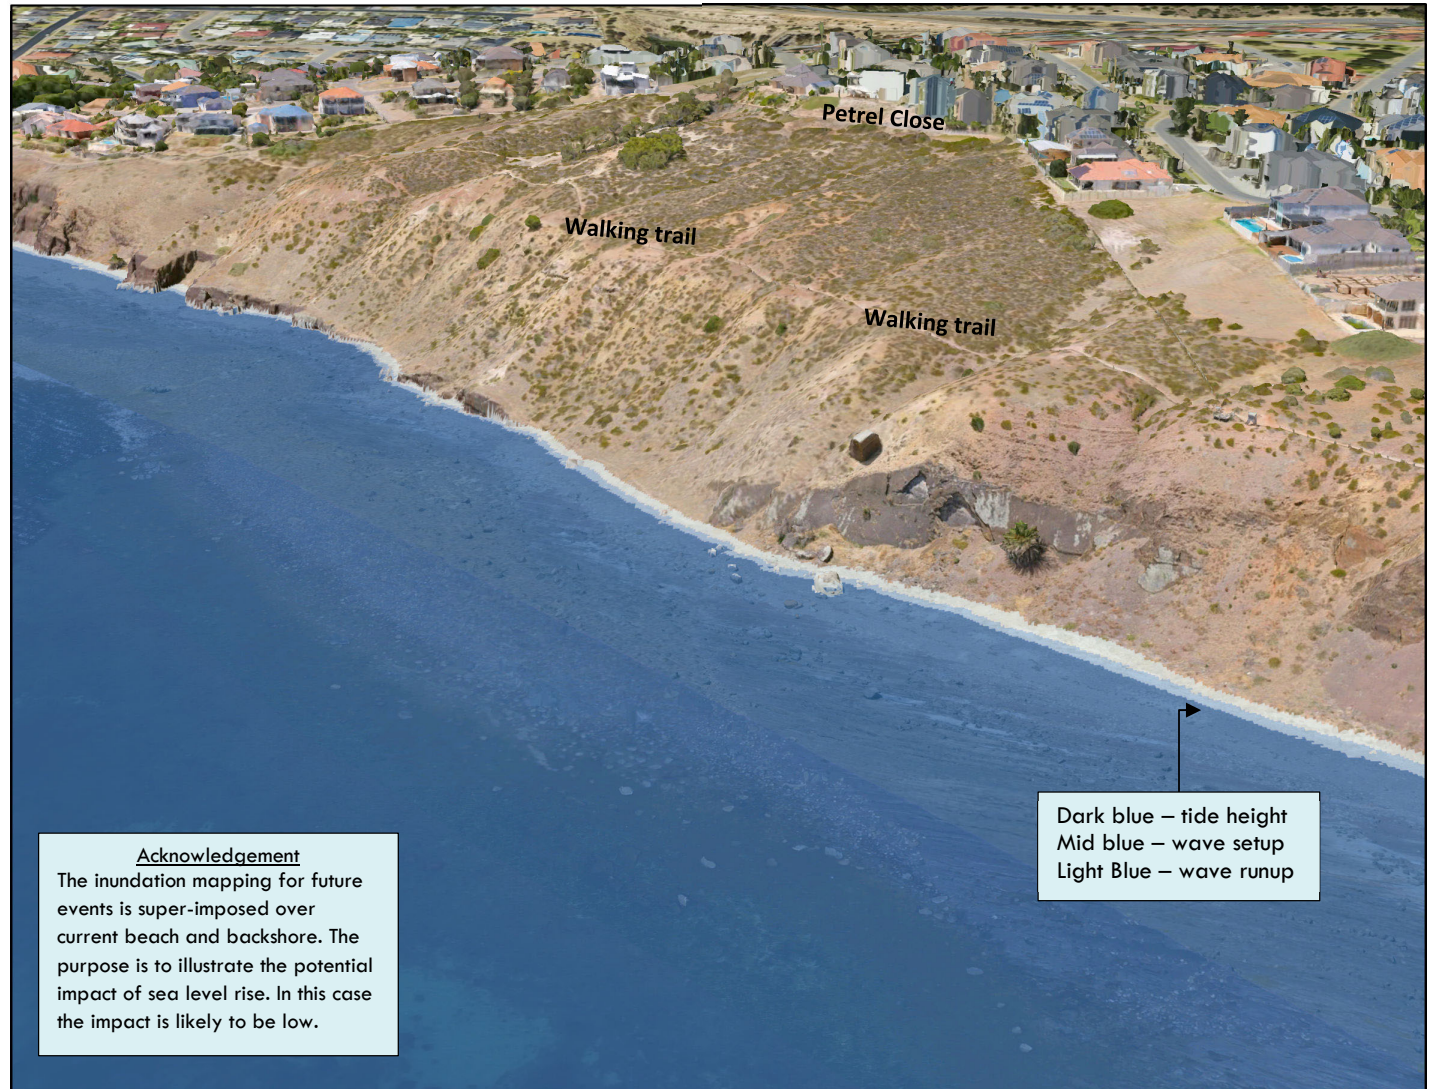
5. Coastal exposure – storm surge (2020)

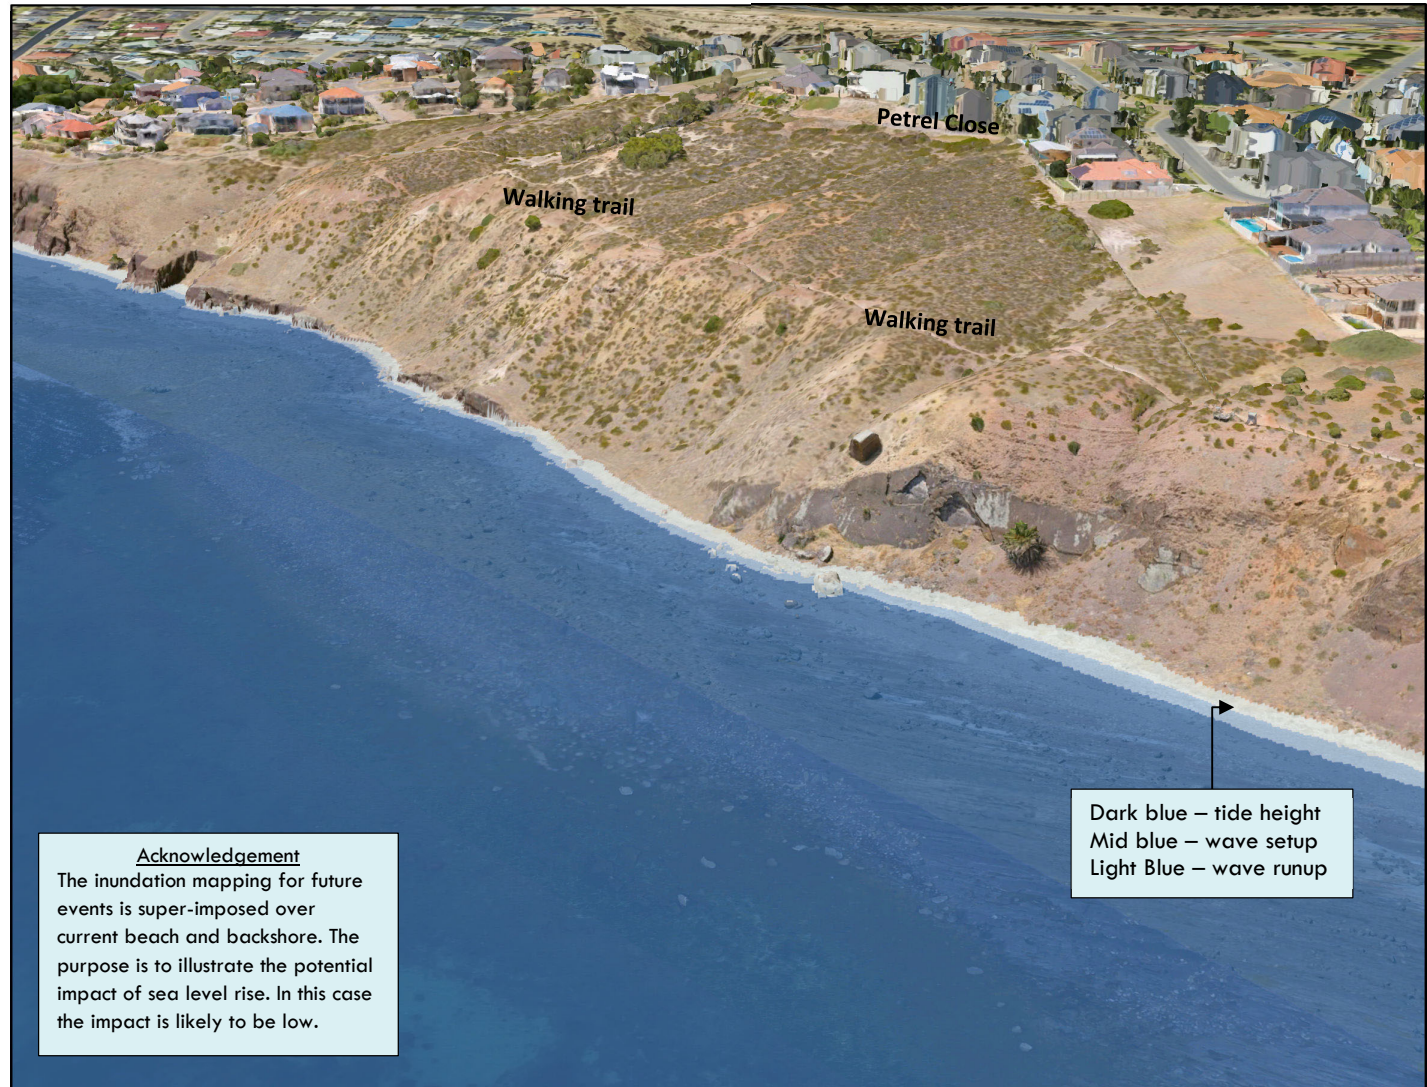
5. Coastal exposure – storm surge (2050)

As a very infrequent event, the impact is likely to be low, but the combination of higher routine tides and storm surges is likely to cause some recession of the Hindmarsh Clay base and increase the slope.

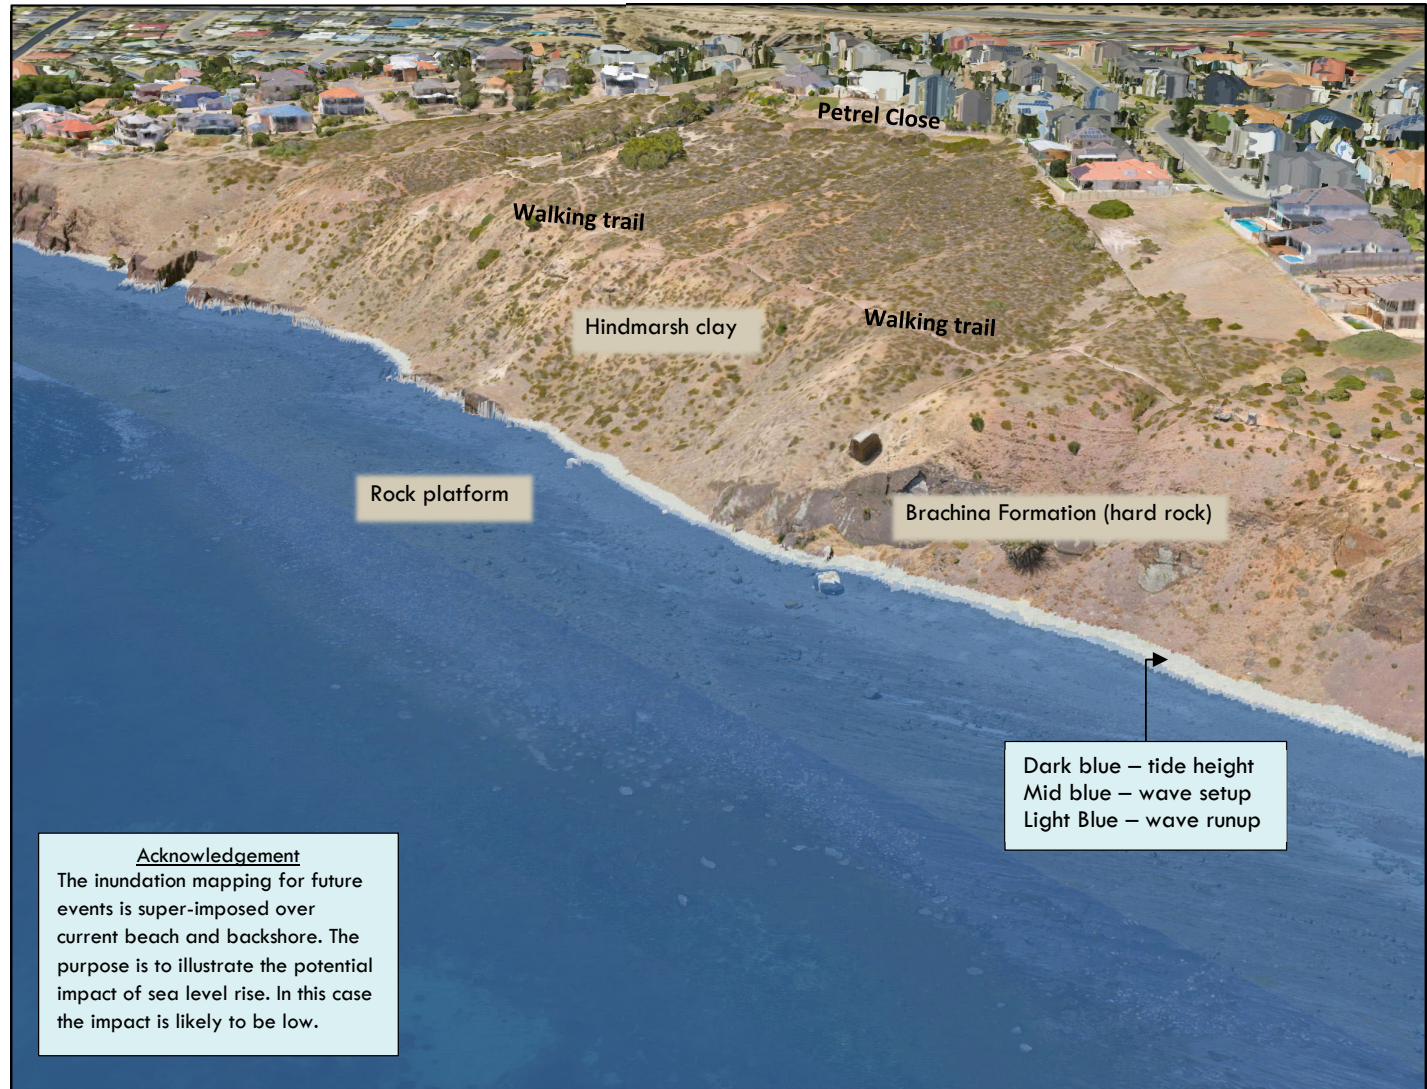
5. Coastal exposure – summary (Cell 4.2)

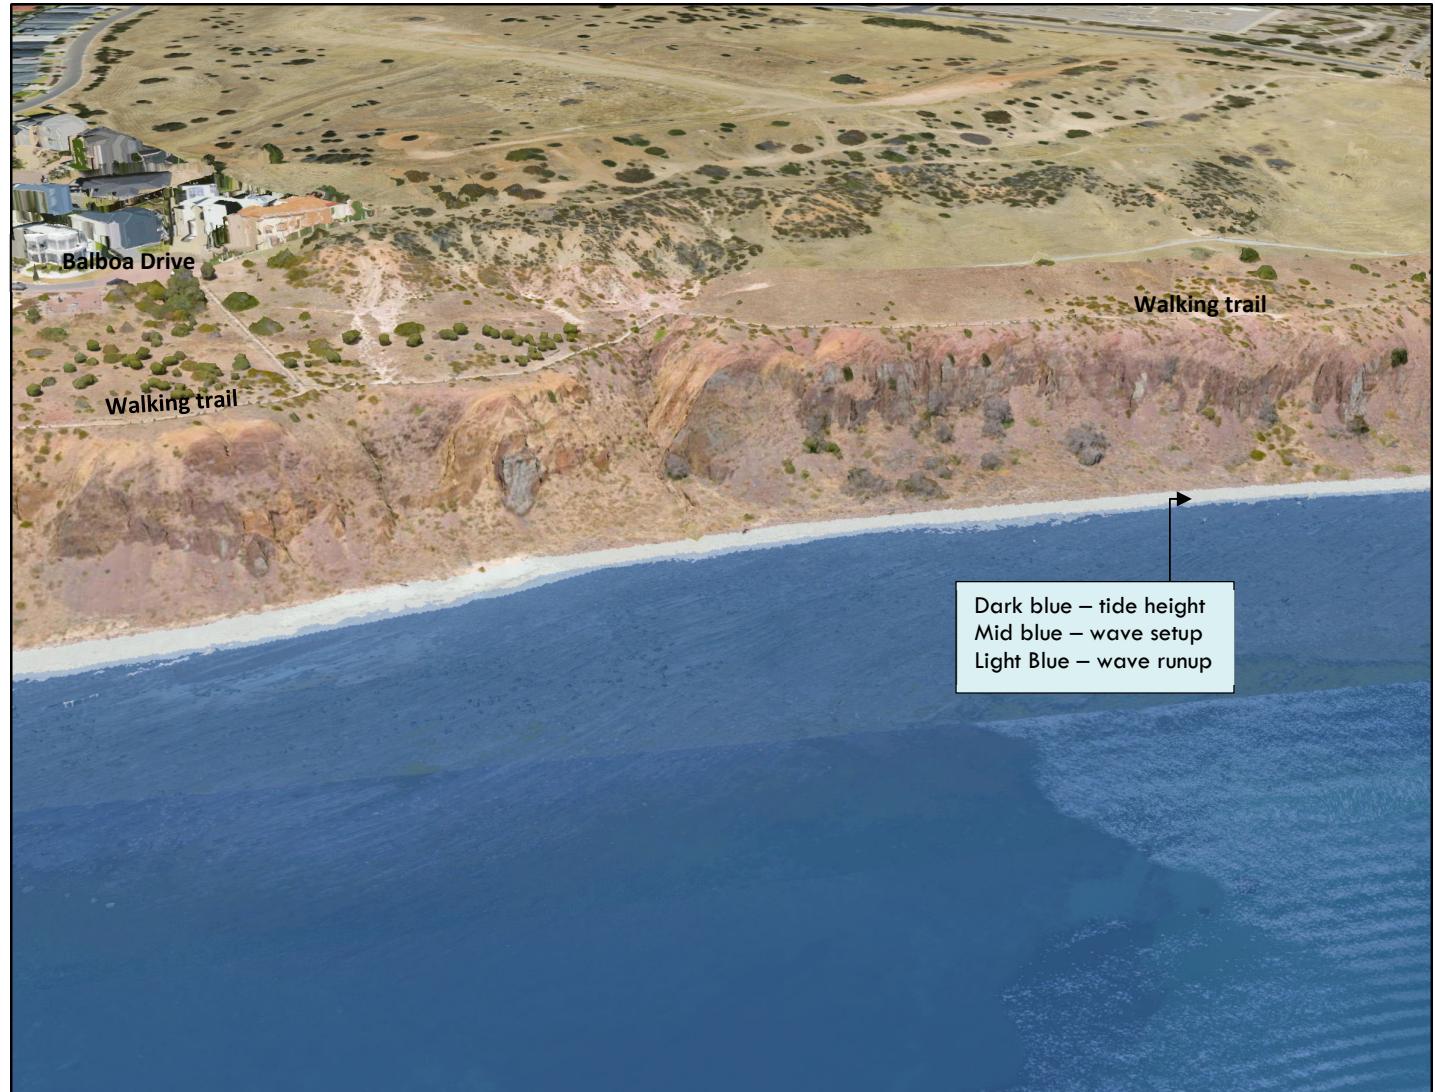
5. Coastal exposure – routine high water (2050)

Routine high-water events of this nature, and in context of higher storms, will cause recession of the shoreline back to the road. The

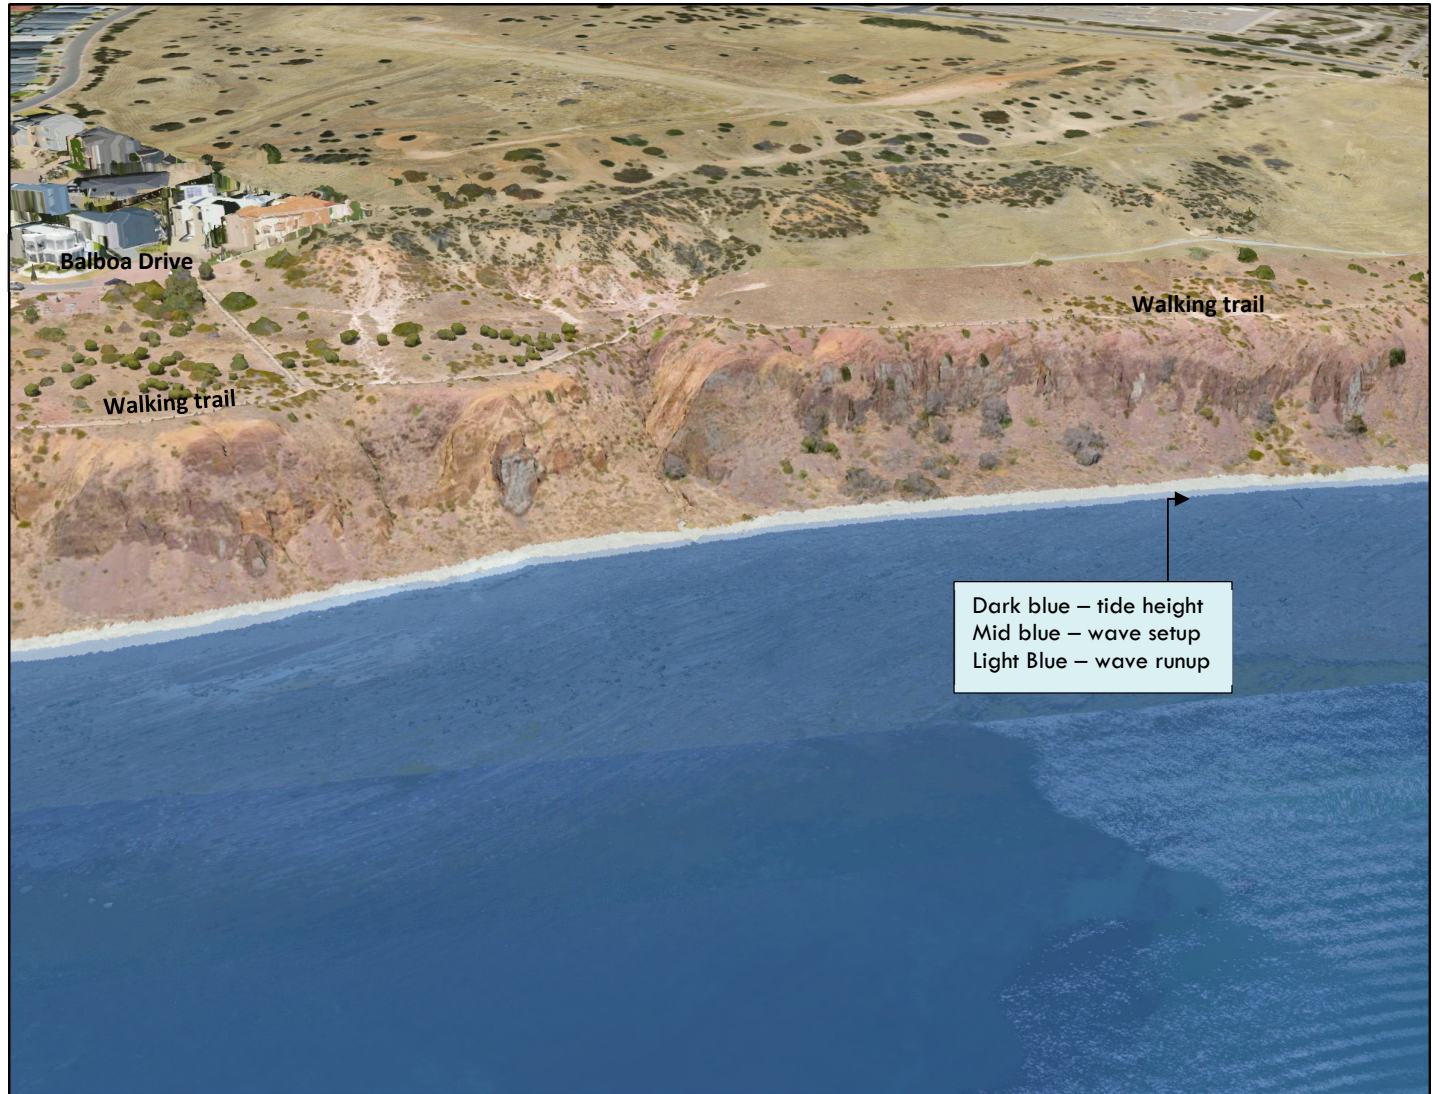
5. Coastal exposure – storm surge (2050)

As a very infrequent event, the impact is likely to be low, but the combination of higher routine tides and storm surges is likely to cause some recession of the Hindmarsh Clay base and increase the slope. However, it is likely that the harder rock lays underneath the base.

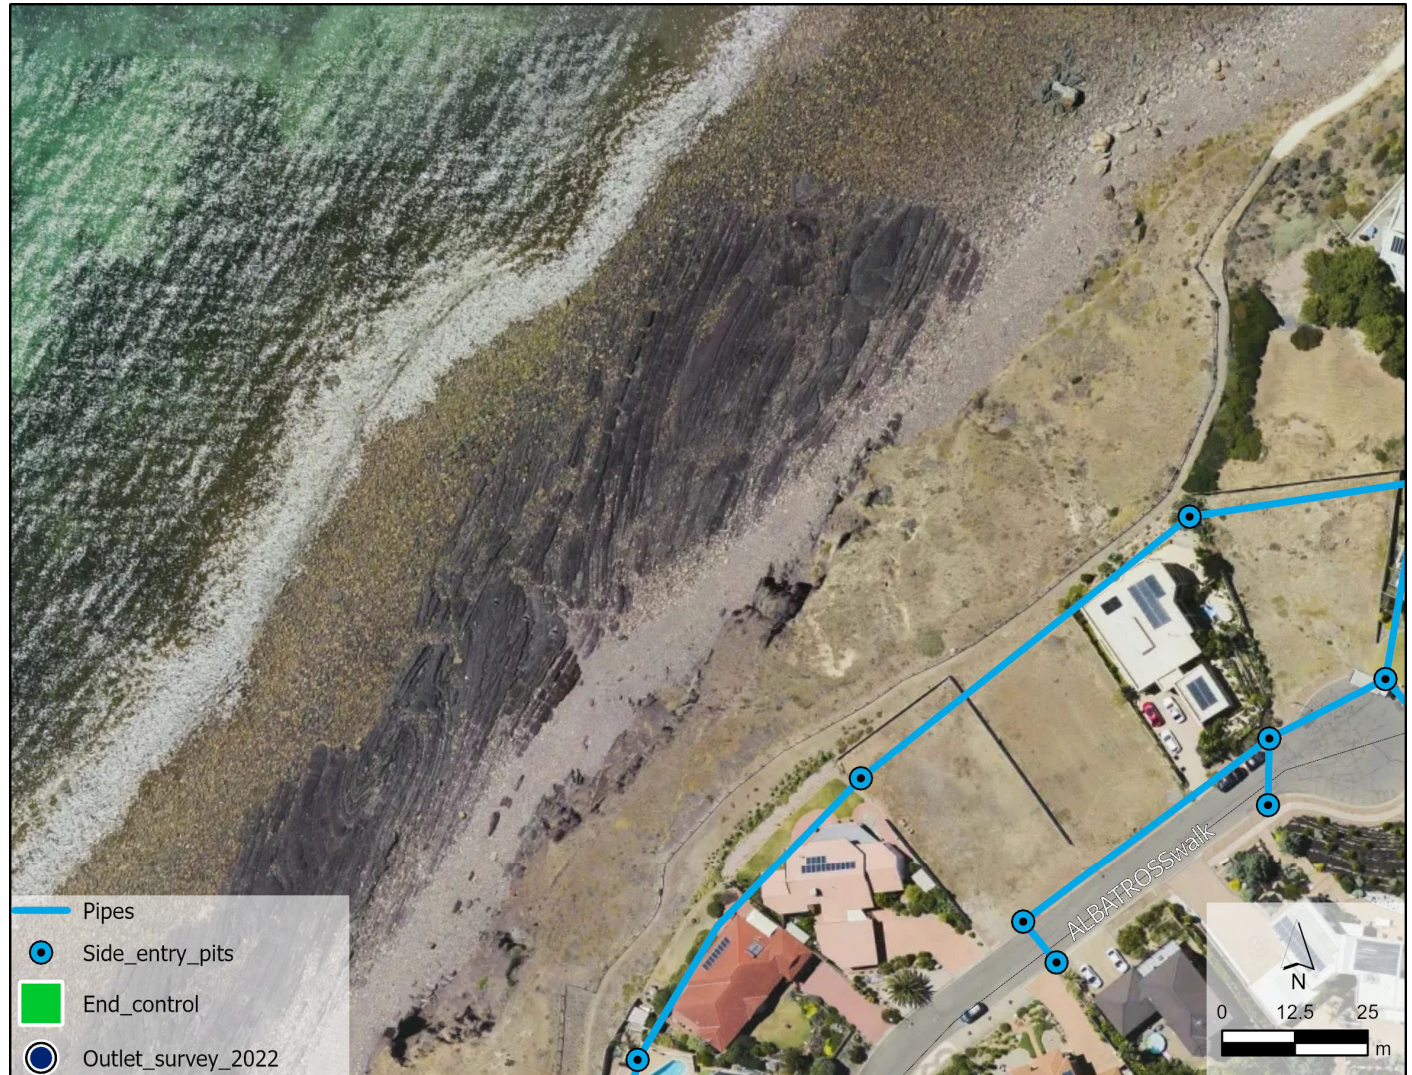
6. Storm water runoff from urban settlement

Outlet 4.2 – pipes broken at bottom of cliff; storm water has created a gully through the clay bank. In the context of this coastal environment impact is rated 2 out of 4, but a review is recommended.

Figures (a) and (b). The storm water infrastructure was likely under engineered in the first instance due to the remote location. The pipes have broken, and gully formed from storm water flows from Balboa Drive.
