## Coastal Adaptation Study

# MARINO CLIFFS

By Integrated Coasts

Review date 1 December 2022

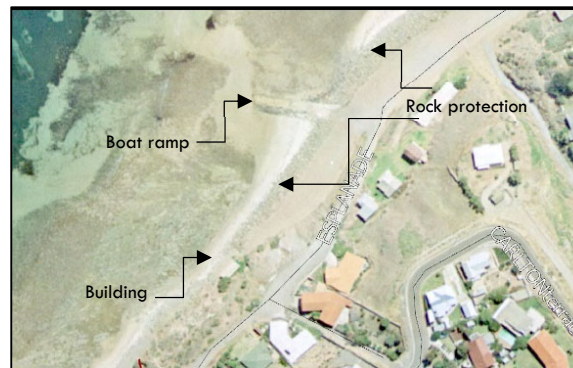
Figure b. A small boat ramp installed 1960s (or prior), later superseded by the boat ramp at Jervois Terrace, Marino. Rocks were informally placed along the foreshore, later consolidated into its current form ~2000.

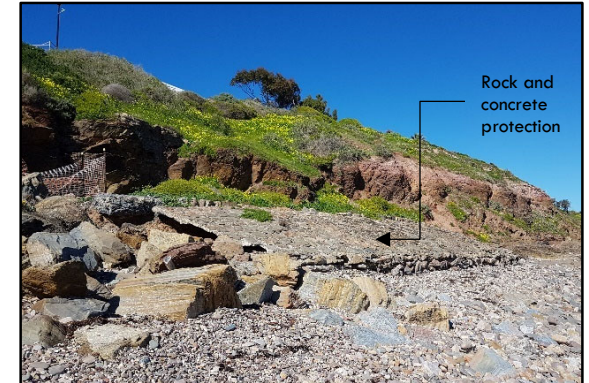
Figure c. Rock and concrete sloping seawall protected former building in this location (see aerial photograph, 1979).

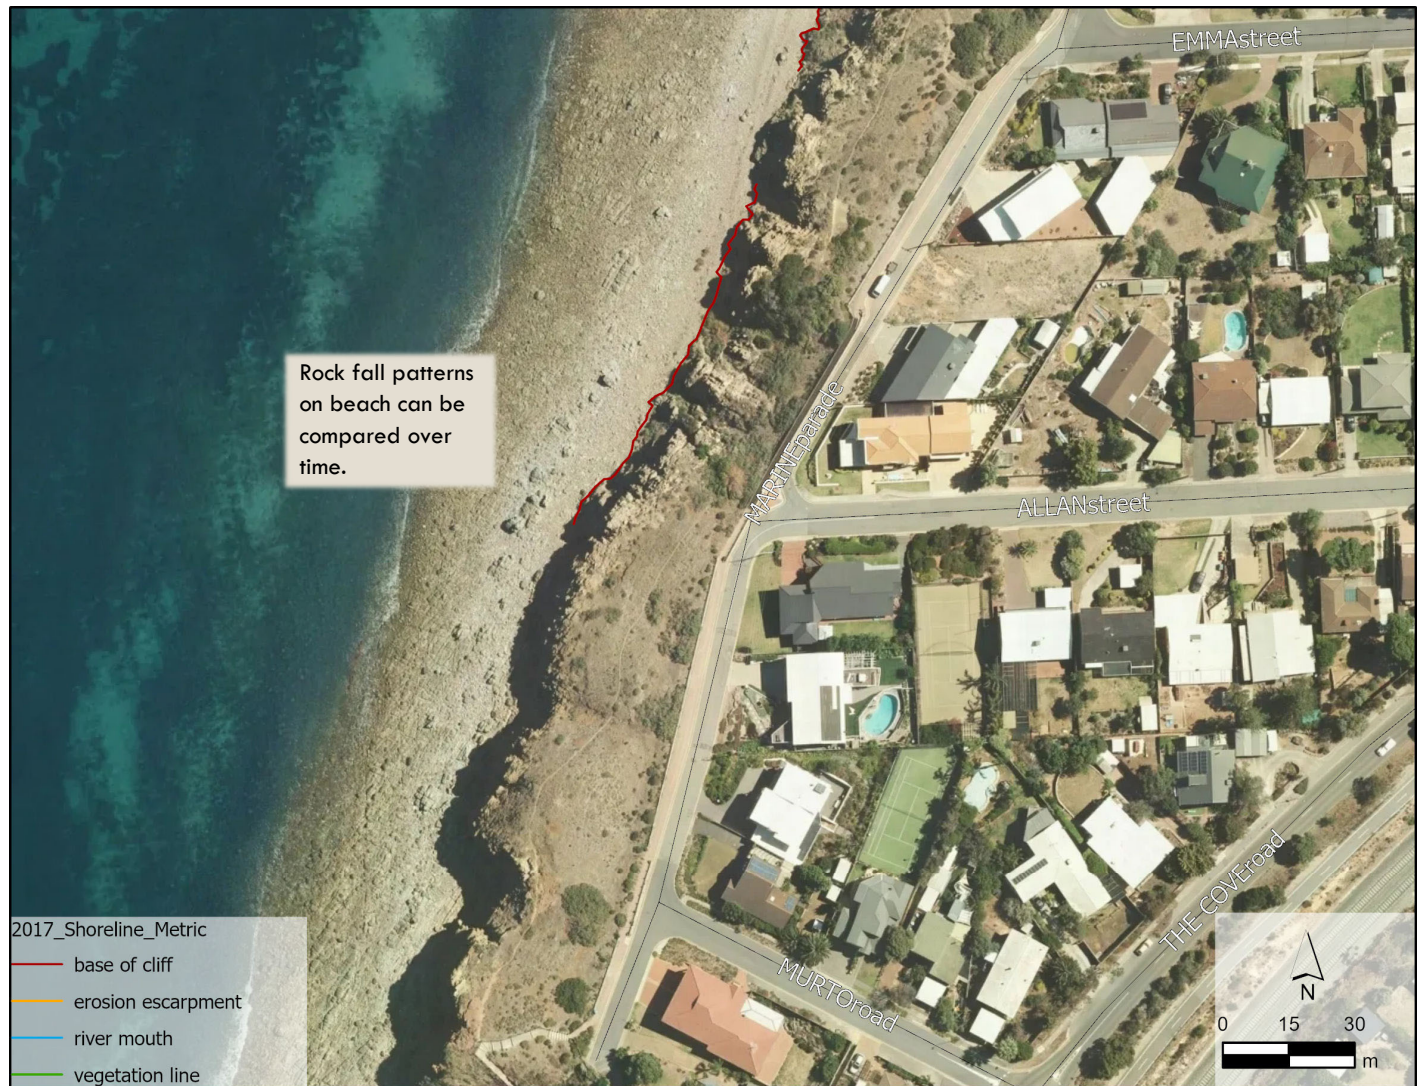
Minor changes to at base cliff, possibly related to wave impact. Increasing vegetation from 1979 to 2002, stable thereafter (with less cover in 2007). No increase of rock falls on beach or observed slumping.

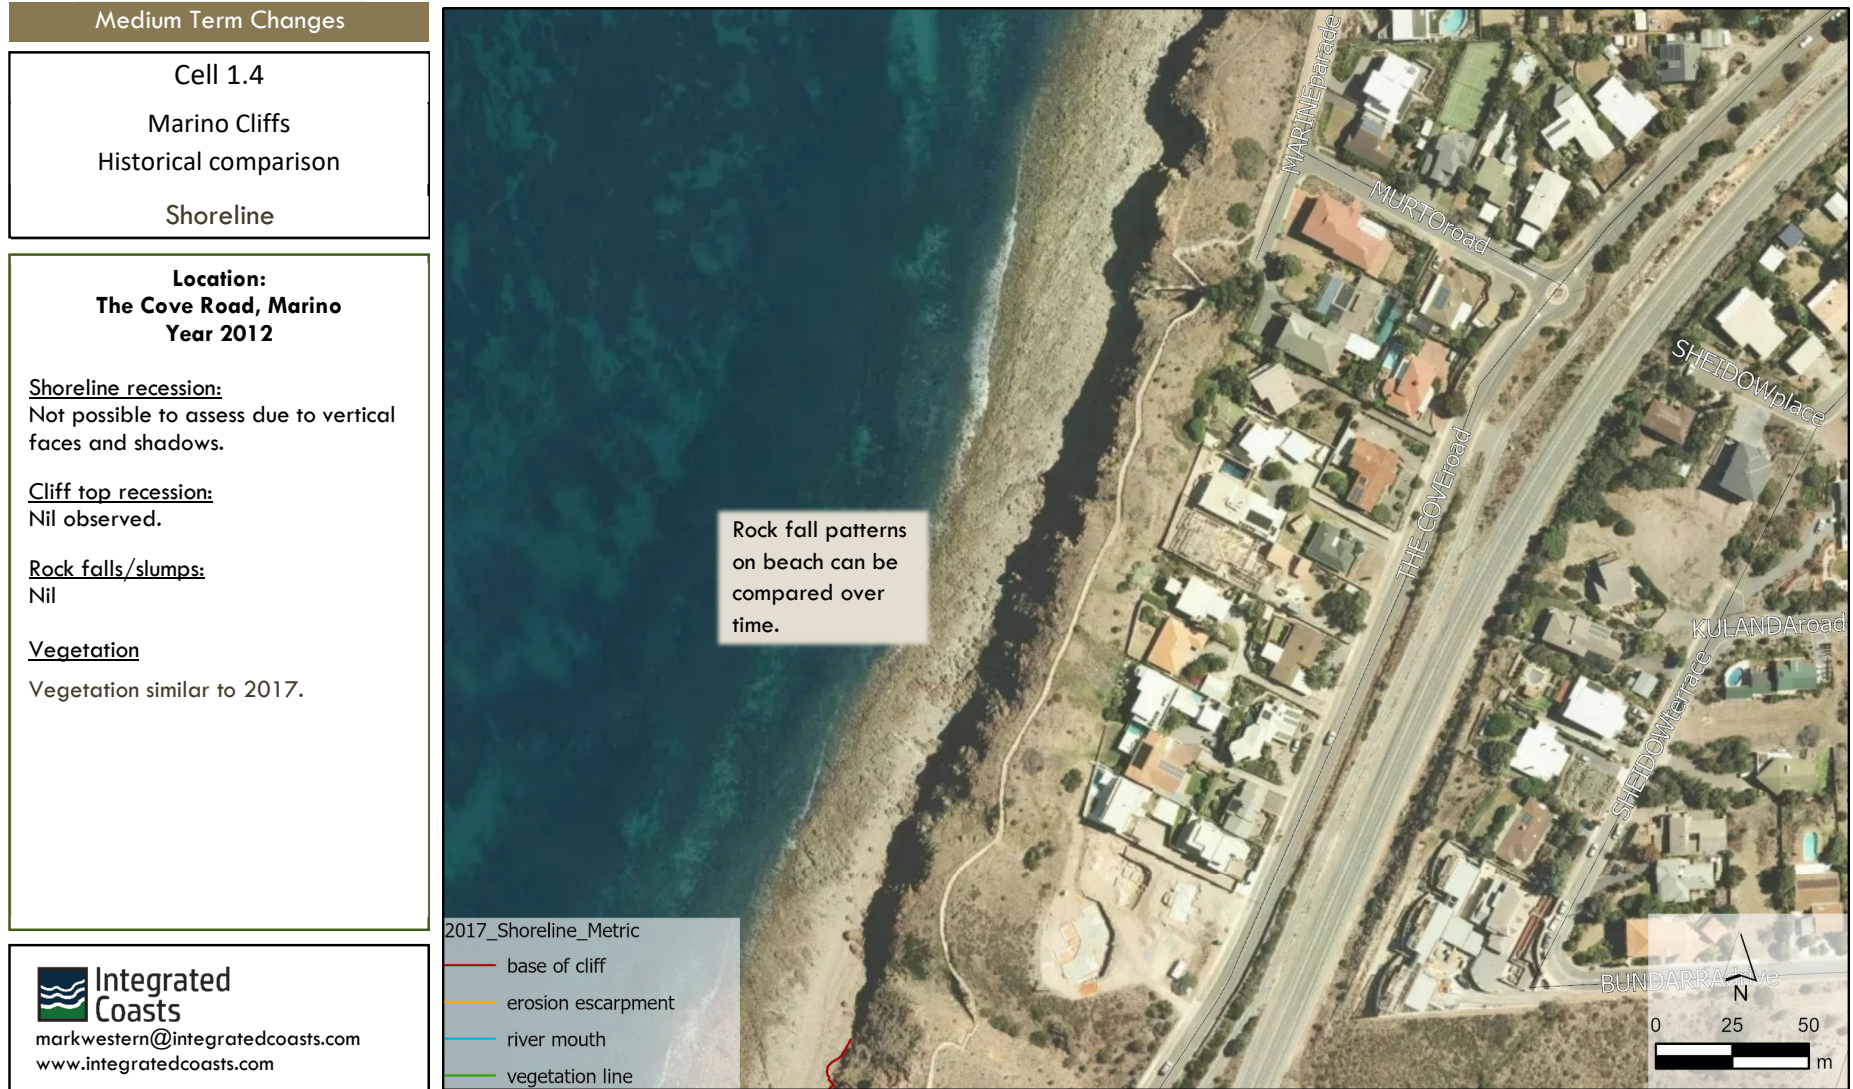
No observed erosion/ recession of cliff top apart from possible recession (see 1989). No increases in rock falls to the beach. Shadows at base of cliff made interpretation of shoreline recession impossible.

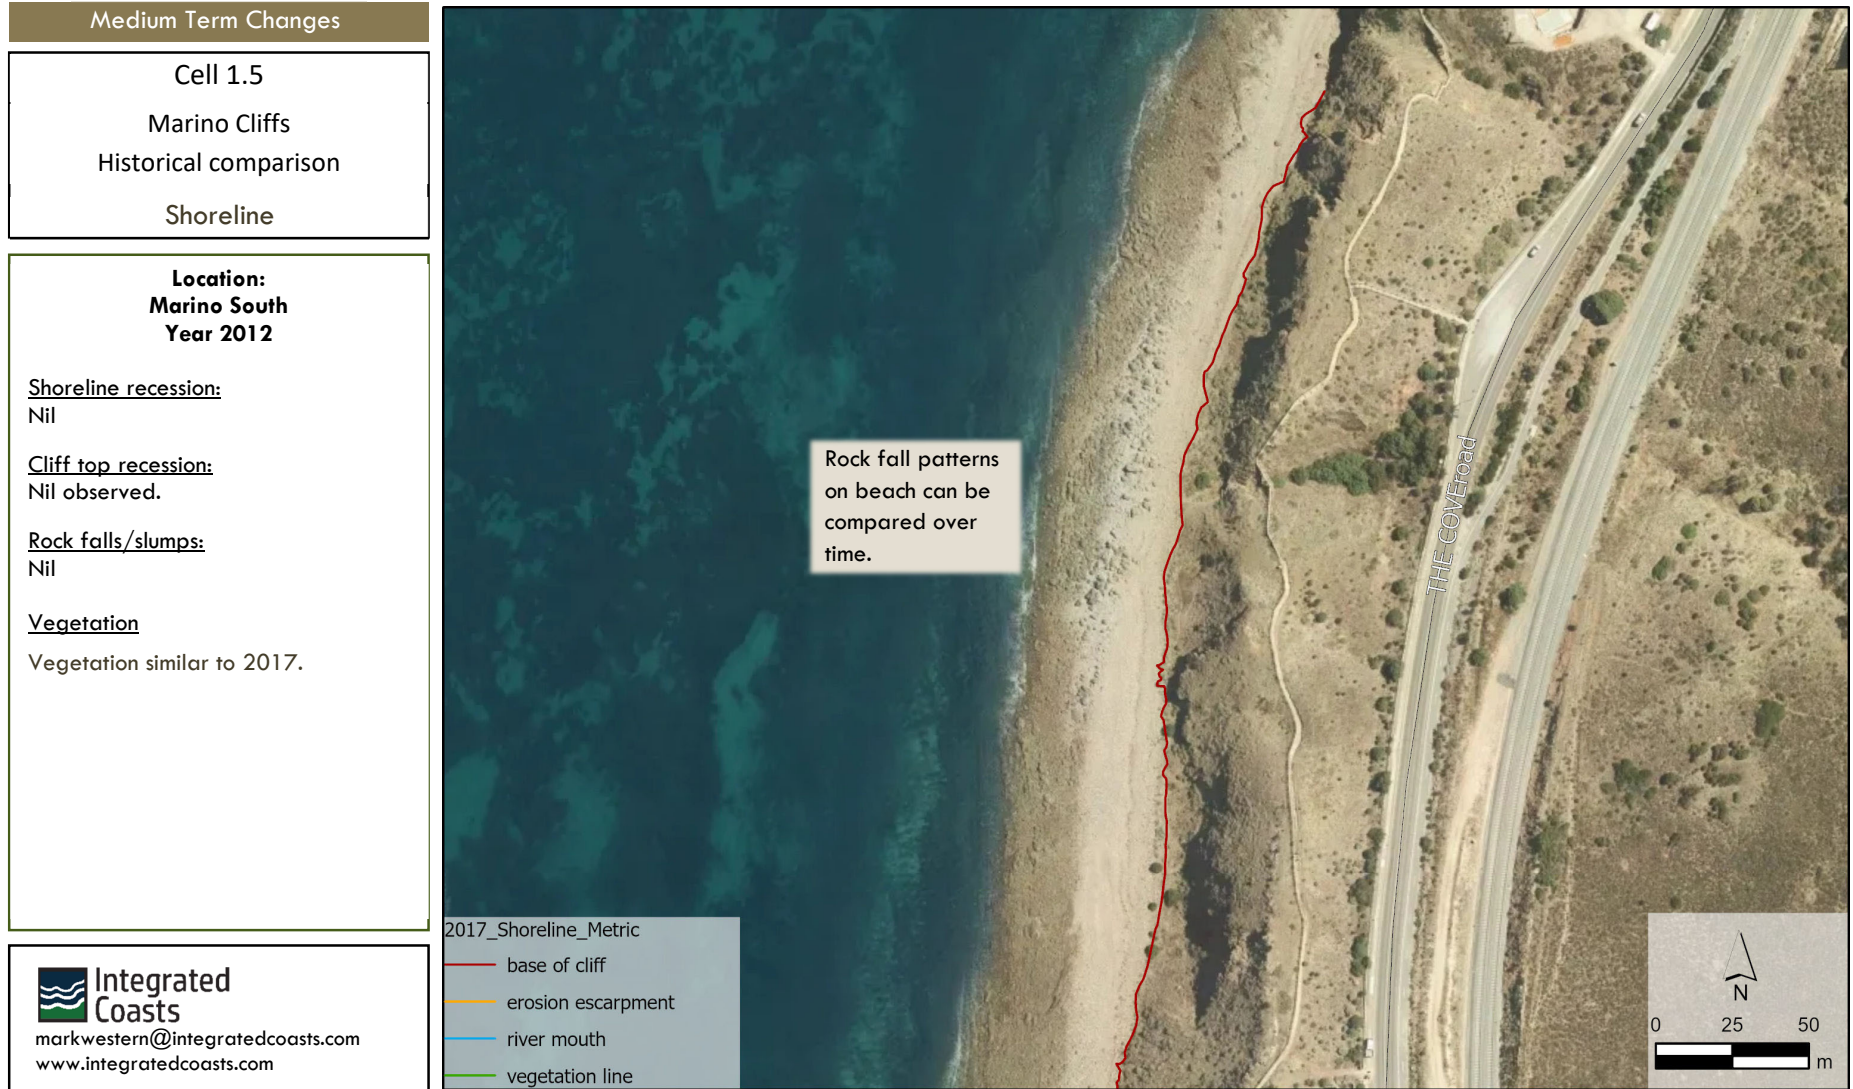
Very little change observed. Possible recession of shoreline (but this may be pebble bank/ vegetation changes).

Very little change observed. Possible recession of shoreline (but this may just be decadal changes in pebble bank and not due to wave attack).

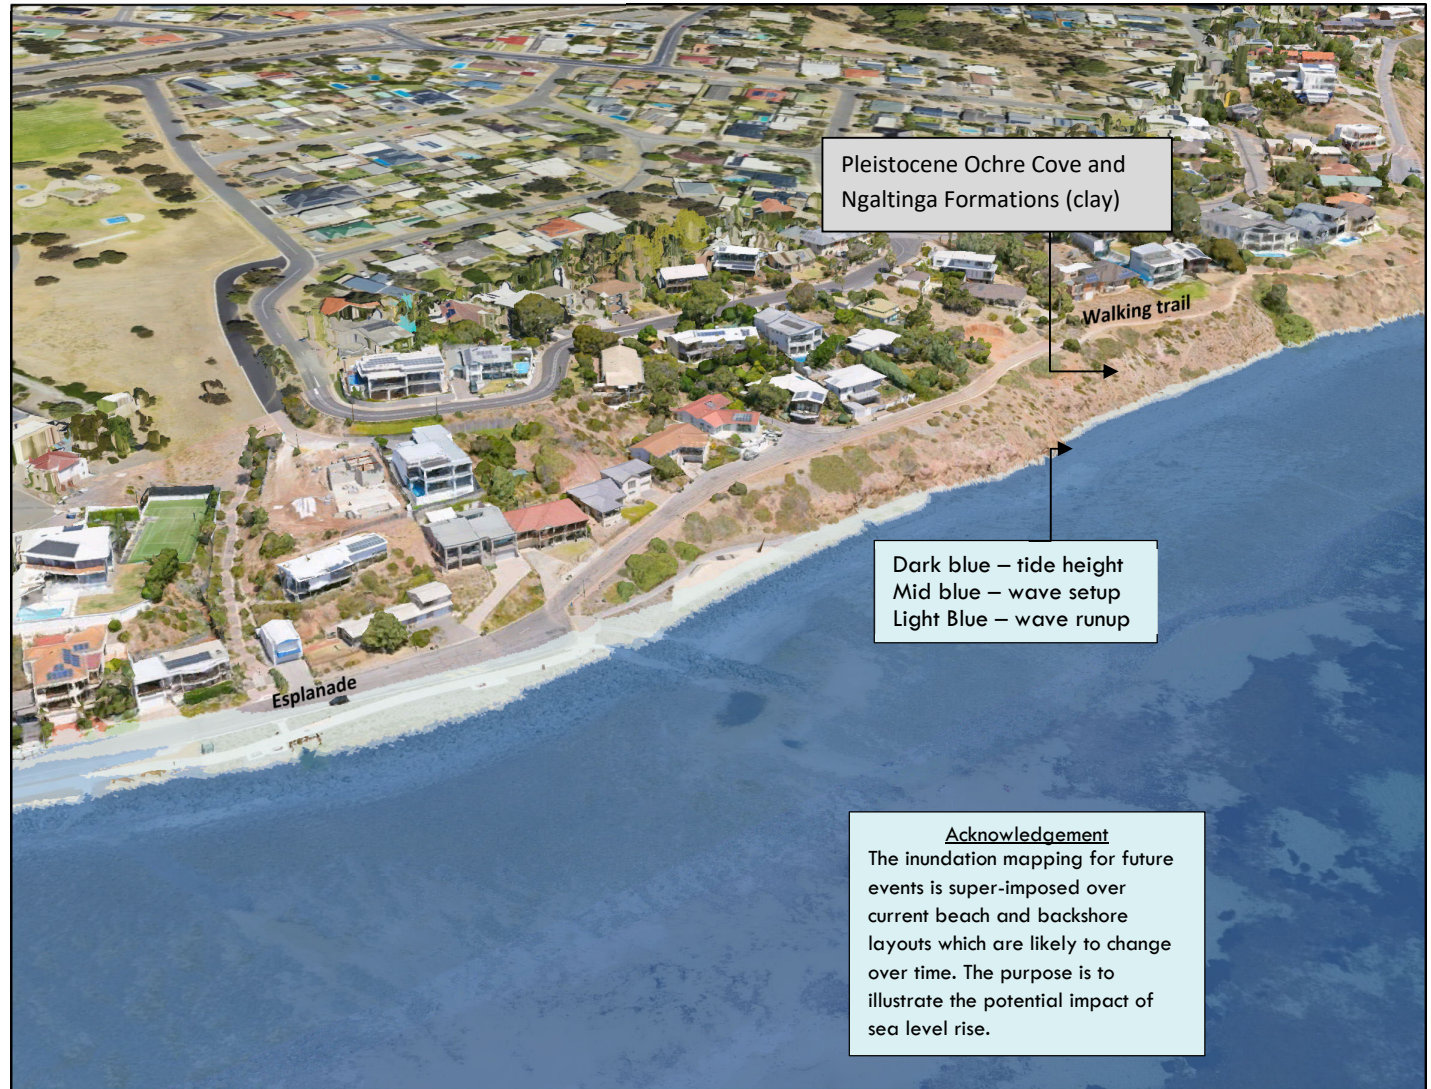
Significant storm events will overtop the rock revetment on the Esplanade. Routine tidal events are unlikely to cause significant recession to the escarpment under the walking trail in this period.

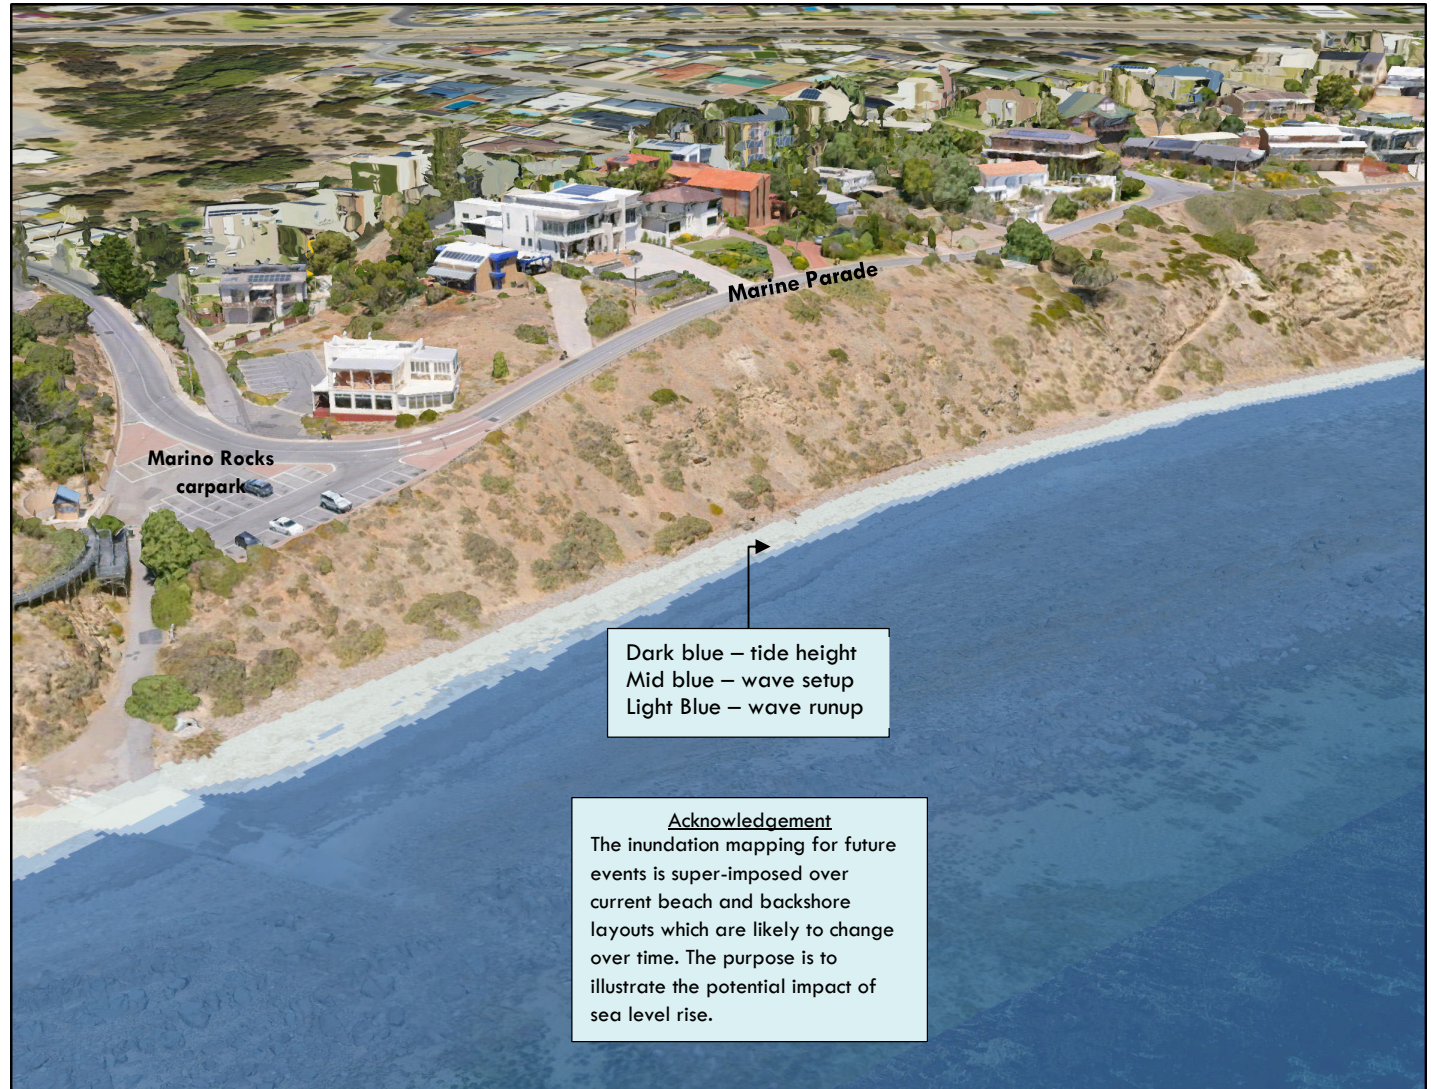
**Assessment:** The cliff under the carpark contains undifferentiated material (i.e. not rock). Routine impact to the base of the cliff will cause recession that is likely to destabilise the cliff slope under the carpark.

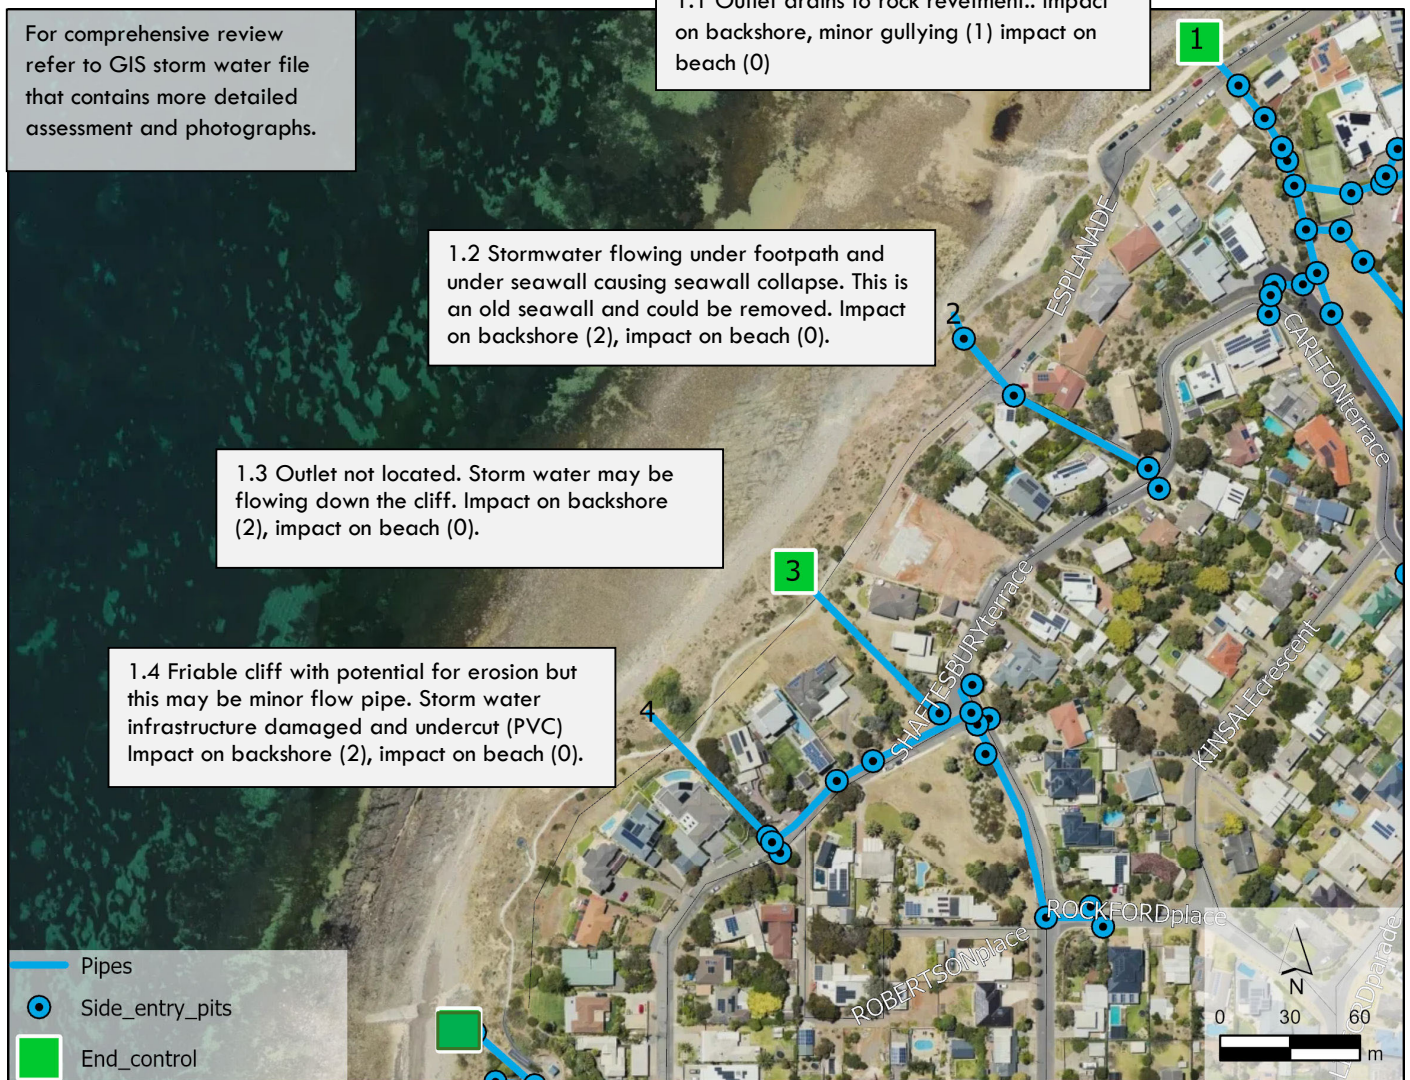
1.4 is damaged and undercut.

1.4 Friable cliff with potential for erosion but this may be minor flow pipe. Storm water infrastructure damaged and undercut (PVC) Impact on backshore (2), impact on beach (0).

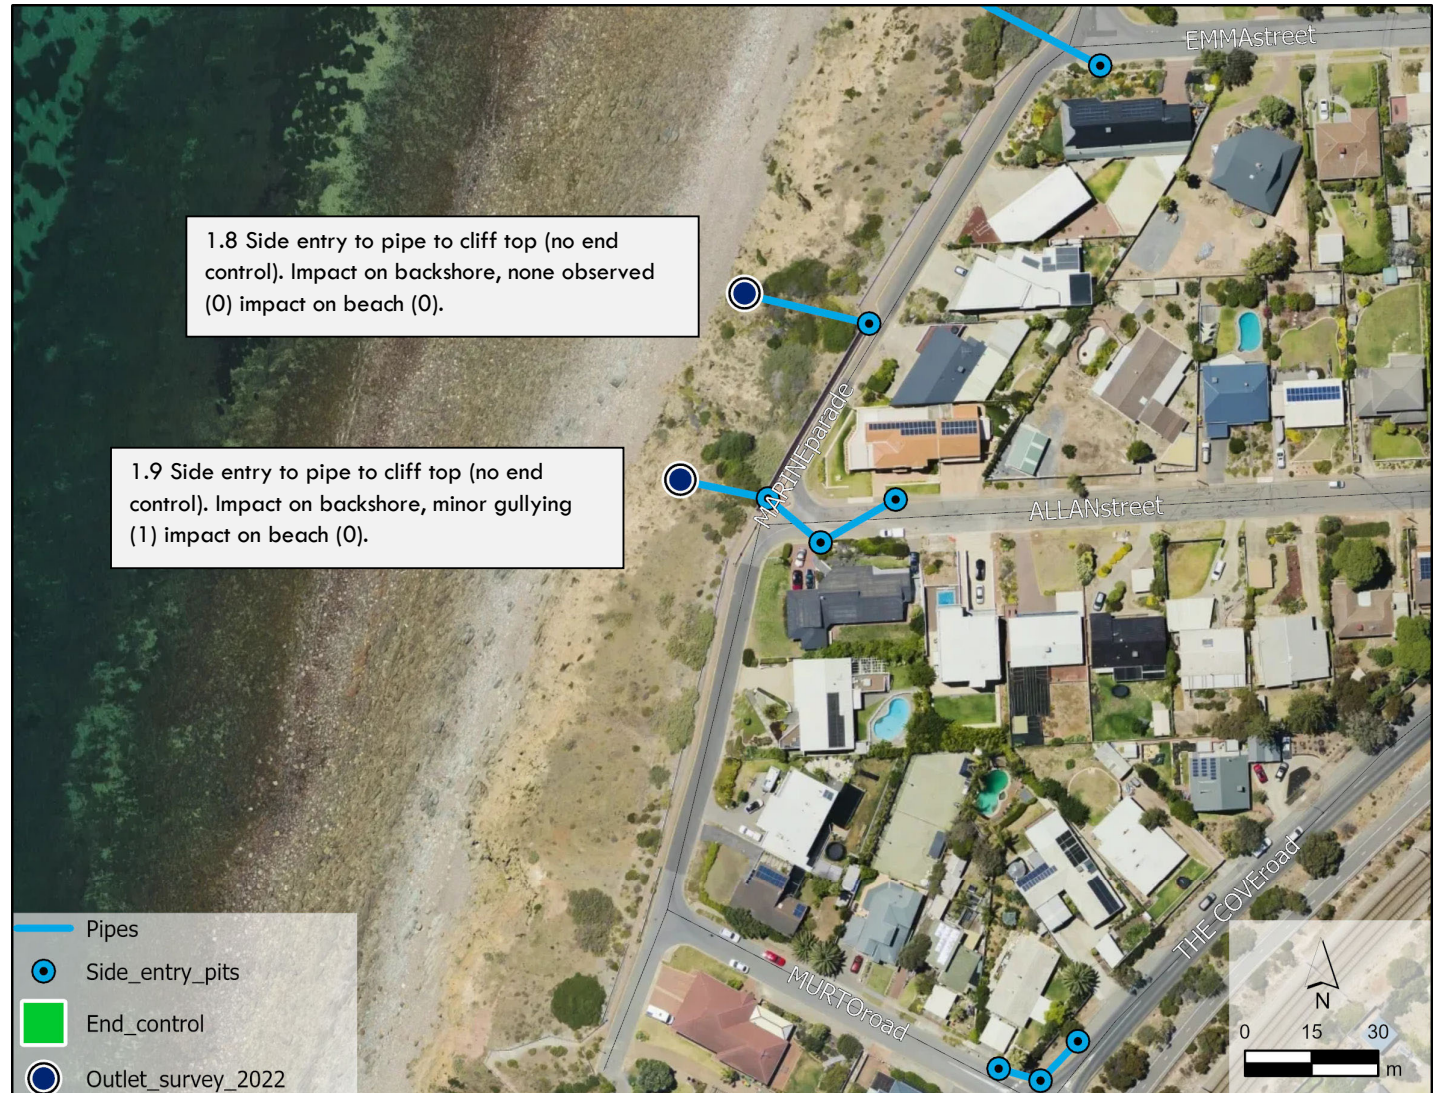
Storm water flows down gully from PVC pipe at the top. Minor gullyng observed (1), no impact to the beach. PVC pipe may need repair.

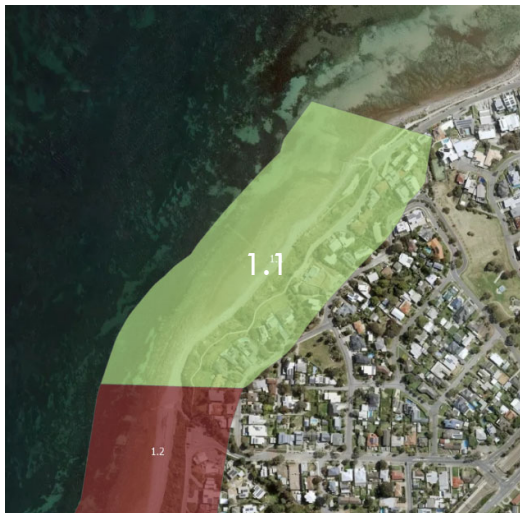
#### Coastal setting

Rock platform beach with shingles. The nearshore zone is dominated by seagrass meadow with low-profile reef in the intertidal zone. Rock revetment protects the lower section of The Esplanade. Underneath the upper section of The Esplanade is 'friable Pleistocene clay' which is more susceptible to erosion. Monitoring storm events (2021-2022) demonstrated that actions of the sea do not interact with the base of the cliff. The southern section of Marino Cliffs is more resistant rock. Private assets are set behind the Esplanade Road or the walking trail.

Land based and aerial photography indicate that there have been minimal changes to the beach and backshores over last one hundred years due to the rocky nature of the coast. No new rock falls were observed.

Stormwater is generally collected within the road reserves and either piped to the beach or flows down cliffs and slopes. Many of the outlets have no end controls but an inspection of outlets after significant rain events in June 2022 found that there was only minor gullyng impact in backshores and no impacts to the beach.

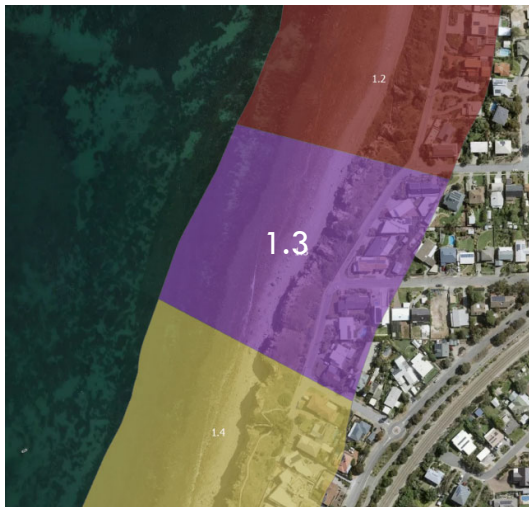
#### Coastal Setting

Predominantly hard rock vertical cliffs that are resistant to erosion, dominated by low profile offshore reef and rocky beach platform, and therefore assessed as low erodibility. Sea flood modelling demonstrates that seas are routinely interacting with the base of the cliffs which will increase if seas rise as projected. However, these cliffs are resistant to erosion. Private assets are set landward of Marine Parade which is positioned at the top of the cliff in some places, on the edge.

Land based and aerial photography indicate that there have been minimal changes to the beach and backshores since 1949 due to the rocky nature of the coast. No new rock falls were observed.

The rate of sea level rise remains relatively low at 3-4mm in this region. Storm monitoring show that actions of the sea regularly interact with these cliffs, but they are resistant to erosion. Sea levels 0.30m higher than present (2050) are unlikely to cause instability, but seas 1.00m higher than present may (2100). In reality the impact is unknown.

Current impact on the coast by actions of the sea is low due to the rocky nature of this location. Seas 0.30m higher than present is unlikely to cause instability, but seas 1.00m higher may (but this is unknown) The main risk is to Marine Parade, and possible loss of access to private residences if this was required to be closed.

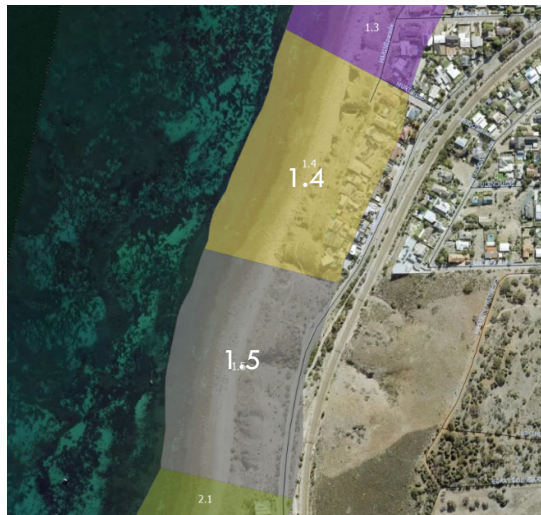
#### Coastal Setting

Hard rock vertical cliffs in Cell 1.4 that are resistant to erosion and sloping cliffs in Cell 1.5, with some unconsolidated material at their base. Rocky beach platform and low-profile offshore reef. The walking trail is positioned on top of the cliff, there is no esplanade road, and private property (Cell 1.4) is set well back from the coast (20 to 40m). There are no private assets in Cell 1.5. Beach access stairs are positioned in the vicinity of Murto Road to provide pedestrian access to the beach.

Land based and aerial photography indicate that there have been minimal changes to the beach and backshores since 1949 due to the rocky nature of the coast. No new rock falls were observed.

The rate of sea level rise remains relatively low at 3-4mm in this region. Storm monitoring show that actions of the sea regularly interact with cliffs in Cell 1.4 but they are resistant. Sea levels 0.30m higher than present are unlikely to cause instability, but seas 1.00m higher than present may. In reality the impact is unknown.

Current impact on the coast by actions of the sea is low due to the rocky nature of this location. Seas 0.30m higher than present is unlikely to cause instability, but seas 1.00m higher may (but this is unknown). Public assets are relatively minor including access stairs and walking trail. In the context of rising sea levels, pedestrians accessing the beach may be more prone to be 'caught' by incoming tides.
