Coastal Adaptation Study

## HALLETT COVE CLIFFS NORTH

Cell 2

Review date 1 December 2022

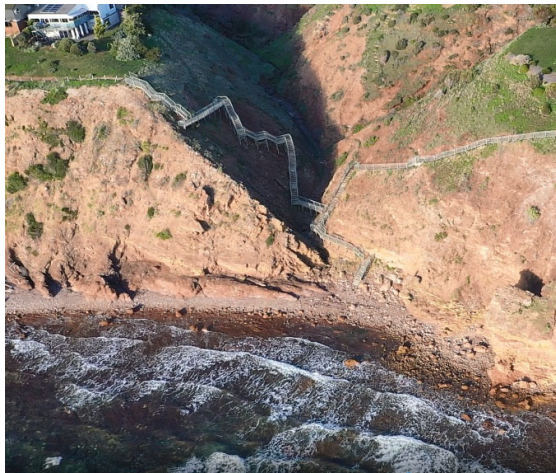
Parts of the walking trail were closed in 2019 and repairs undertaken before reopening in 2020.

Figure a: Coastal walking trail with access stairs and ramps and one access point to the beach.

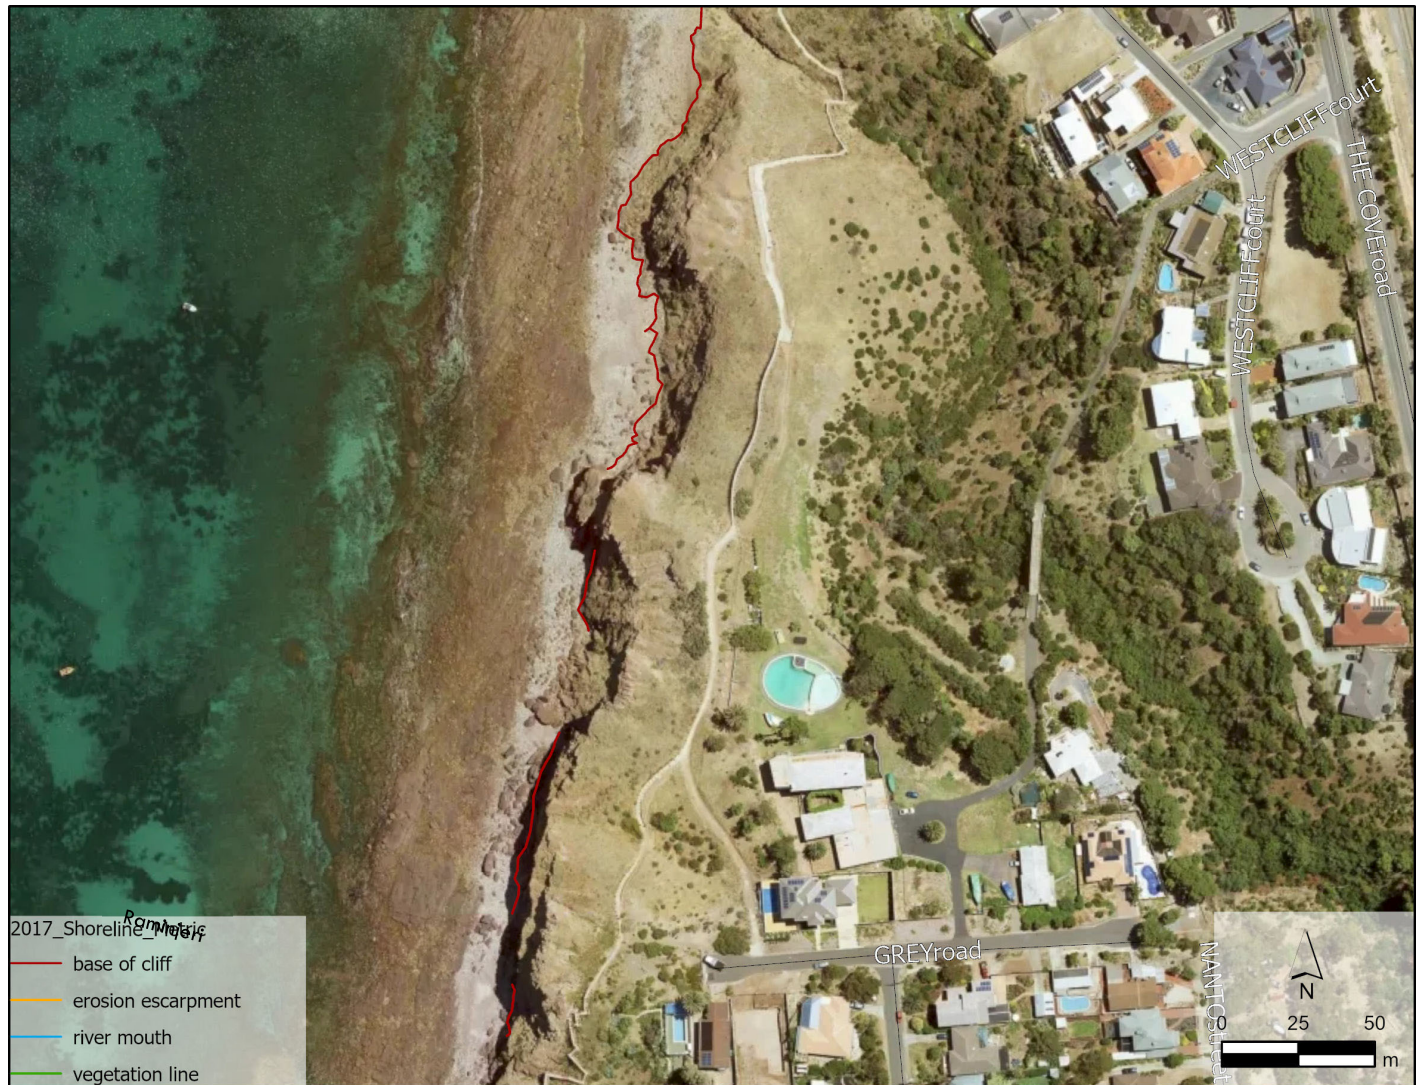
No evidence of shoreline change or cliff top change. Minor rock fall observed in north of this minor cell in 2002. Vegetation cover increasing from 1979 to 2017.

A stable section of the coastline with one minor rock fall observed in 2007 aerial photograph.

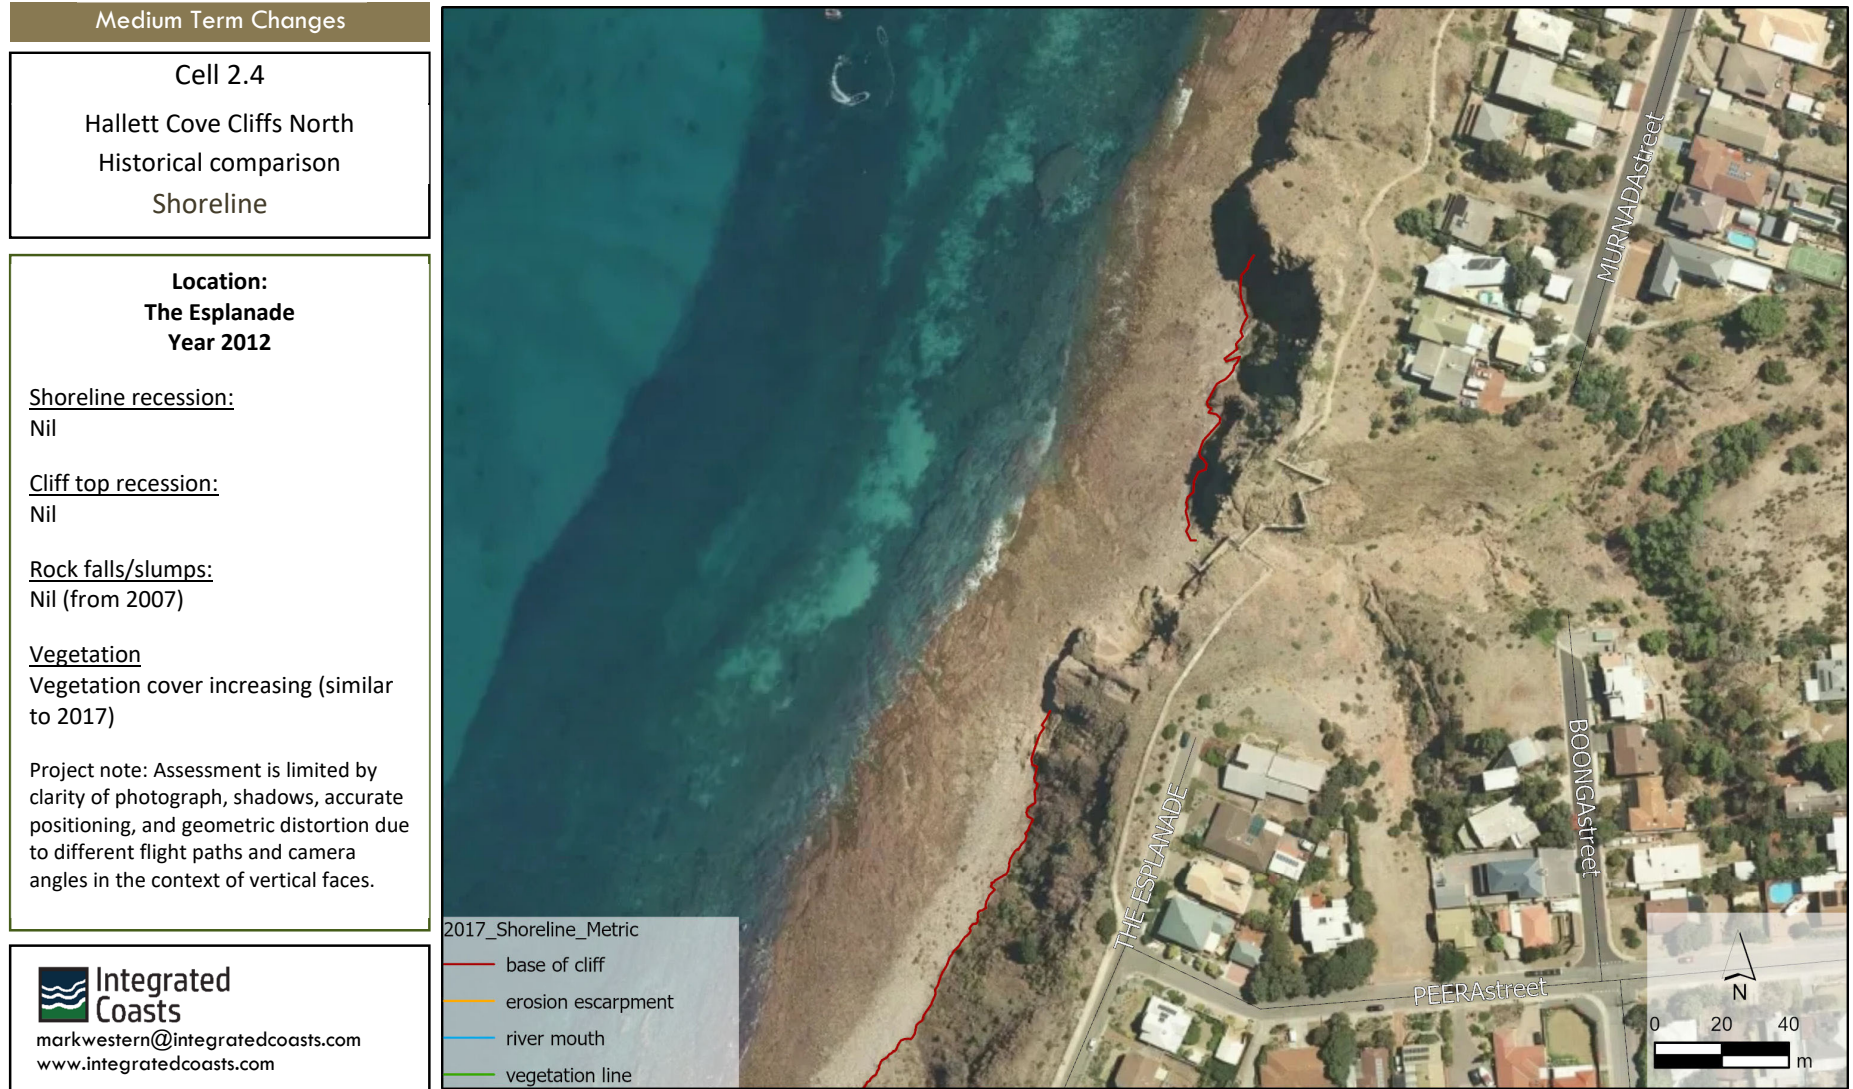
A stable section of the coastline with no rock falls or slumps observed from 1979 to 2017. Possible minor recession of the base of the cliff where shown.

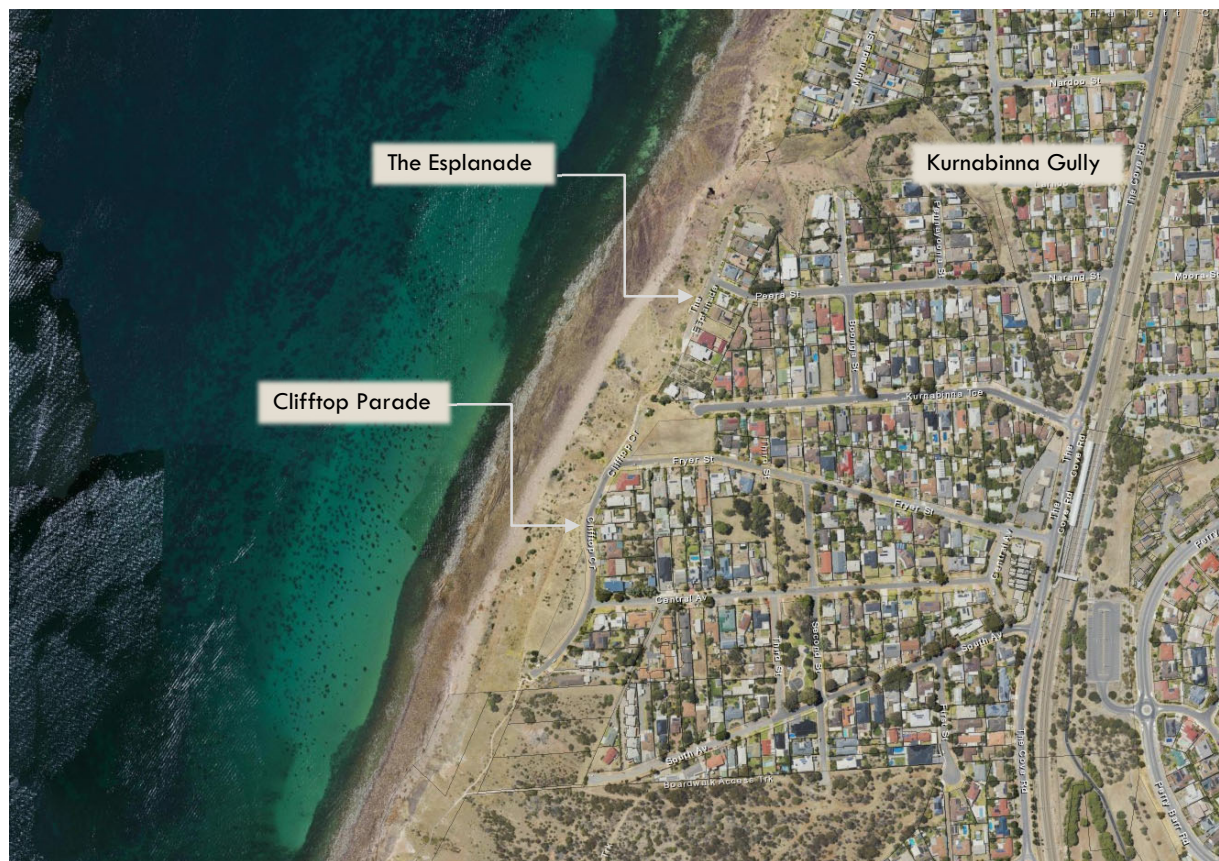
Figure a. The cliffs at Hallett Cliffs (North) are natural barrier to human intervention which is generally set well back from the cliff tops. Private property usually abuts the coastal reserve. Exceptions are The Esplanade and Clifftop Parade.

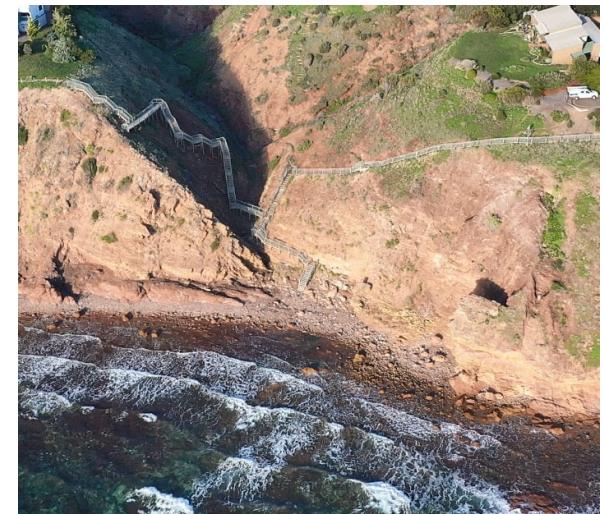
Figure b. The access stairs at Kurnabinna Gully is the only human infrastructure implemented along this section of coast. Proposals are being considered for a walking bridge across the gully (CoM, 20 October, 2021).

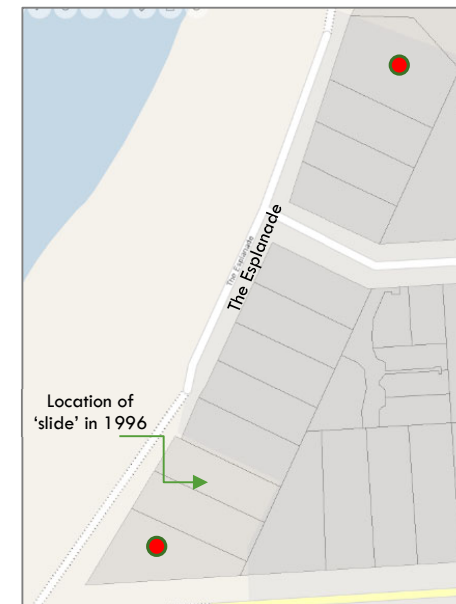
Generally, the development controls appear adequate to control the potential for increased development density along The Esplanade as most sites have frontages ~15m. However, there are some exceptions as noted in Figure a.

Figure a. Street and site layout of The Esplanade, Hallett Cove, South Australian Property and Planning Atlas, 2022.

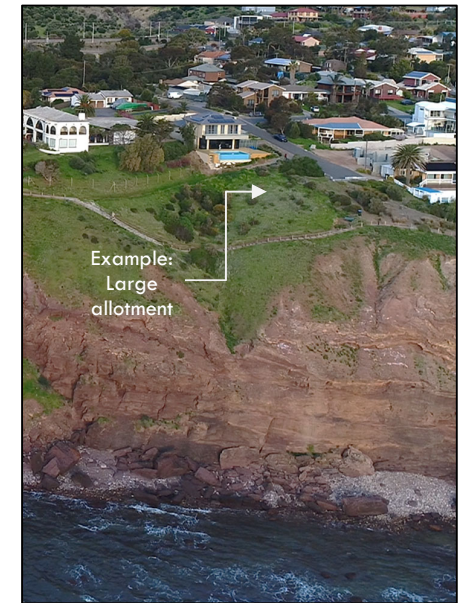
Figure b. A few larger allotments remain near the coast, the one pictured positioned within a gully. (This is an example only; no particulars are known about this site).

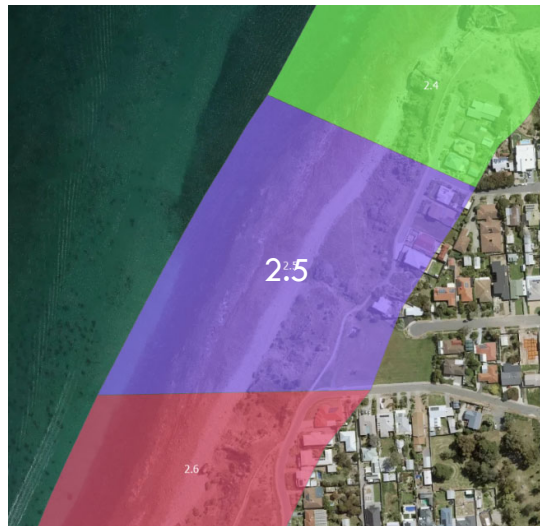
Predominantly hard rock vertical cliffs that are resistant to erosion (Wilmington Formation, but contains some friable material), dominated by low profile offshore reef and rocky beach platform with thin layer of sand. Larger events impact the base of the cliffs, but routine tides do not. The Esplanade or the walking trail is set at the top of the cliff. In 1996, a slump occurred in the upper cliff and the cliff slope was mechanically lowered. The slump may have been caused by uncontrolled water.

Land based and aerial photography indicate that there have been minimal changes to the beach and backshores since the 1940s due to the rocky nature of the coast. A slump in a portion of the upper cliff occurred in 1996 and the cliff slope was mechanically lowered.
