Coastal Adaptation Study

HALLETT COVE BEACH

Cell 3

By Integrated Coasts
Review date 1 December 2022

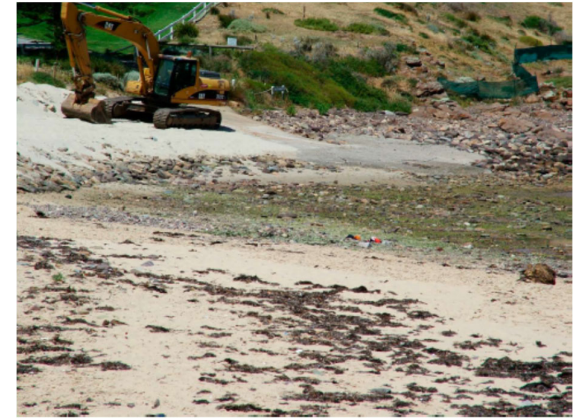
Figures b & c. Rock revetment placed in front of the Field River dune, November 2004, Photograph, City of Marion.

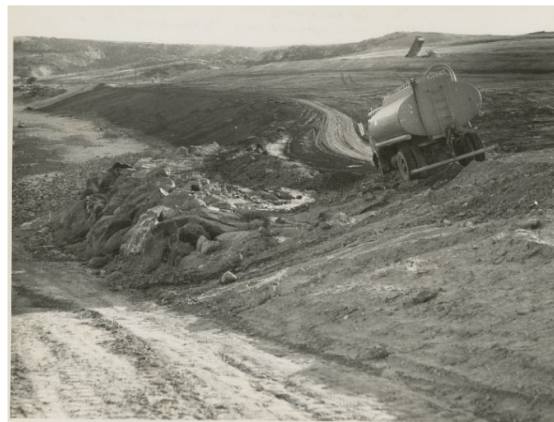
Figure a. The natural dune system removed, earthen embankment installed, 1975, State Library of SA, SRG 847.1.1.31

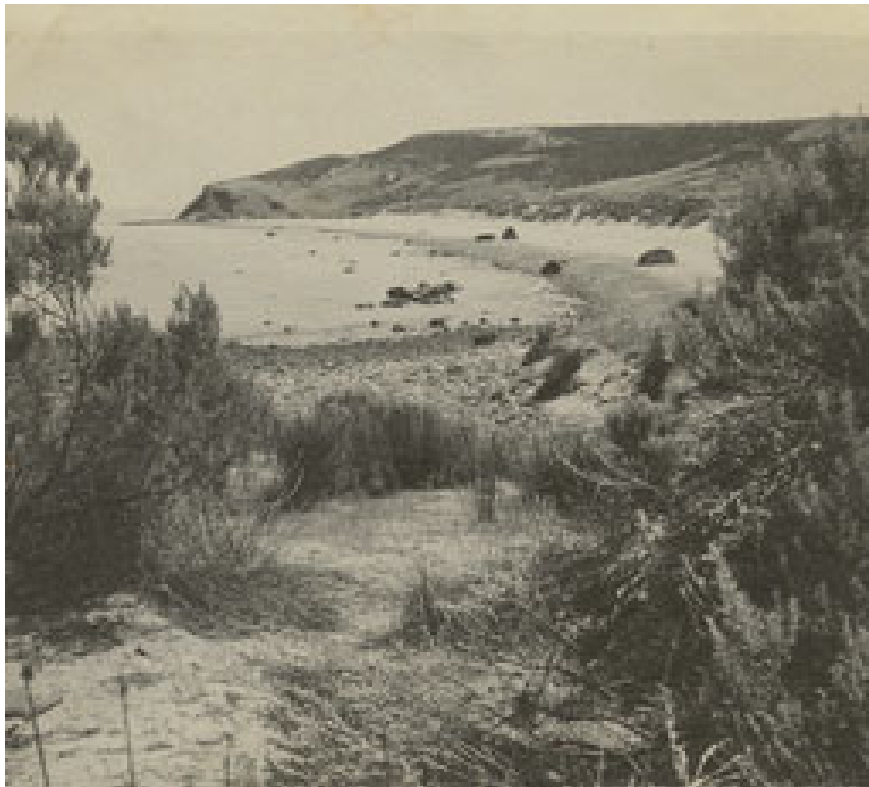
Figure a. Hallett Cove Beach, circa 1920. The backshore to the beach in this time period was a natural dune system. State Library of SA, SRG847.1.1.31

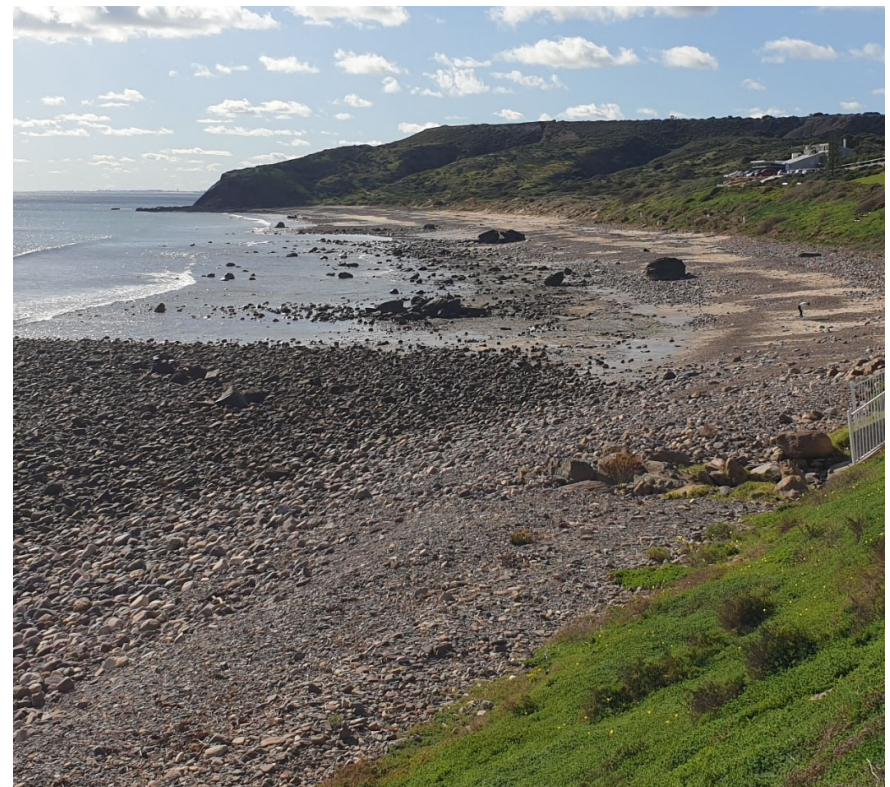
Figure b. Hallett Cove Beach, 4 July 2022 (winter). The location of the vegetation seen in 1920 is likely to have been at the base of this embankment.

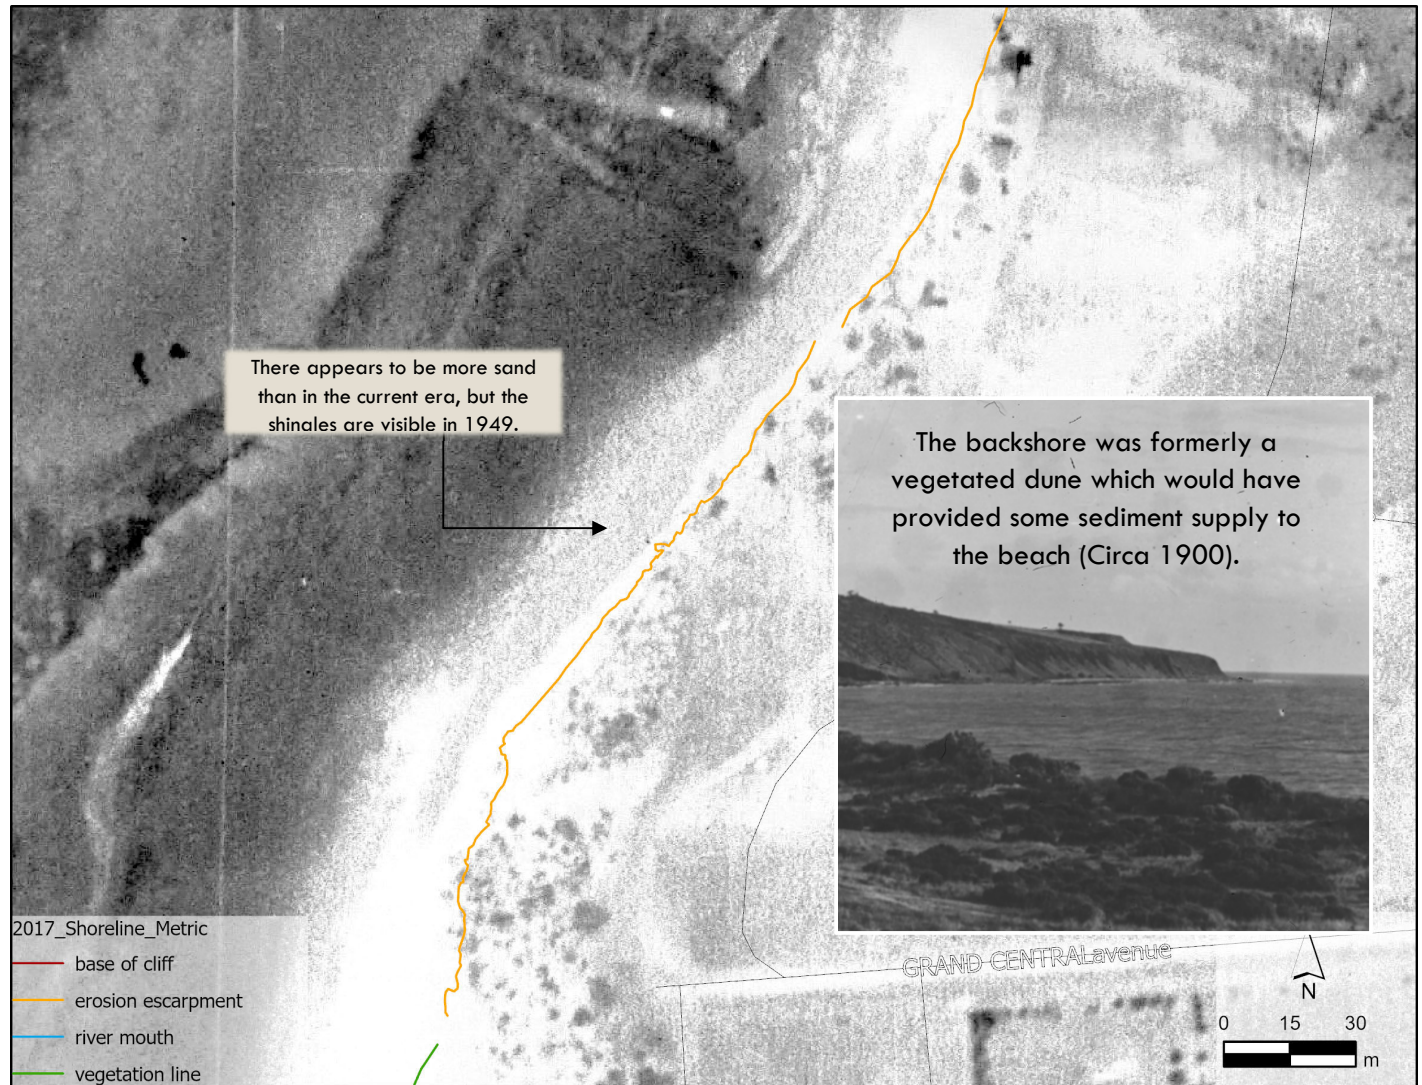
Recession of the embankment
observed in the south (3-6m) when
compared with 2017. This is likely
because the location of the base of
the embankment was determined by
humans in early 1970s.

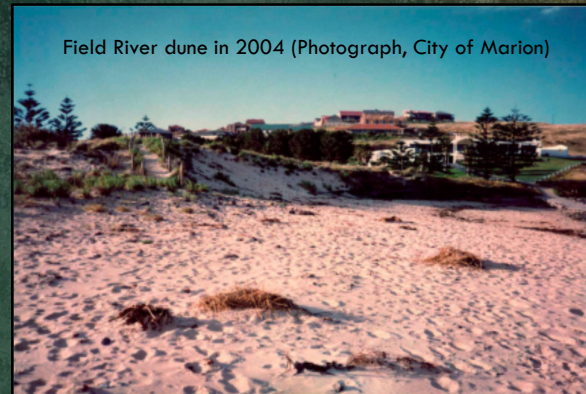
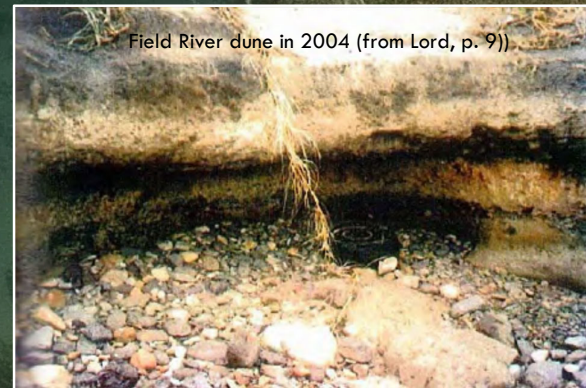
Field River dune in 2004 (Photograph, City of Marion)

Field River dune in 2004 (from Lord, p. 9)

Protection items: Rock revetment was placed on the southern end of the Field River dune in 2004. Before this installation, actions of the sea were creating caves under the dune. Sand drift fencing has been installed in front of the dune to the north of Field River. River Parade and residential area is generally above 6m AHD (well above sea-flood risk).

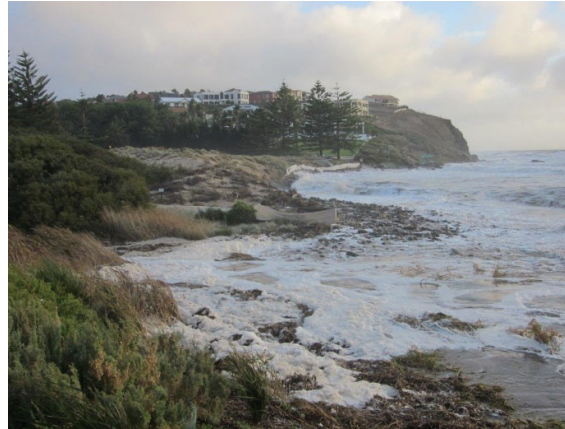
Photographs and videos of the storm are only available for the Field River area that show waves impacting the base of banks and the dunes (example, Figure a). Water in Field River was also elevated (Figure b). The sand dune at Field River, which began receding in the 1990s suffered further erosion (Figure c).

Figure a. Photograph taken at 17.20, 9 May 2016 by Bill and Glenys Summersides, residents on The Esplanade at Marino (used with permission).

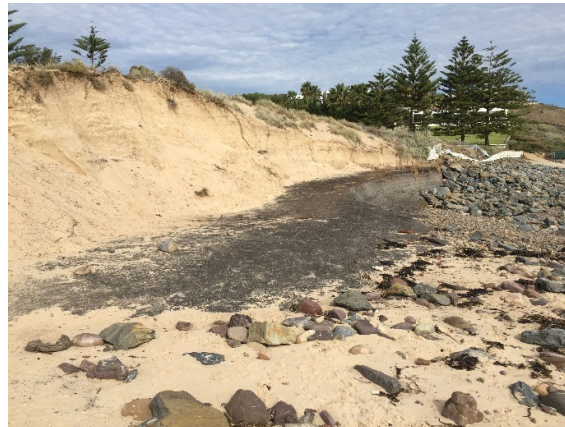
Figures c. Field River dune suffered its first major erosion event (Photograph: unknown, 14 May 2016)

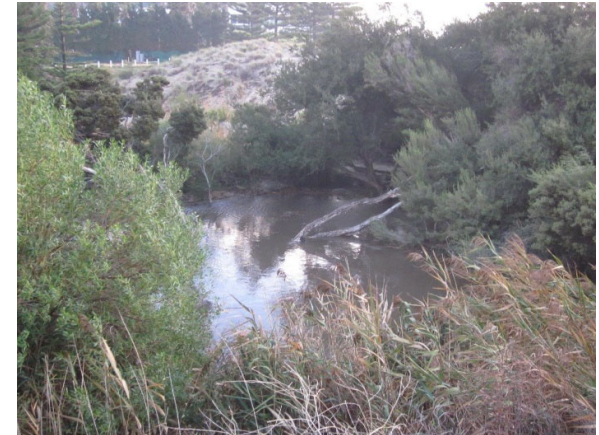
Figure b. Elevated water in Field River, but not with rainwater. (Photo: Bill and Glenys Summersides, residents on The Esplanade at Marino, used with permission).

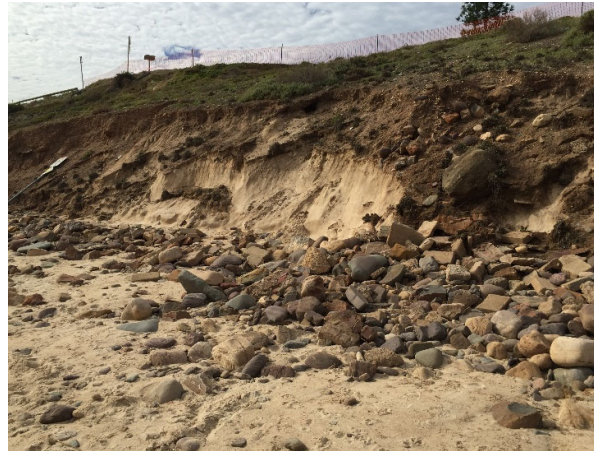
The scars in the embankment reveal some of the history of Hallett Cove Beach. The former dune can be seen under the earth that was imported when Heron Reserve was formed (Figure a). The imported fill and buried debris were revealed in the area adjacent the pedestrian ramp (Figure b). See also photograph from 1975 in the Settlement History that shows how Hallett Cove Beach backshore was formed. The key point here is that a flexible dune system was removed that probably provided some sediment to the beach.

Figure a. The slope under Heron Reserve was scarped in the storm (Photograph, City of Marion, 14 June 2016).

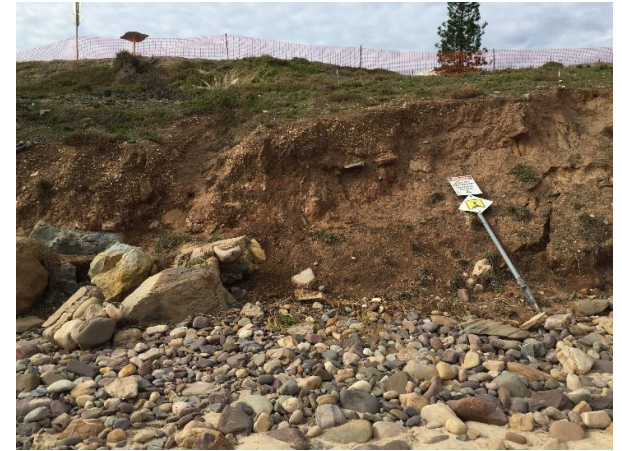
Figure b. The slope under Heron Reserve was scarped in the storm (Photograph, City of Marion, 14 June 2016).

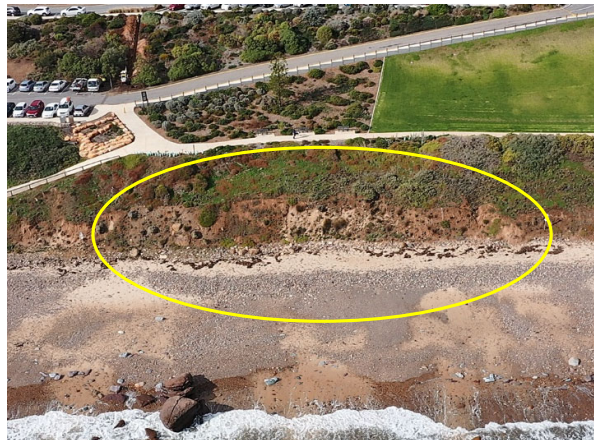
Figure c. The same location as Figure (a) taken in September 2022 (Integrated Coasts, drone video, 17 September 2022).

All three areas were repaired by importing clay, remaking the slope, covering with geotextile matting and revegetating (Figures c, d).

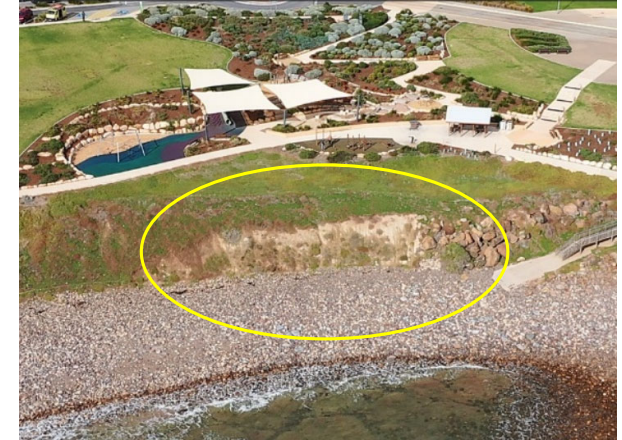
Figure d. The same location as Figure (b) taken in September 2022 (Integrated Coasts, drone video, 17 September 2022).

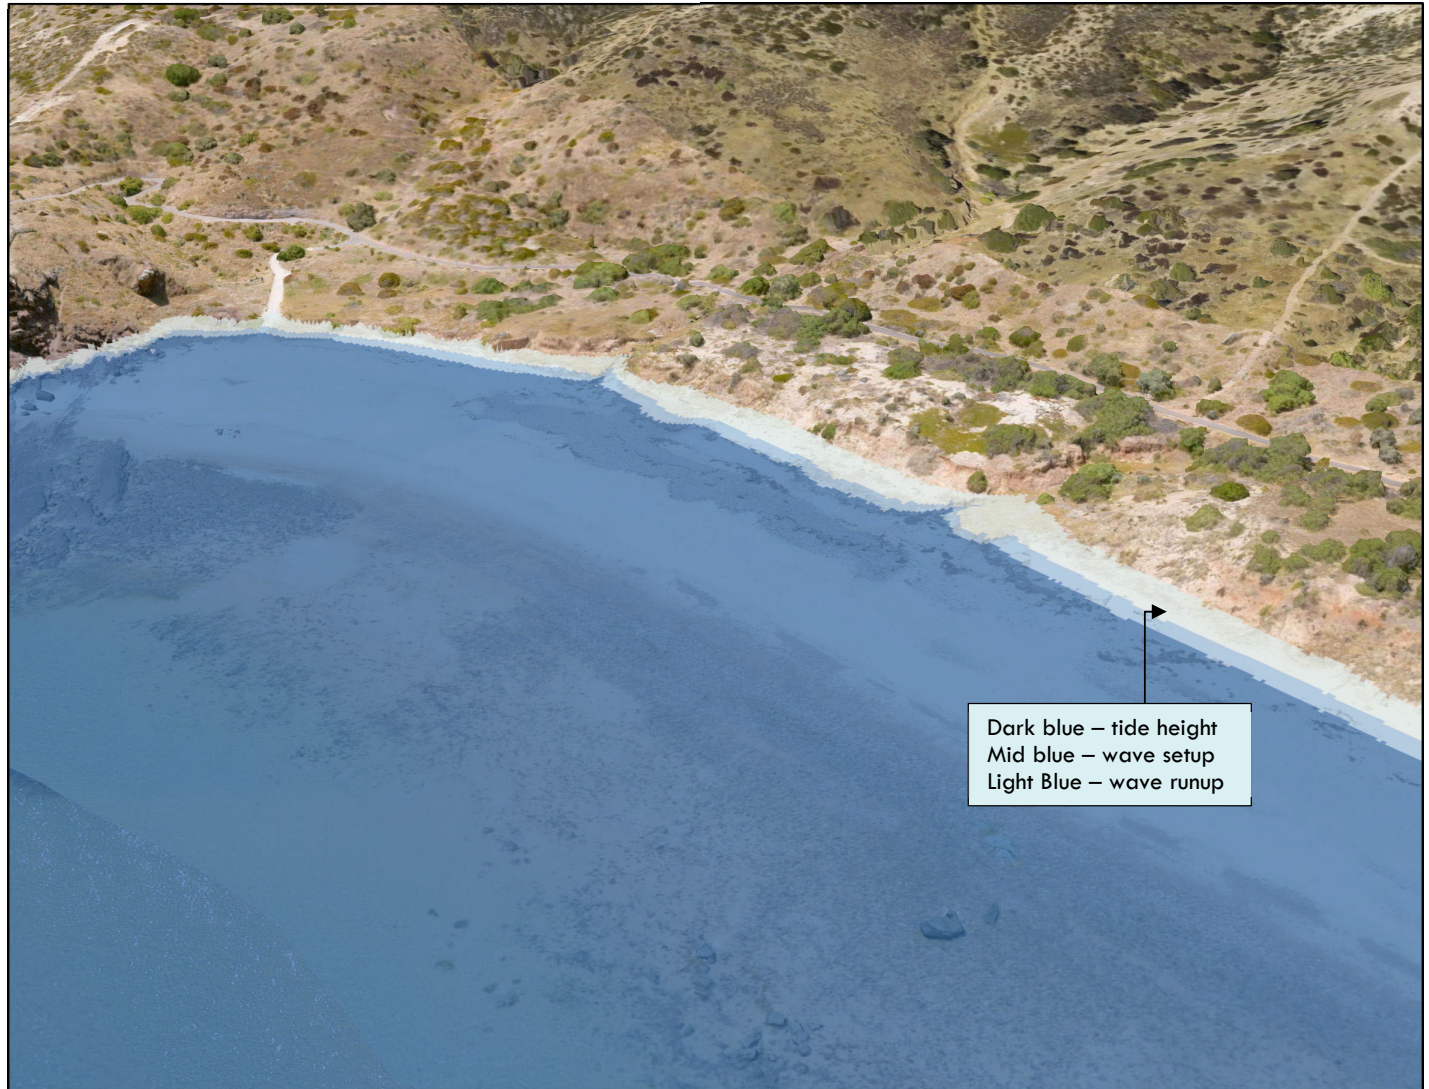
5.2 Coastal exposure — routine high water (2100)

Assessment: Actions of the sea at 1.00m higher than present can be expected to cause significant recession (measured in decametres, perhaps 2).

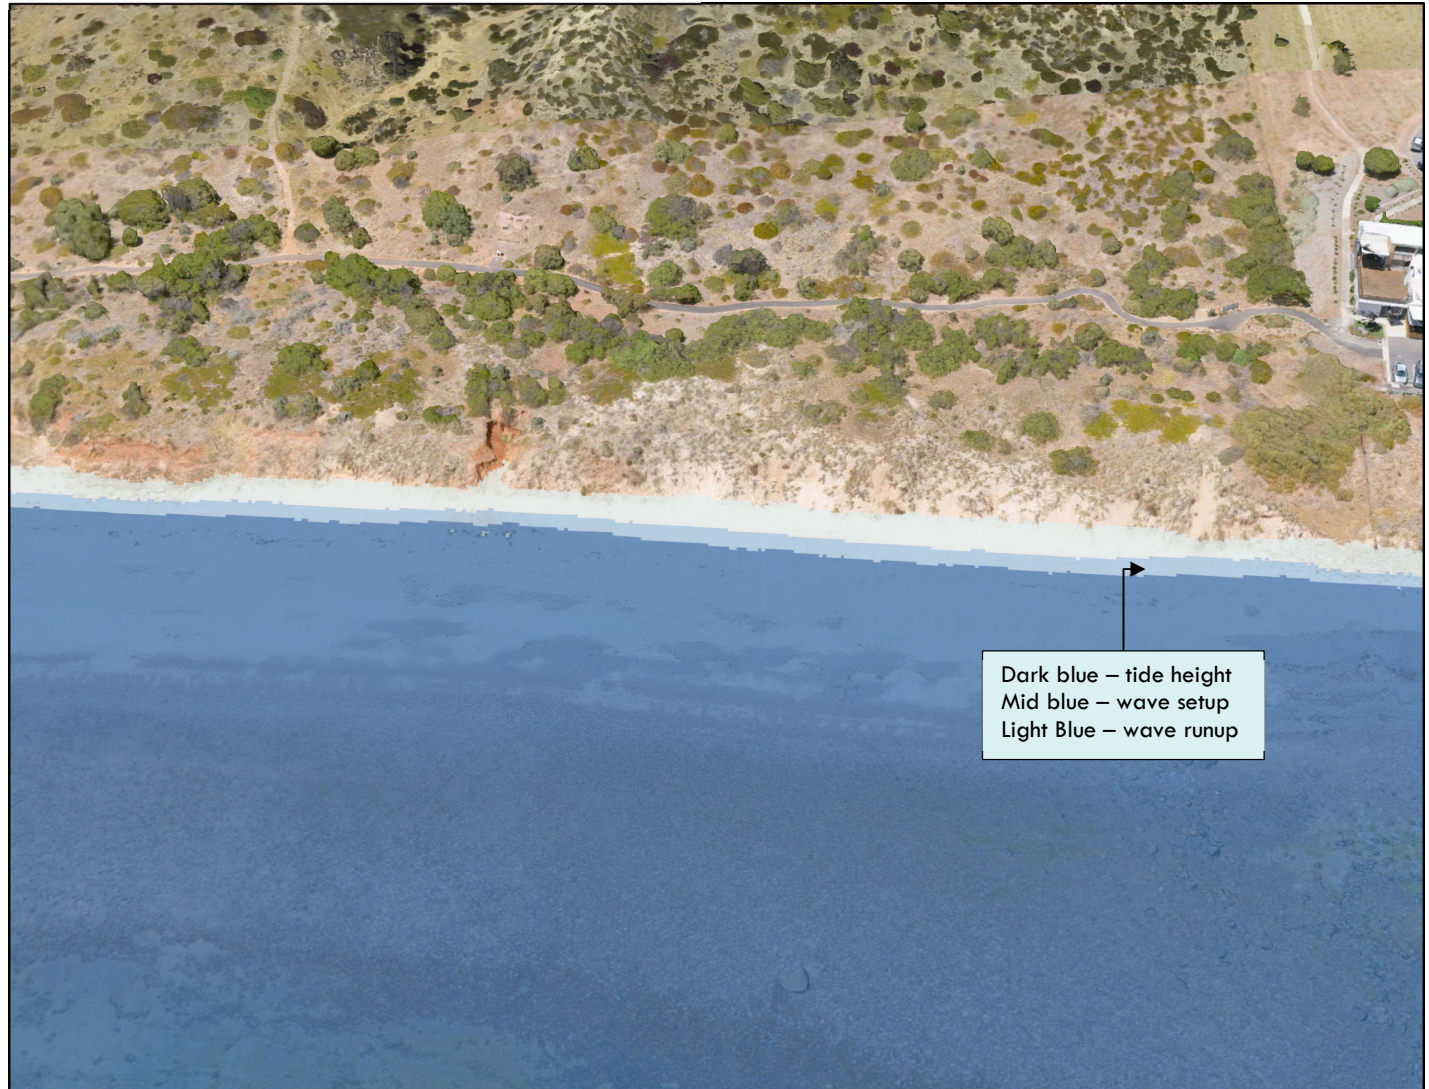
5.2 Coastal exposure — routine high water (2100)

Assessment: Actions of the sea at 1.00m higher than present can be expected to cause significant recession (measured in decametres, perhaps 2).

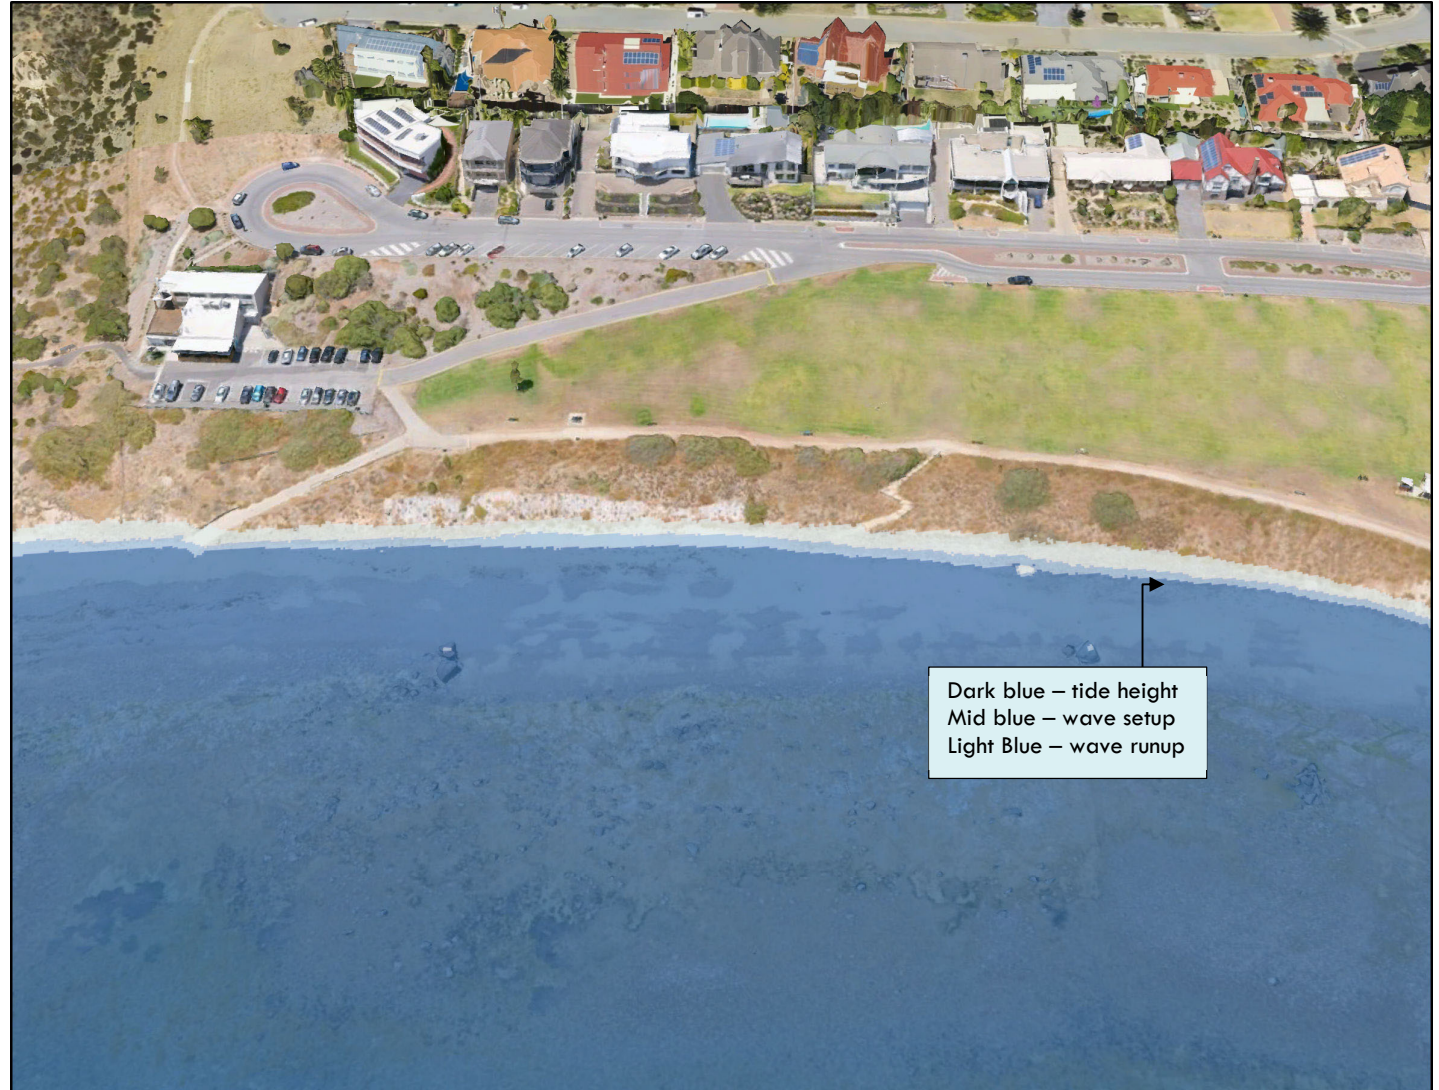
5.2 Coastal exposure — routine high water (2100)

Routine high-water events at 1.00m higher than present would cause significant recession and collapse of the embankment.

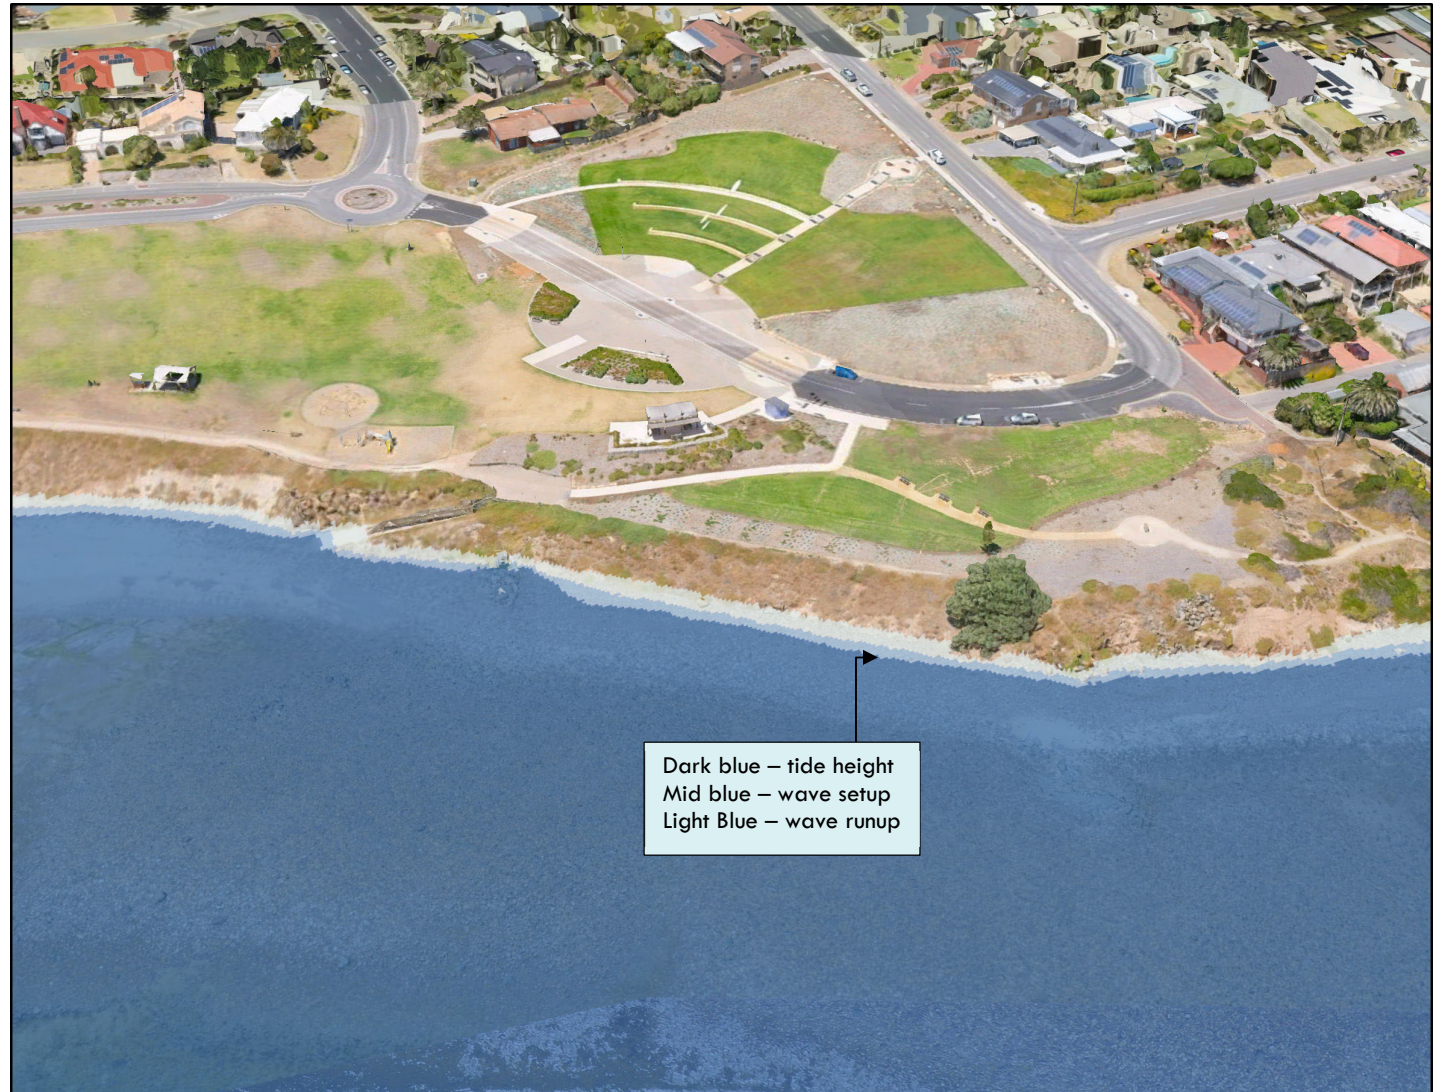
5.2 Coastal exposure — routine high water (2100)

Routine highwater events at 1m higher than present would cause significant undercutting of the embankment resulting in collapses.

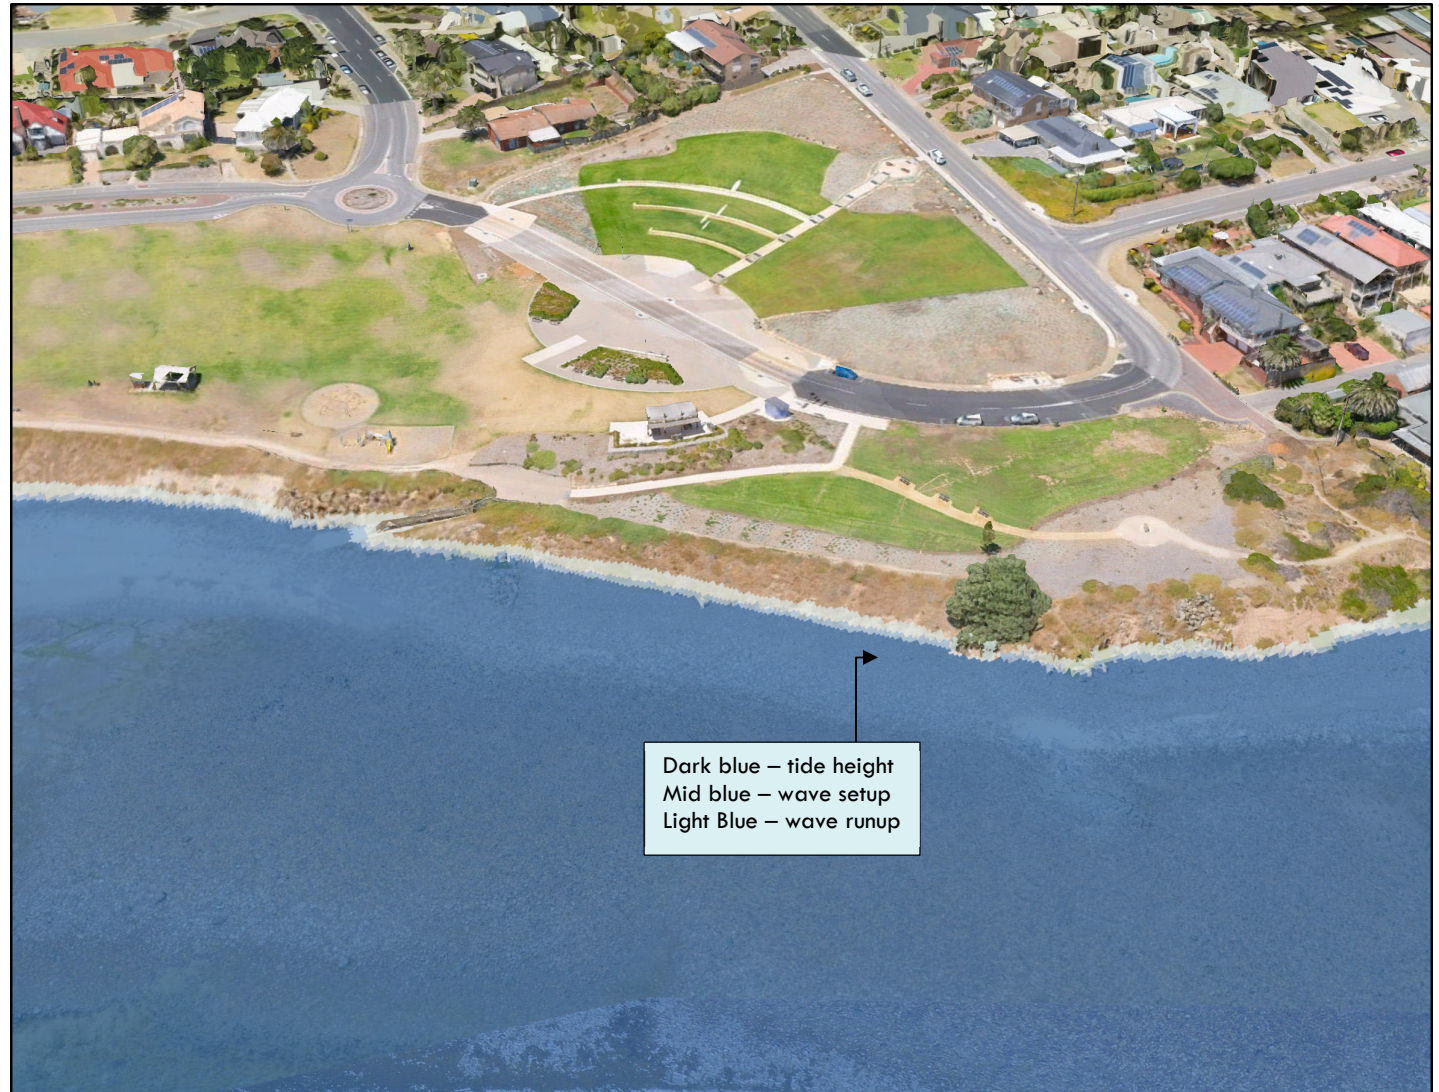
If sea levels rise as projected, then routine high-water events combined with storm events will cause significant recession of the escarpment. The slope would steepen and the bank eventually collapse.

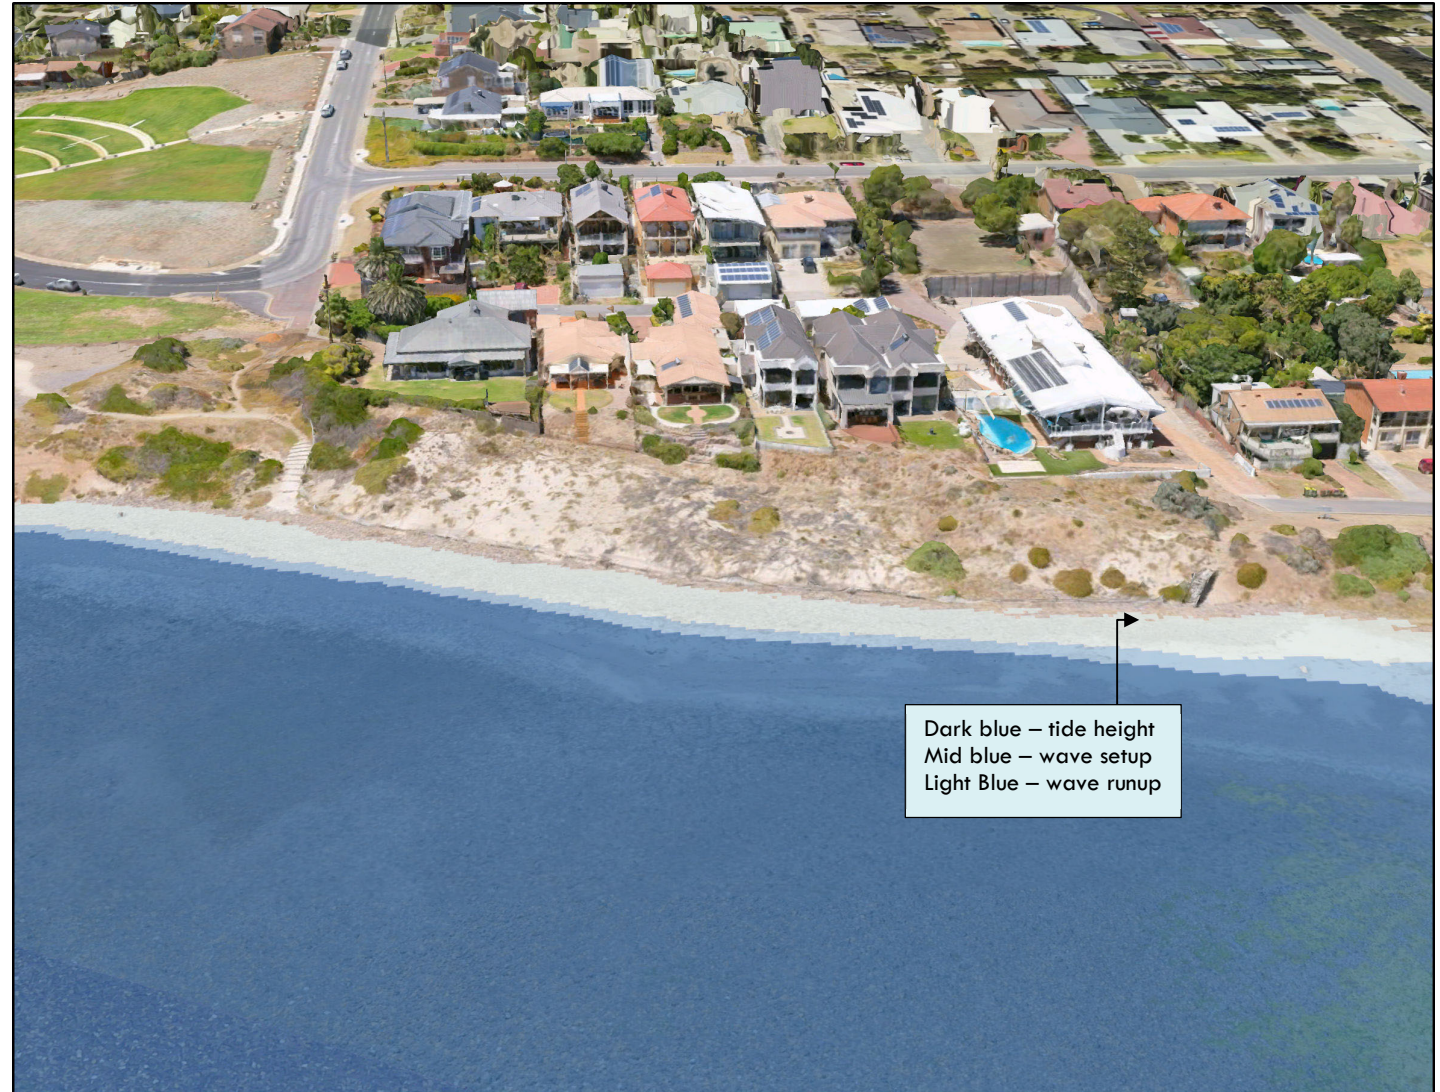
Routine highwater events 1.00m higher than present would cause significant recession of the dunes (perhaps 10m).

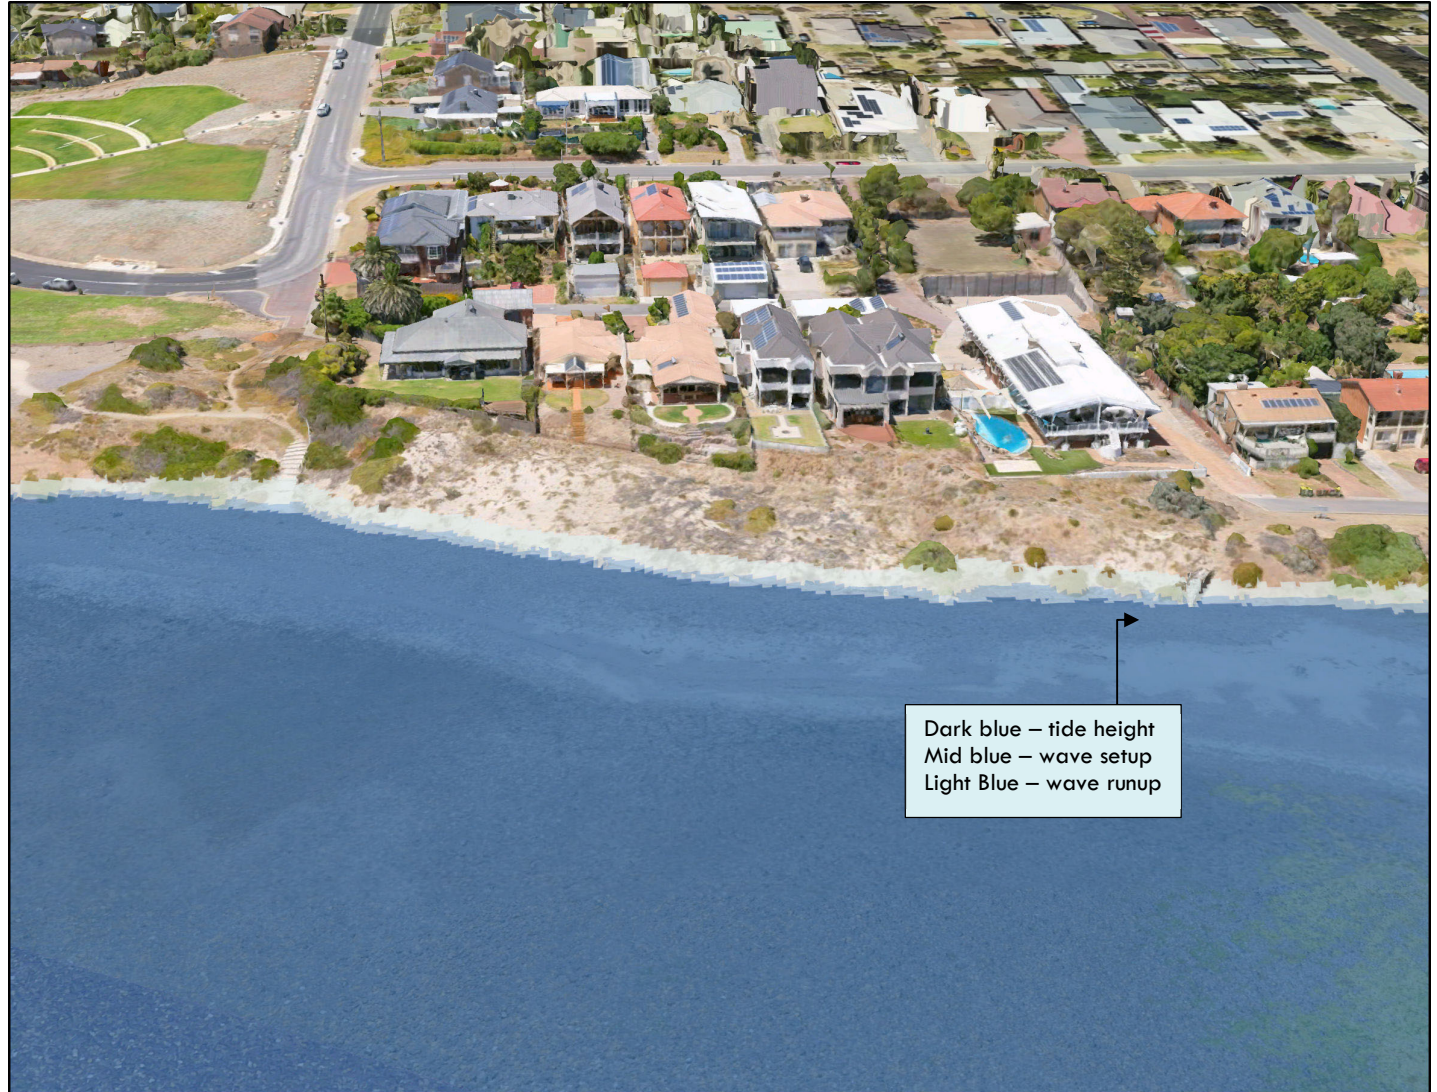
If sea levels rise as projected, then routine high-water events combined with storm events will cause significant recession of the dunes and the Field River dune (perhaps 10m to 15m).

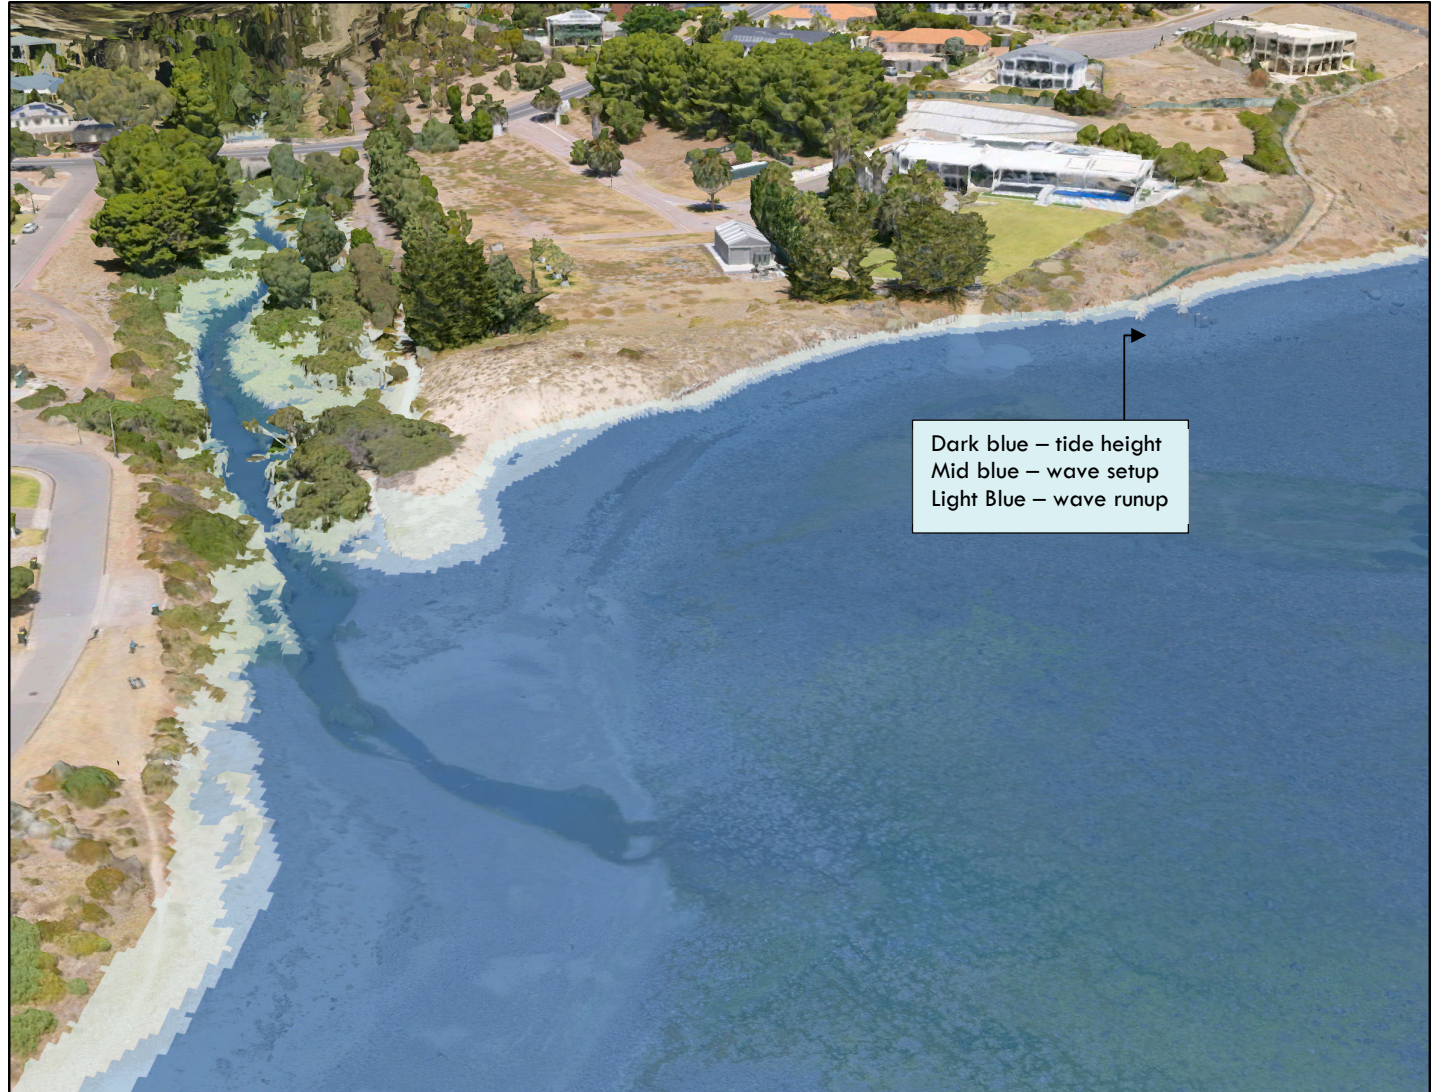
The impact of this storm event would have a similar impact as storm event 9th May 2016 which scoured the base of the embankments along River Parade and caused recession in the dune.

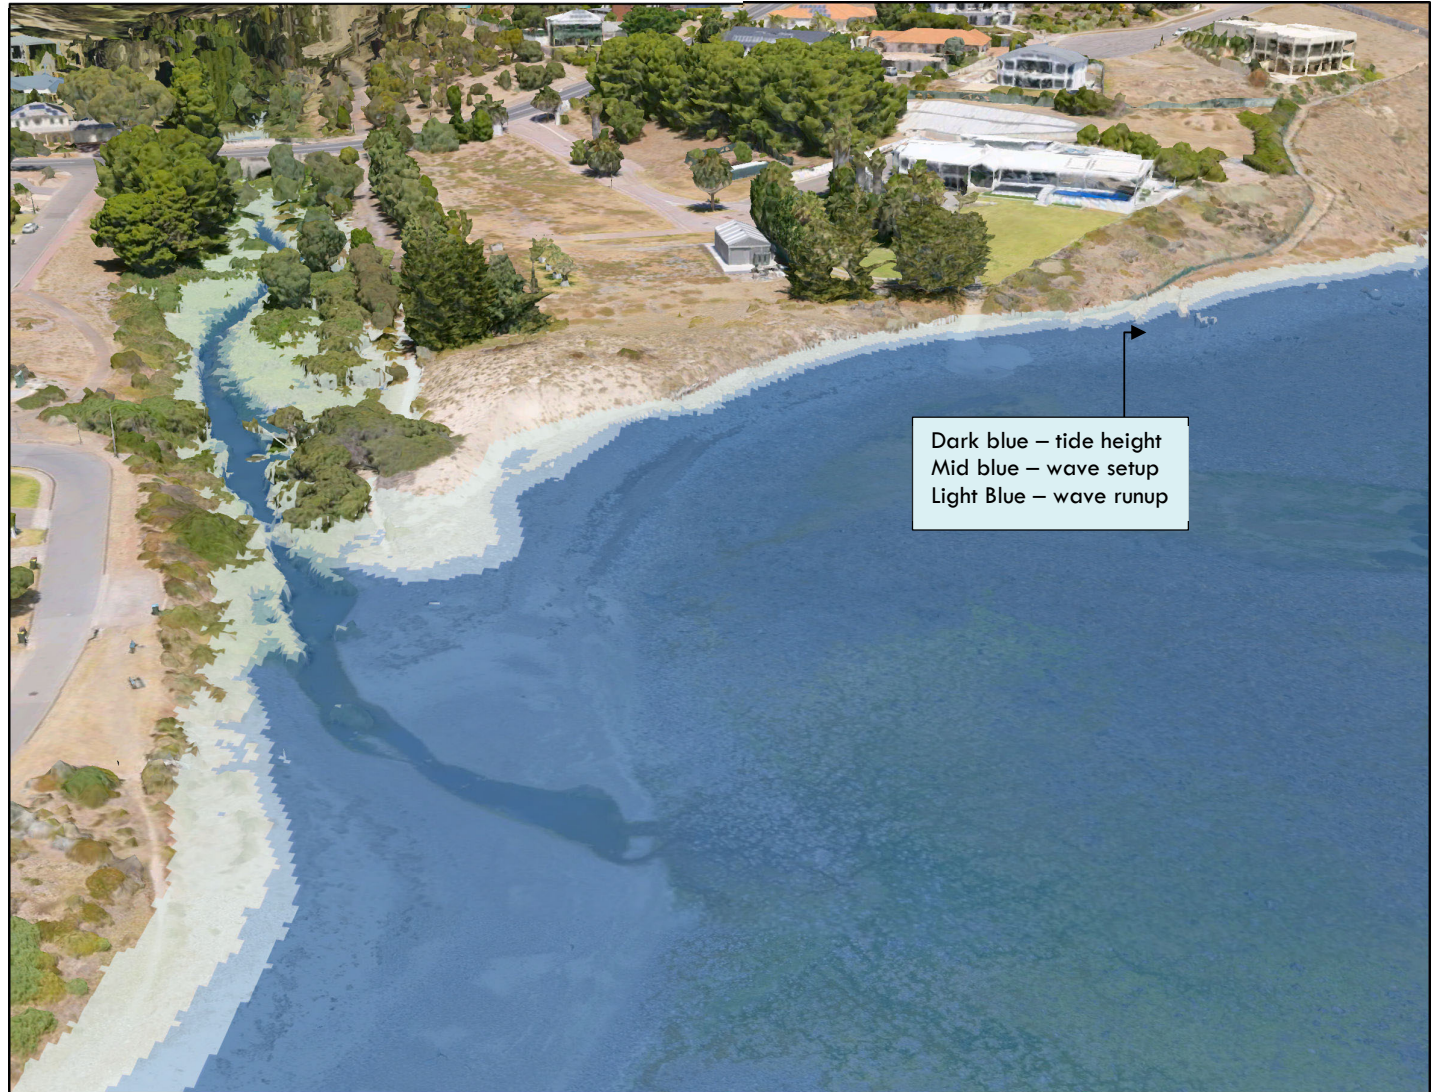
Combined with routine highwater events 0.30m higher than present would cause significant recession of the dune and undercutting of the embankments along River Parade.

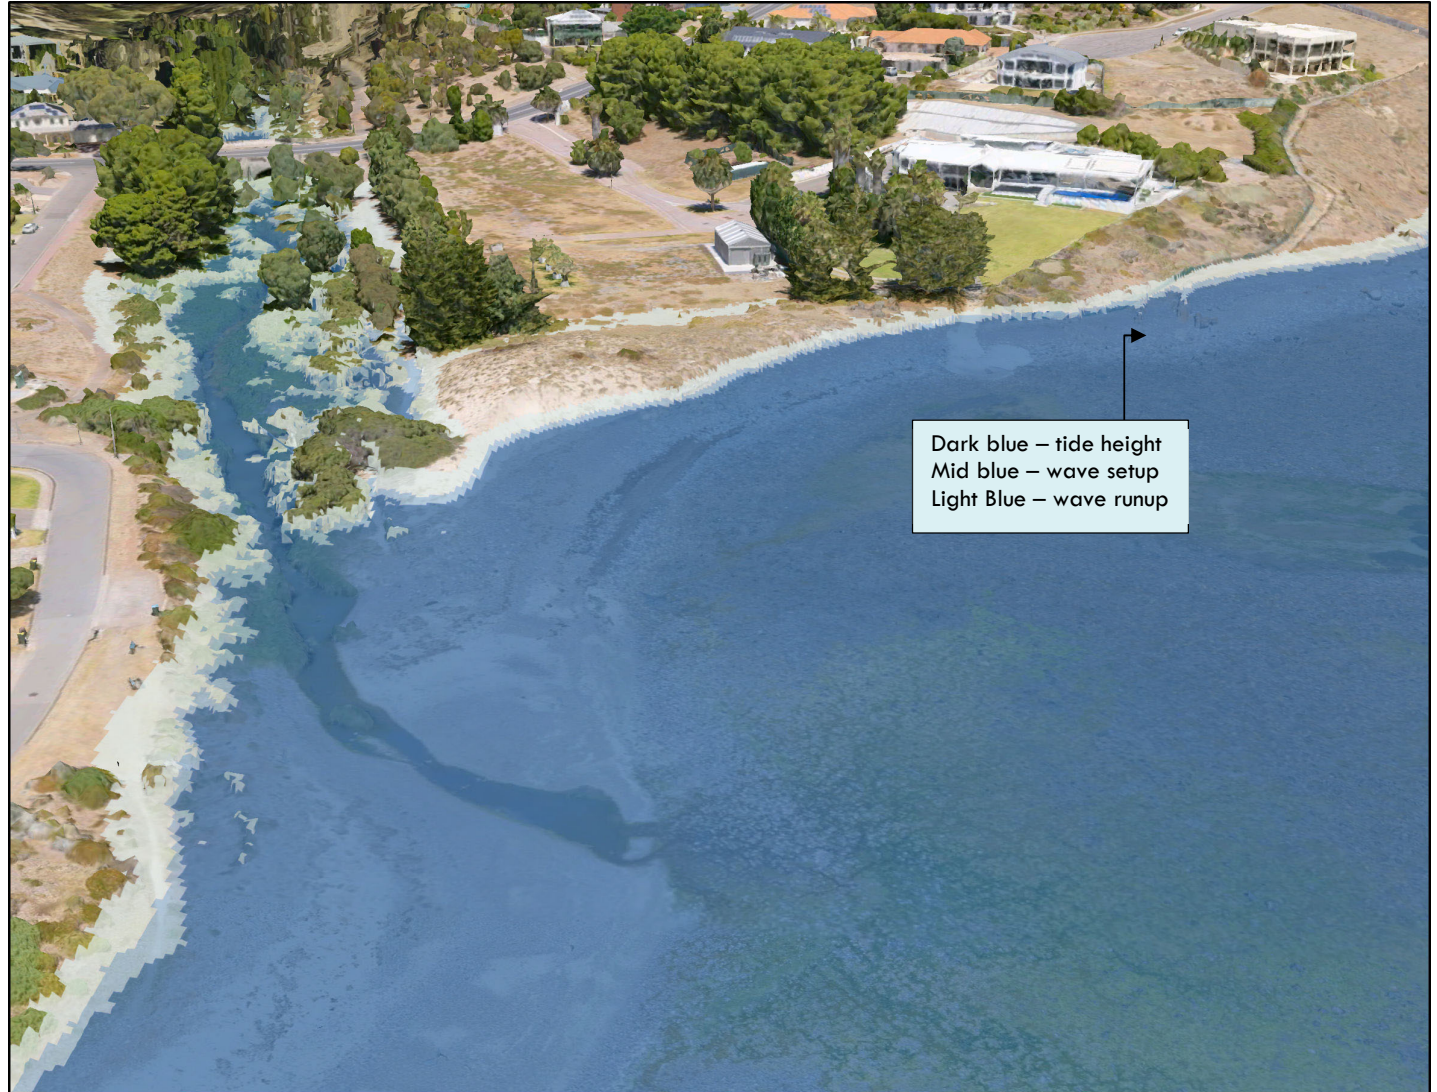
Routine highwater events have an impact on the base of the dune but is limited elsewhere. Events 0.30m higher than present would cause significant recession of the dune and undercutting of the embankments. The current 1 in 100-year event is likely to overtop the walking trail.

If sea levels rise as projected, then routine high-water events combined with storm events will cause significant recession of the dune (perhaps removing it), and the embankments along River Parade would be undercut/ collapsed. The walking trail would be continually overtopped.

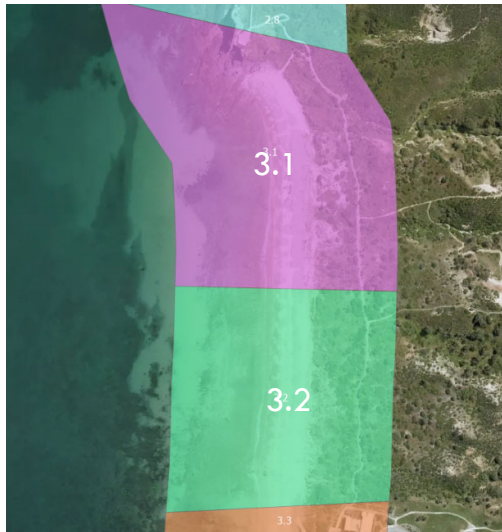
Land based and aerial photography indicate that shoreline undergoes cycles of erosion and accretion over decades, most likely due to storm activity. Since 1979, sections of the coast have undergone net recession of 2m to 6m and sand levels declined, but the beach has always been rocky underneath the thin layer of sand.
