Coastal Adaptation Study

HALLETT COVE BEACH

Cell 3

By Integrated Coasts
Review date 1 December 2022

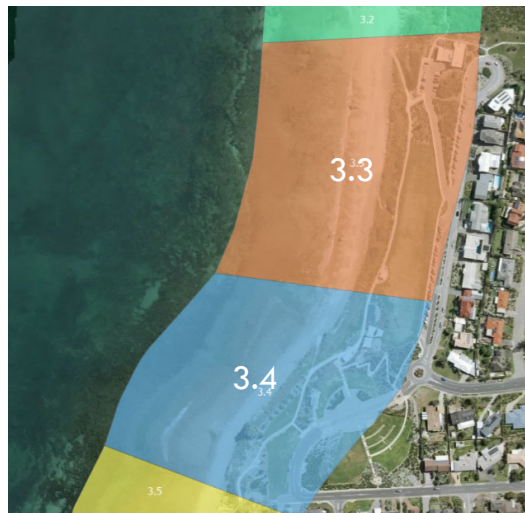
Land based and aerial photography indicate that 4-6m recession of the base of the embankment has occurred since 1979. In the north, this occurred early after installation of the embankment which may indicate that it was installed too far seaward. Sand levels appear lower than 1970s, but this was always a thin layer over shingles.

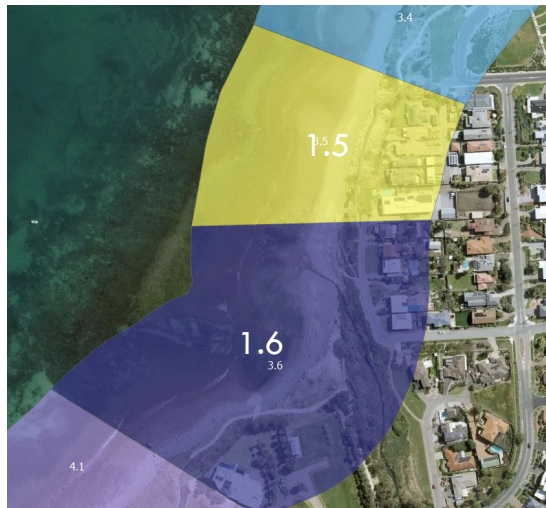
Rocks removed from intertidal zone. Land based and aerial photography show that erosion of the dune started in 1990s, and was further impacted by large events 2007, 2009, 2016.
