City of Marion

DRAFT Coastal Climate Change Adaptation Plan

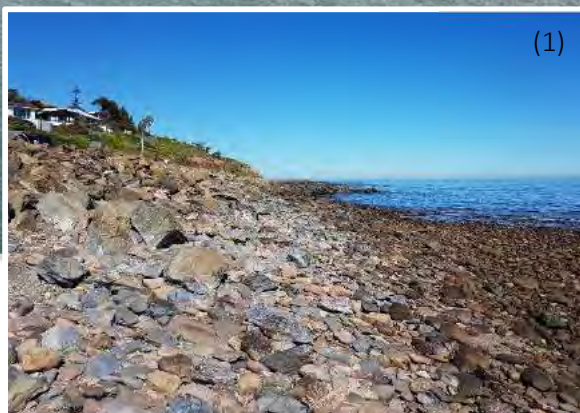
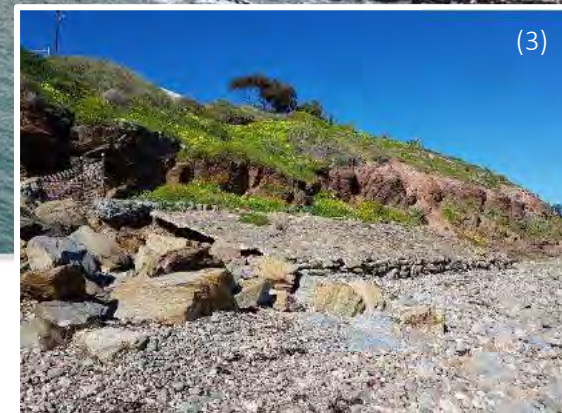
Cell 1: Marino Cliffs (1:1)

Rock revetment protecting The Esplanade is degrading (1). Small groyne exists (see above) perhaps to act as protection for small boat launching in the past (2). Protection structure (3) is likely to have protected former building, now undermined with erosion.

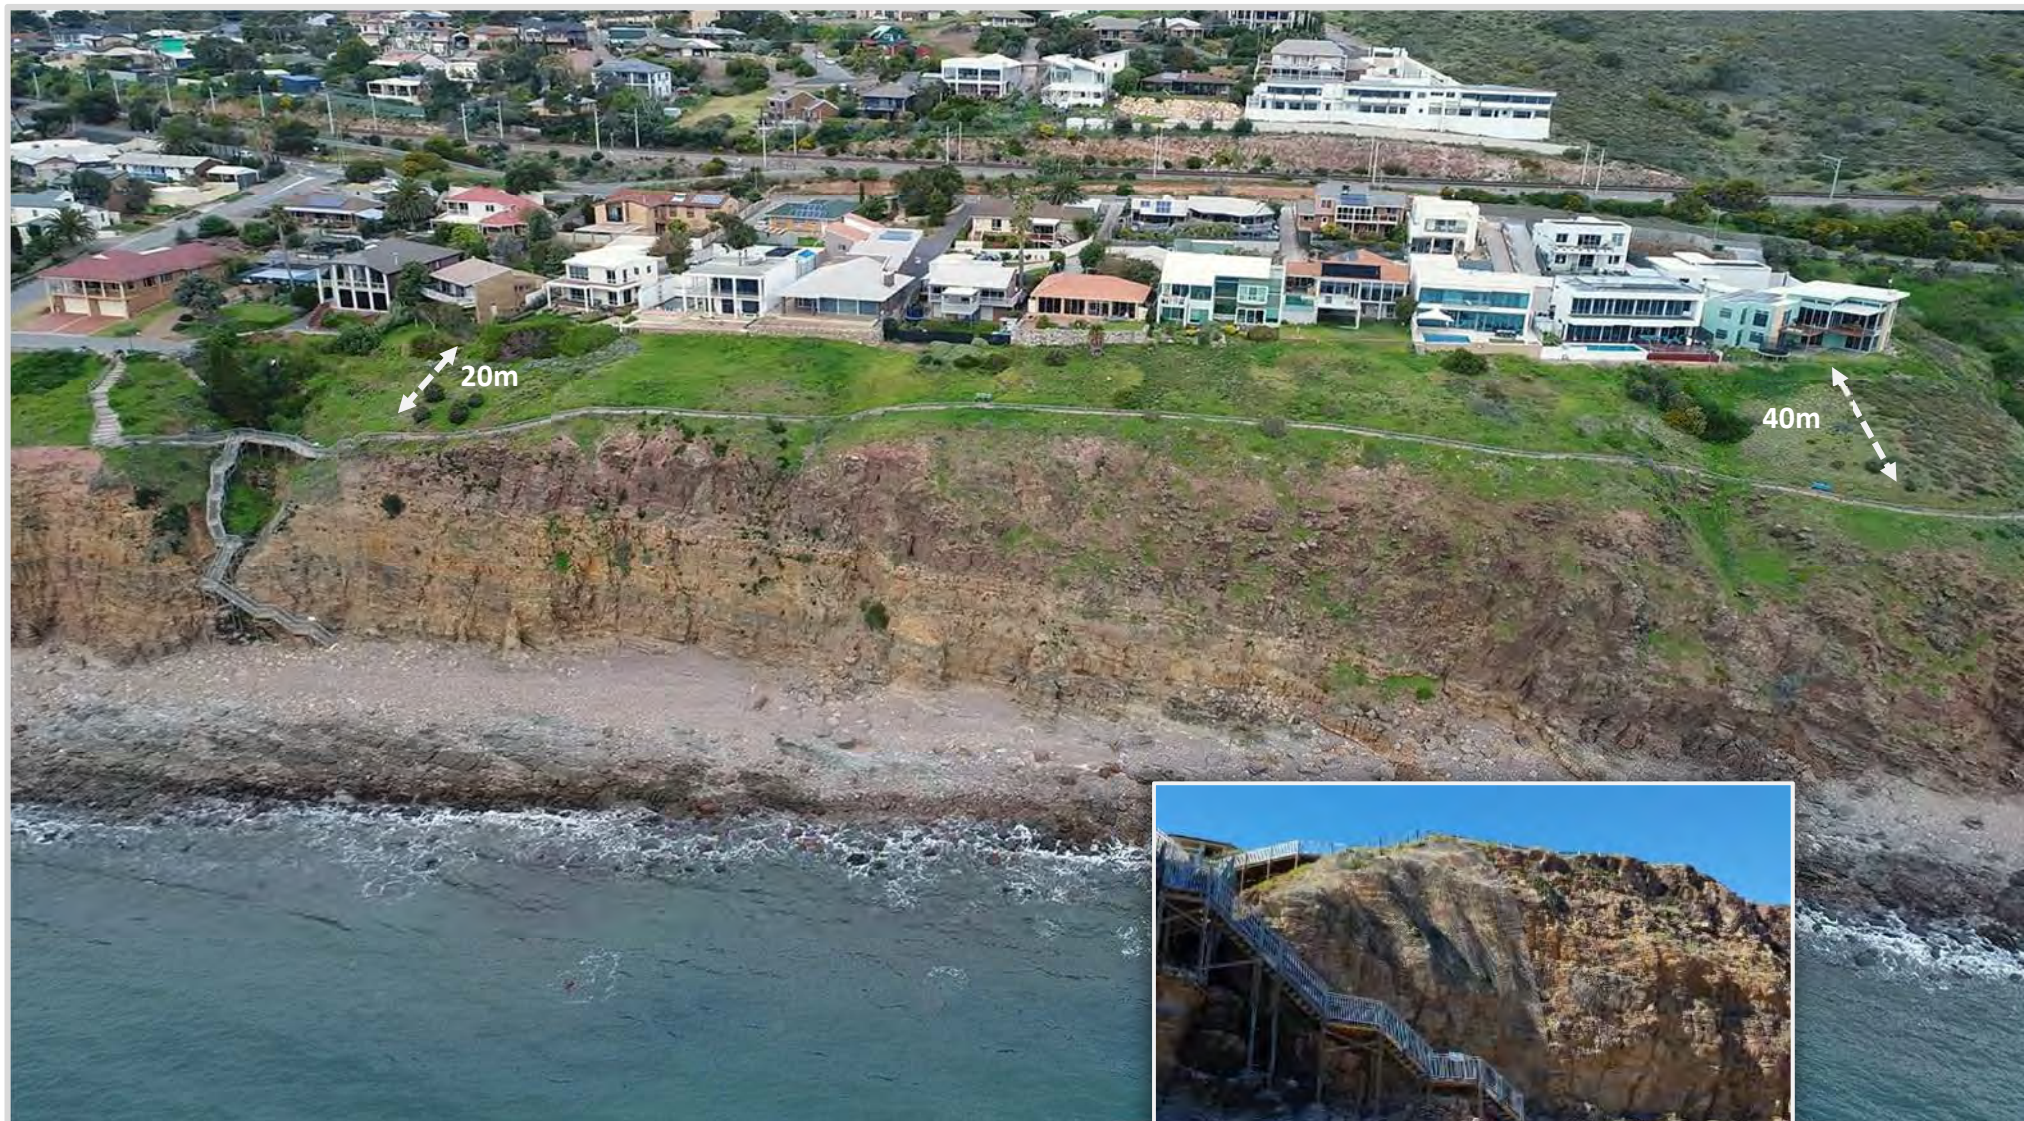
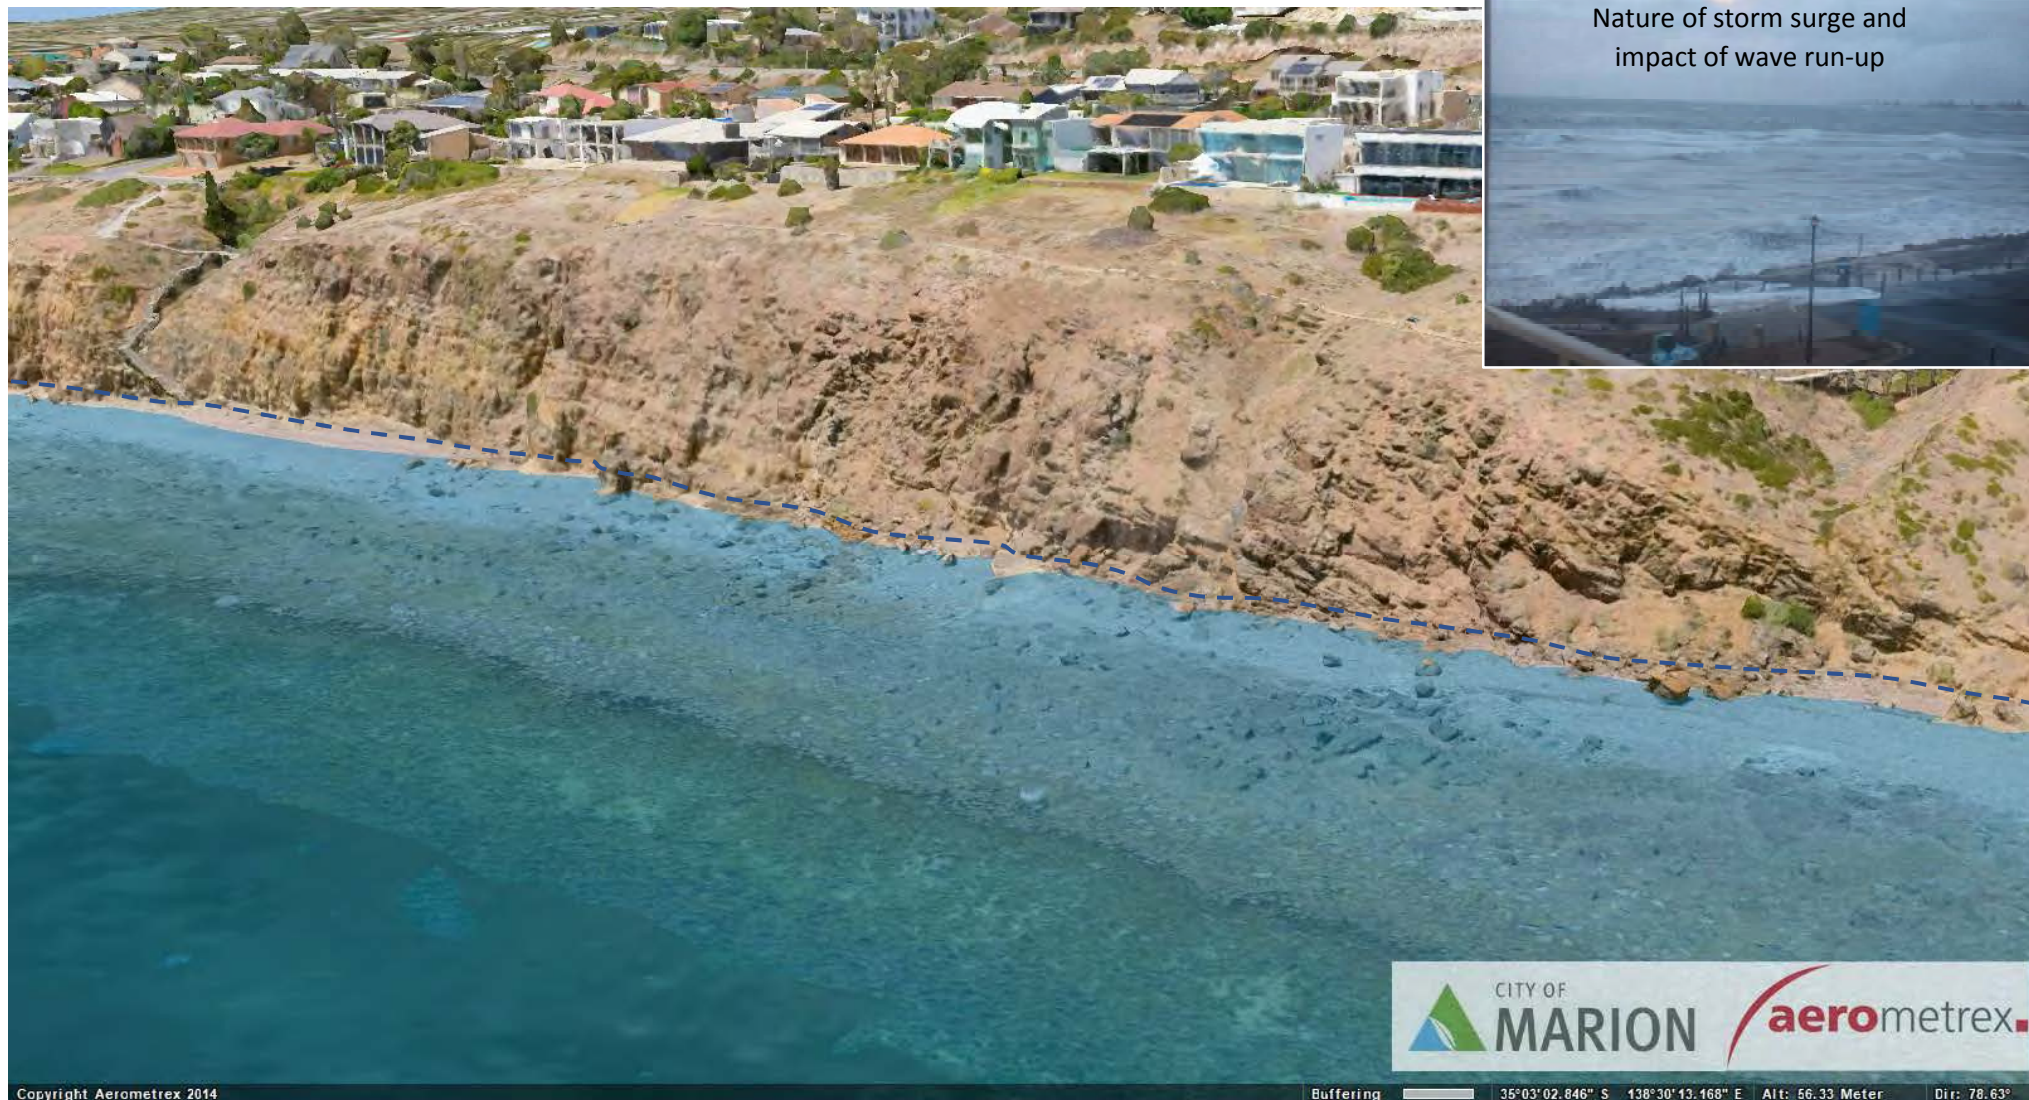
Cell 1: Marino Cliffs (4)

Falling rocks hazard contained with wire netting. Beach access stairs may come under increasing impact from sea processes but improved design can cater for impacts when stairs are upgraded.

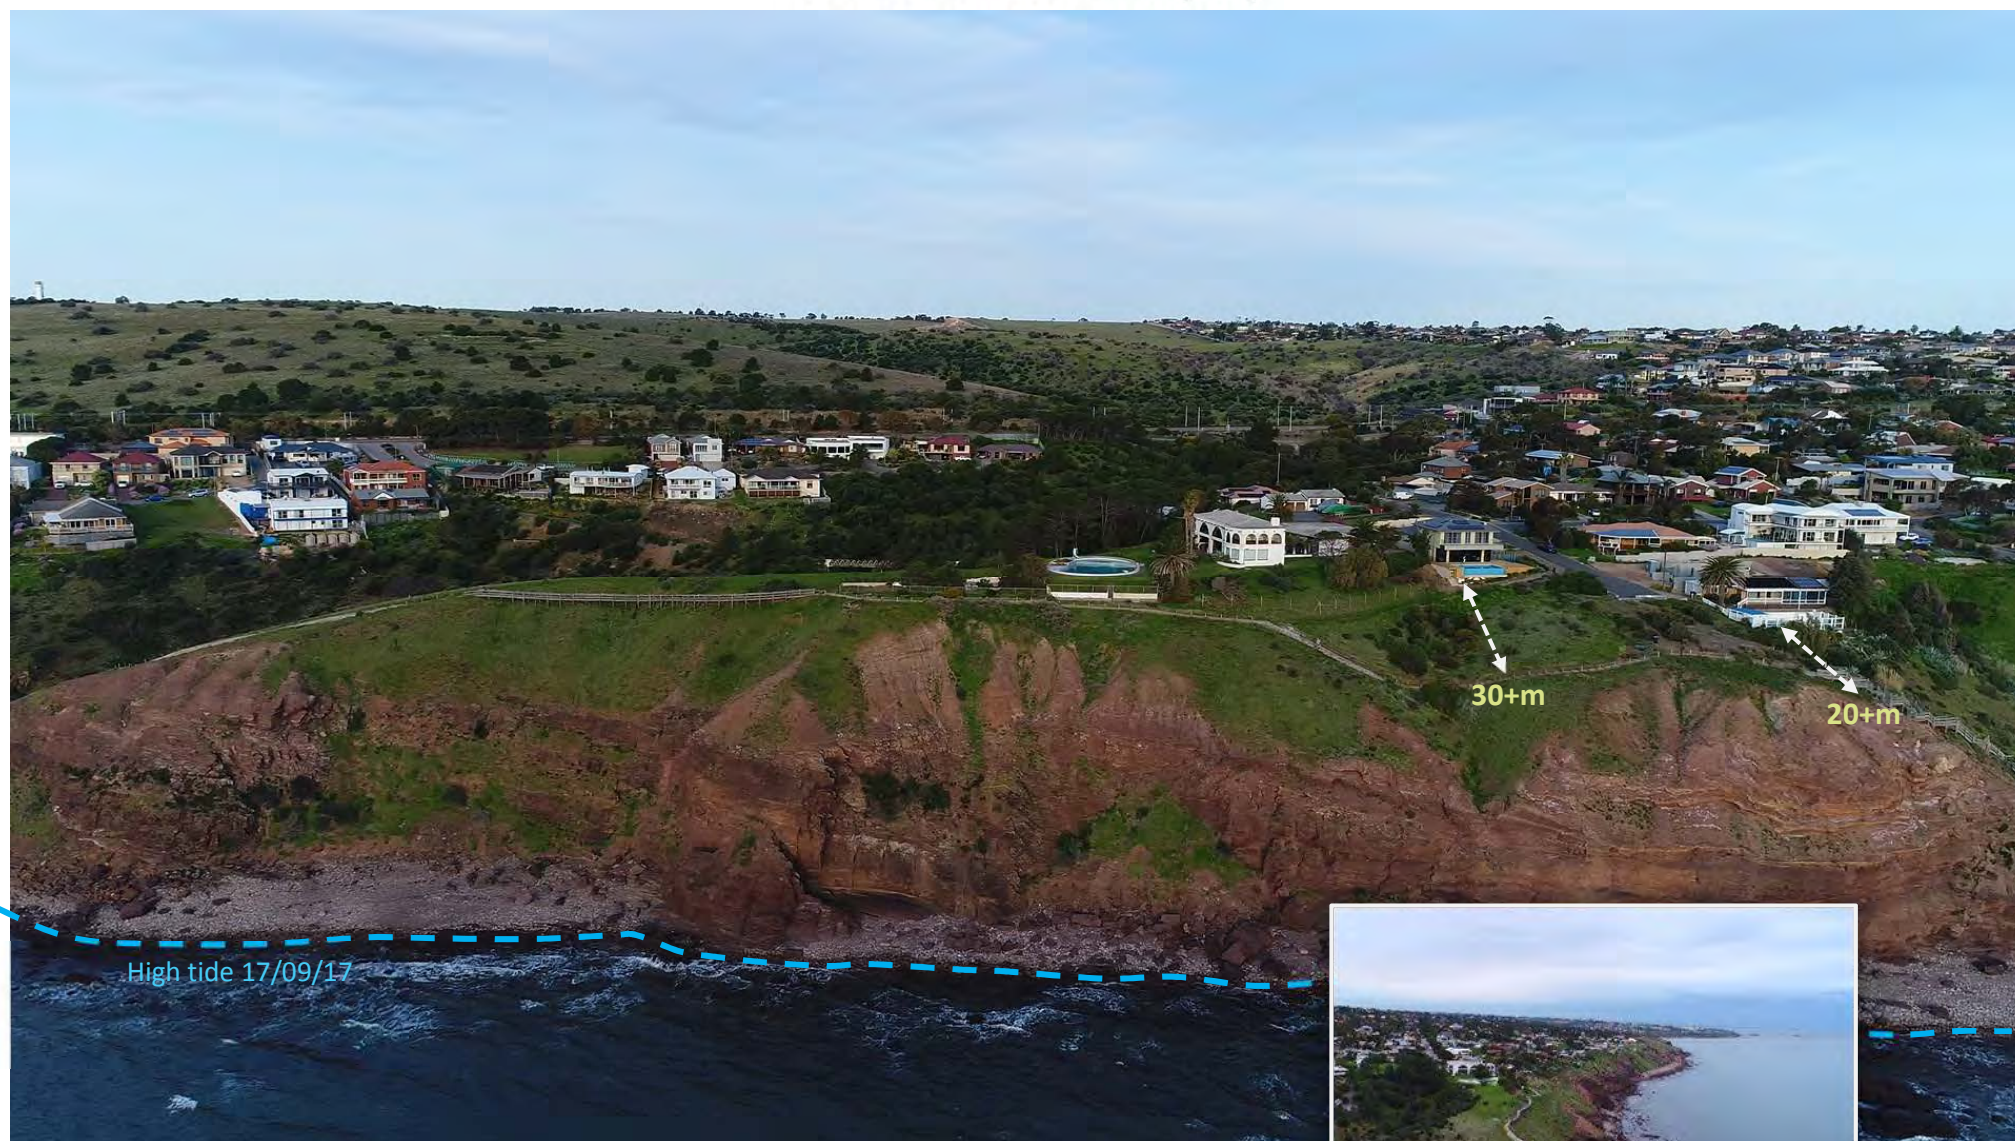
Cell 2: Hallett Cliffs (2:2)

High tide was 2.03CD (high tides can be 2.30 to 2.50). It is likely that some sections of this cliff base is receiving constant wave action. Houses are set well back from the escarpment which is much more vertical in this location. (Check house on south side)

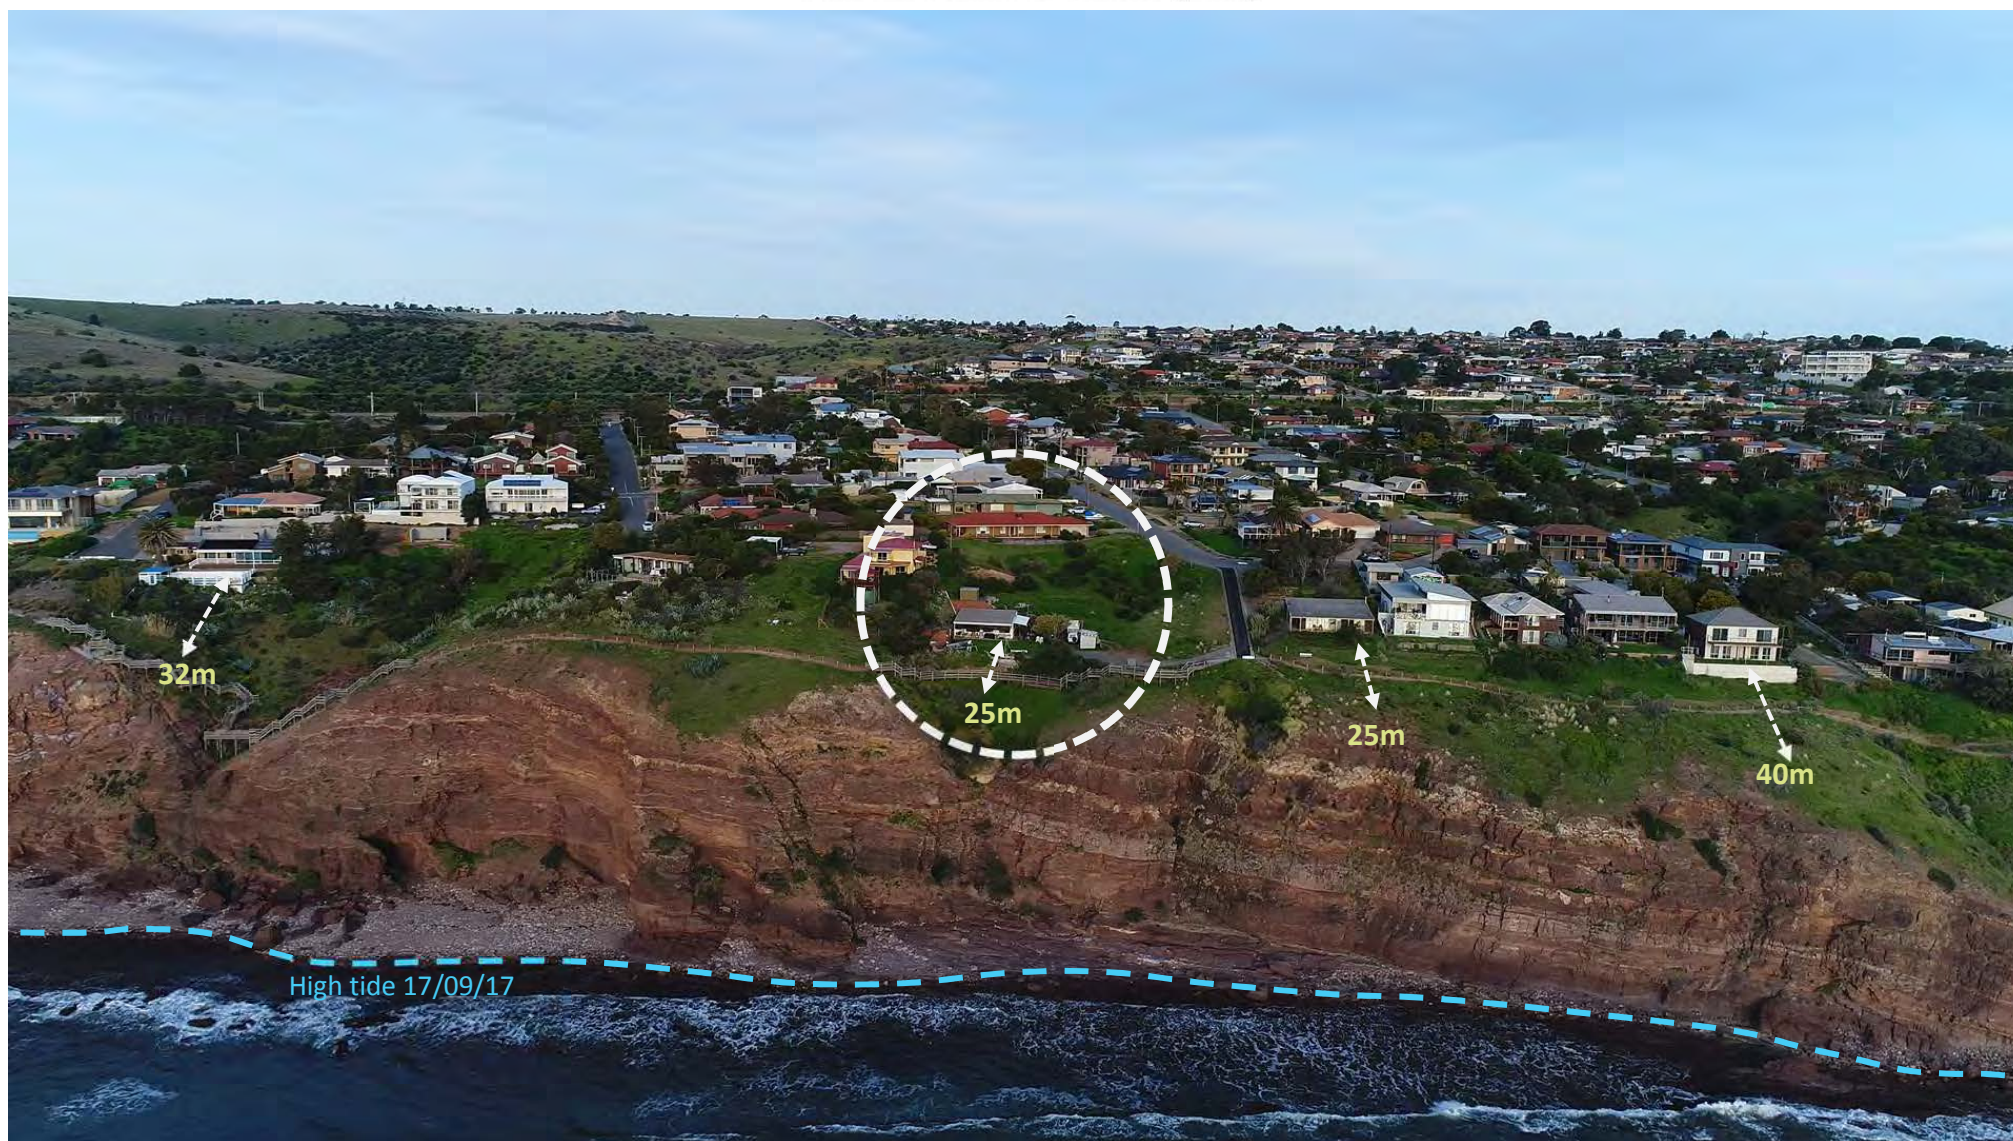
Cell 2: Hallett Cliffs (2:3)

High tide was 2.03CD (high tides can be 2.30 to 2.50). It is likely that some sections of this cliff base is receiving constant wave action. Houses are set well back from the escarpment in this location which is almost vertical. Note: the house within the circle is situated in a gully between two cliffs. Check to see storm water drainage in the area.

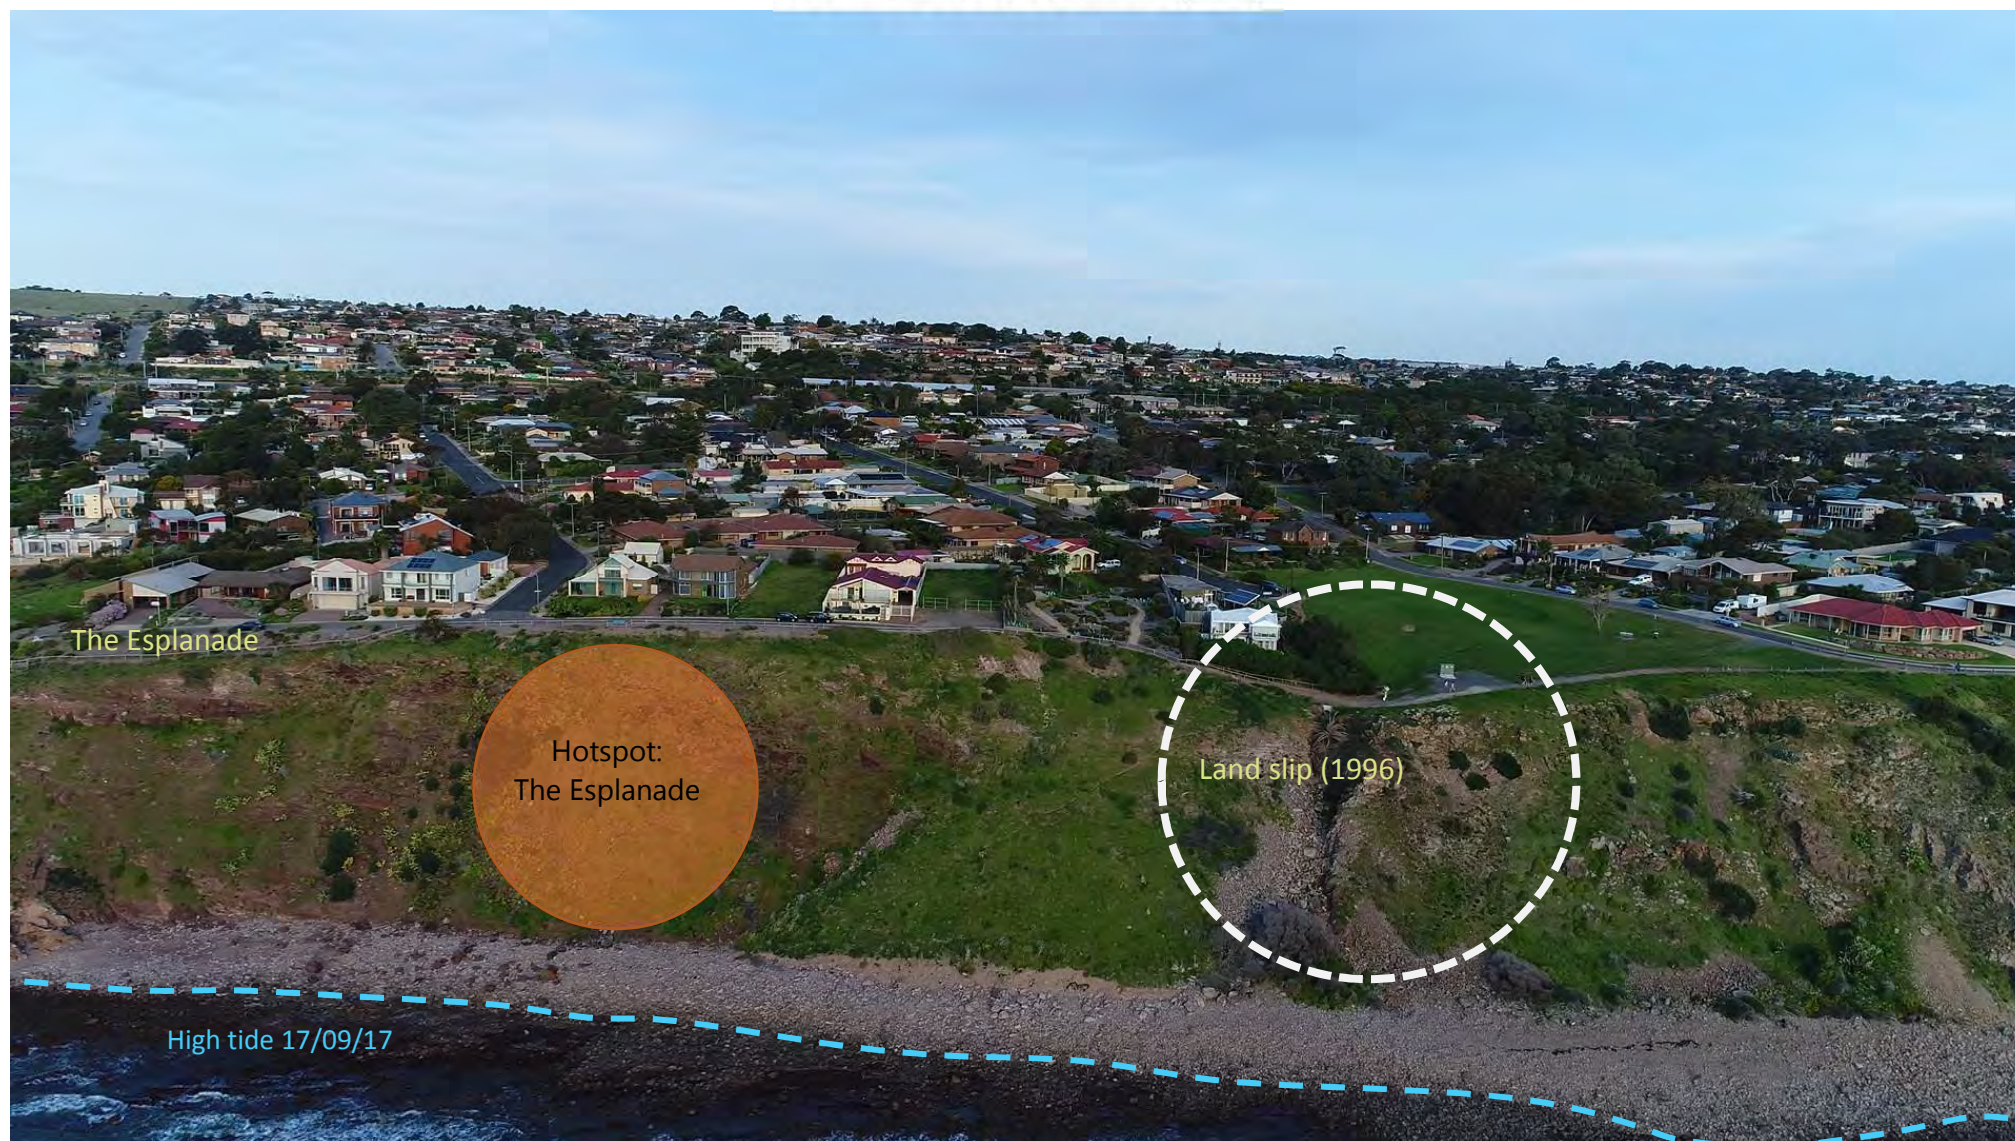
Cell 2: Hallett Cliffs (2:5)

High tide was 2.03CD (high tides can be 2.30 to 2.50). The Esplanade Road is set back only a couple of metres from the top of the escarpment. Houses are set back about 15m. A landslide occurred in this location in 1996-1997 and the cliff was subsequently collapsed to decrease the slope of the escarpment. Fortunately, this area does not appear to be receiving constant wave action at the base. (See hotspot risk assessment)

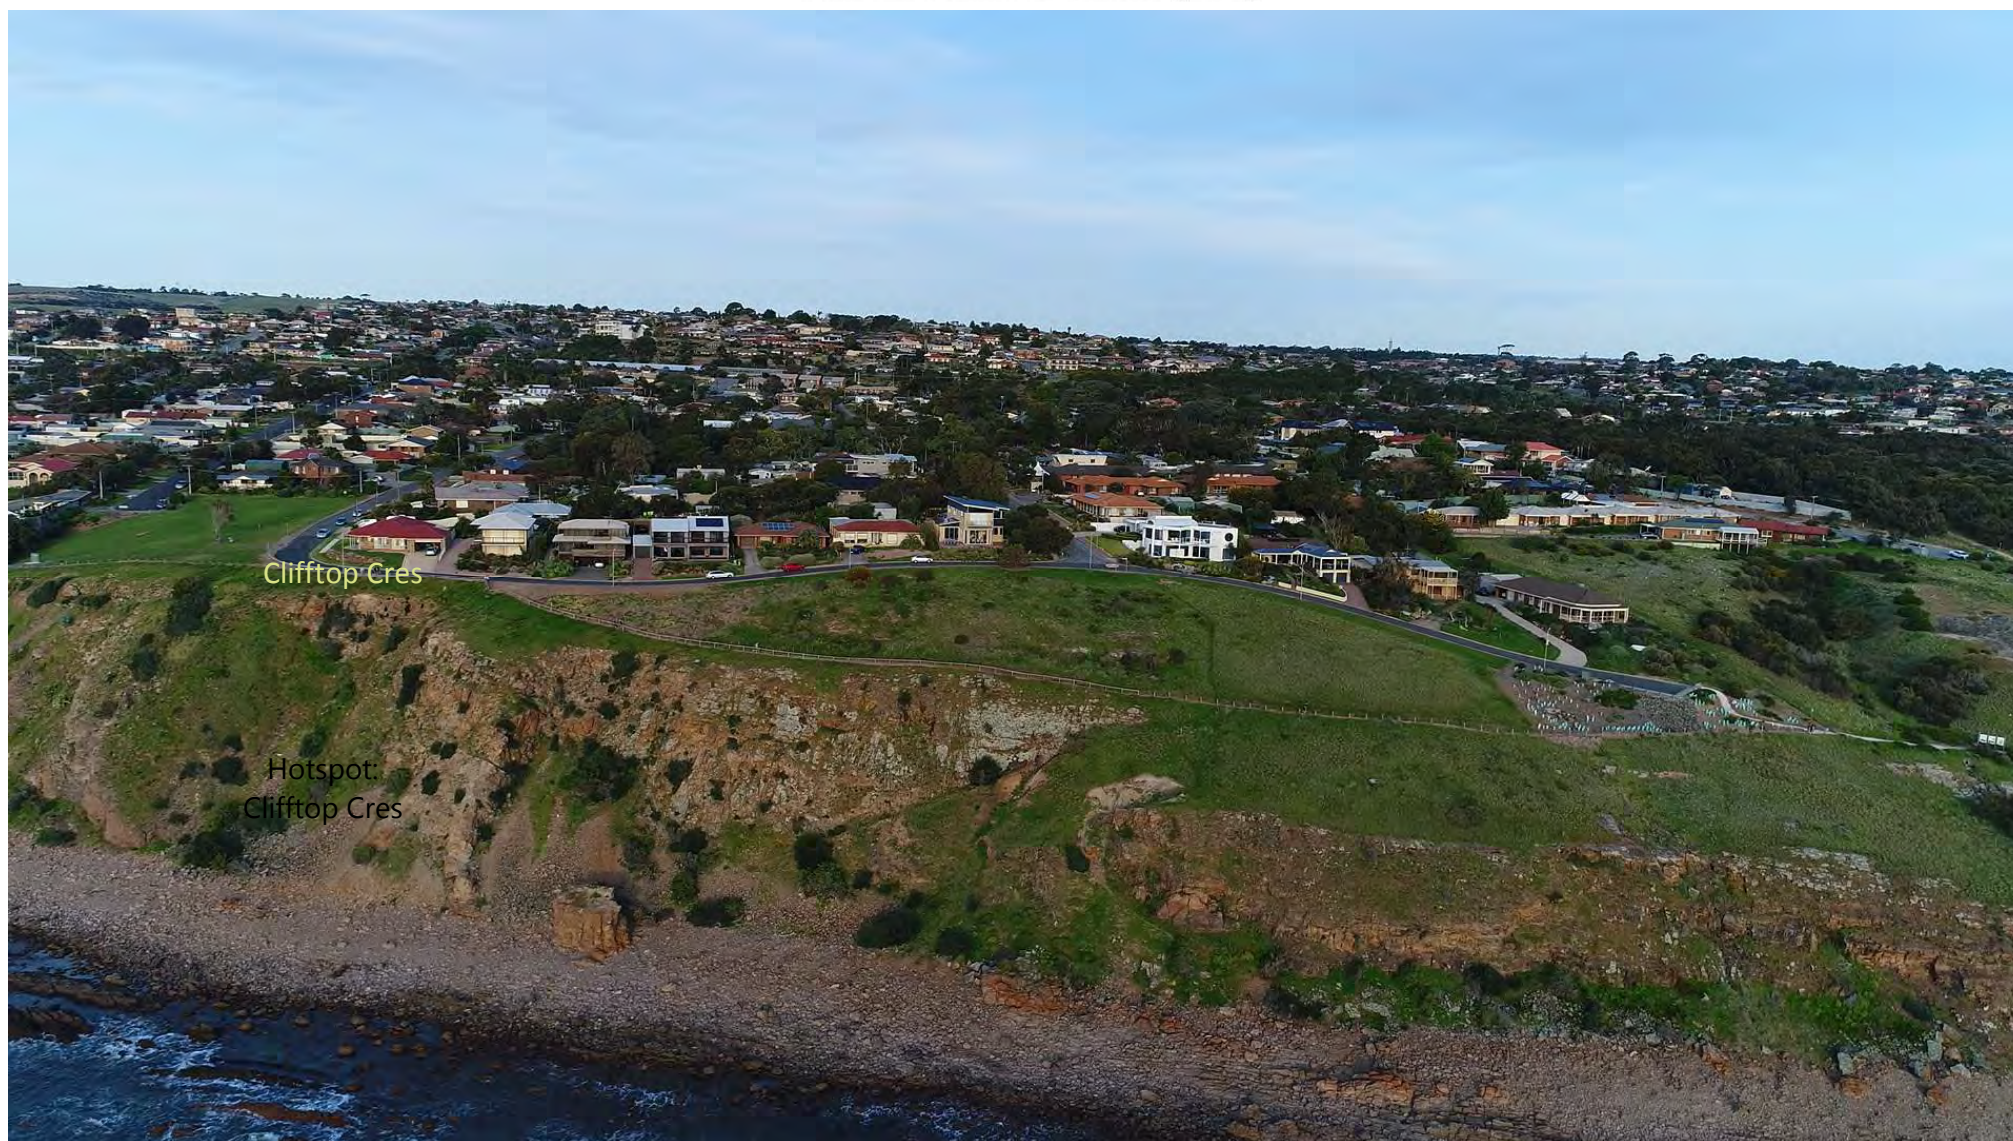
Cell 2: Hallett Cliffs (2:6)

Clifftop Road is set back only five metres from the top of the escarpment. Two houses near the corner are set back about 15m from the clifftop. The remainder of the houses on Clifftop Cres are set back in excess of 30m. The base of the cliff in this area does not appear to be receiving constant wave action. High tide was 2.03CD (high tides can be 2.30 to 2.50). (See hotspot risk assessment below)

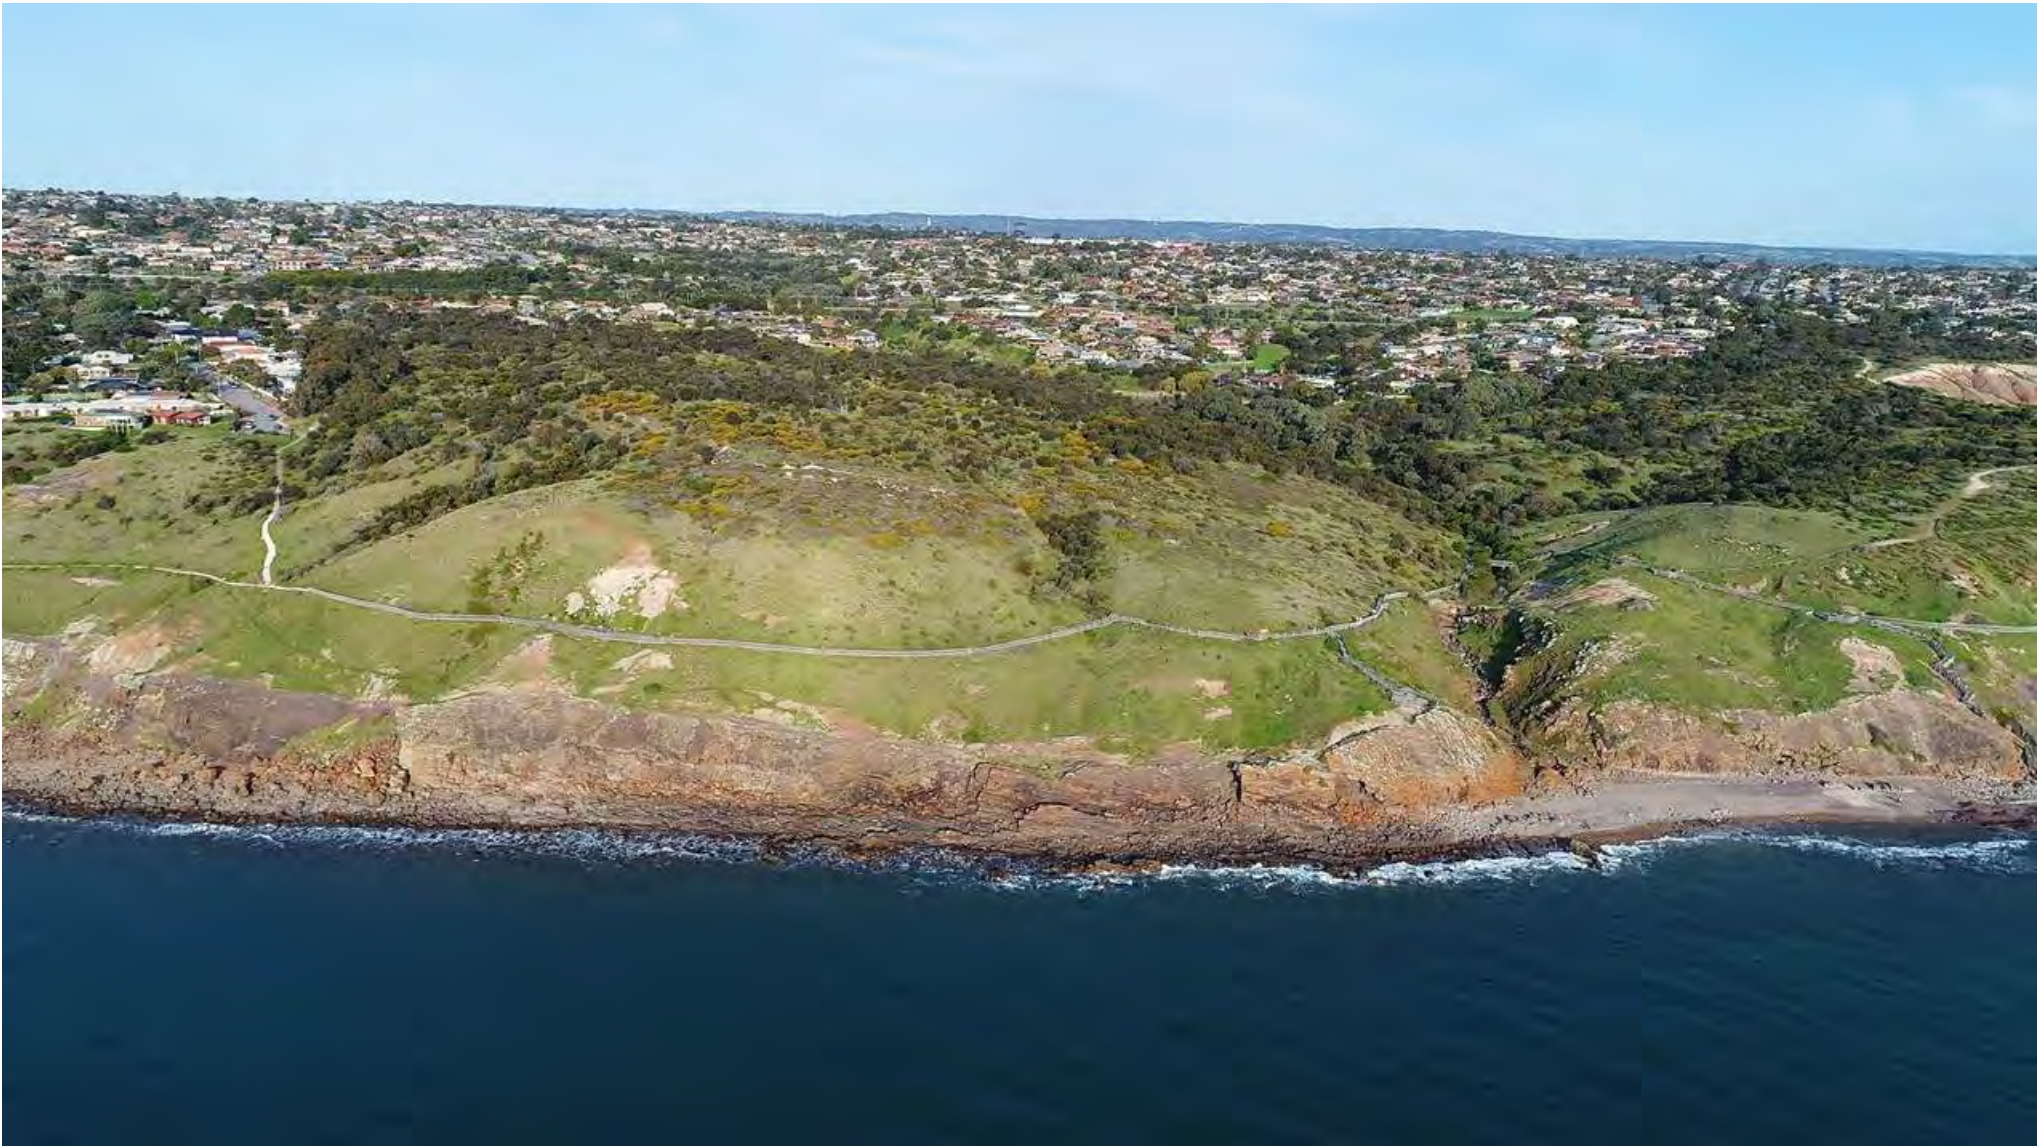
Cell2: Hallett Cliffs (2:7)

Resistant Neo-Proterozoic Brachina Formation (red and green siltstone and sandstone) on the bottom of the cliff. The top is friable composed of Permian Cape Jarvis sediments, underlying Pliocene Hallet Cove sandstone and Pleistocene alluvial deposits. Erosion is mostly subaerial rather than wave-driven, although there is significant rockfall material resting on cliff toe. In a 1-4 erosion resistance scale (1, highly vulnerable; 2, likely vulnerable; 3, likely resistant; 4, highly resistant) this section is 2 overall, likely vulnerable, especially to stormwater flow and other subaerial factors removing material from the top of the cliff. The bottom of the cliff is however likely resistant.

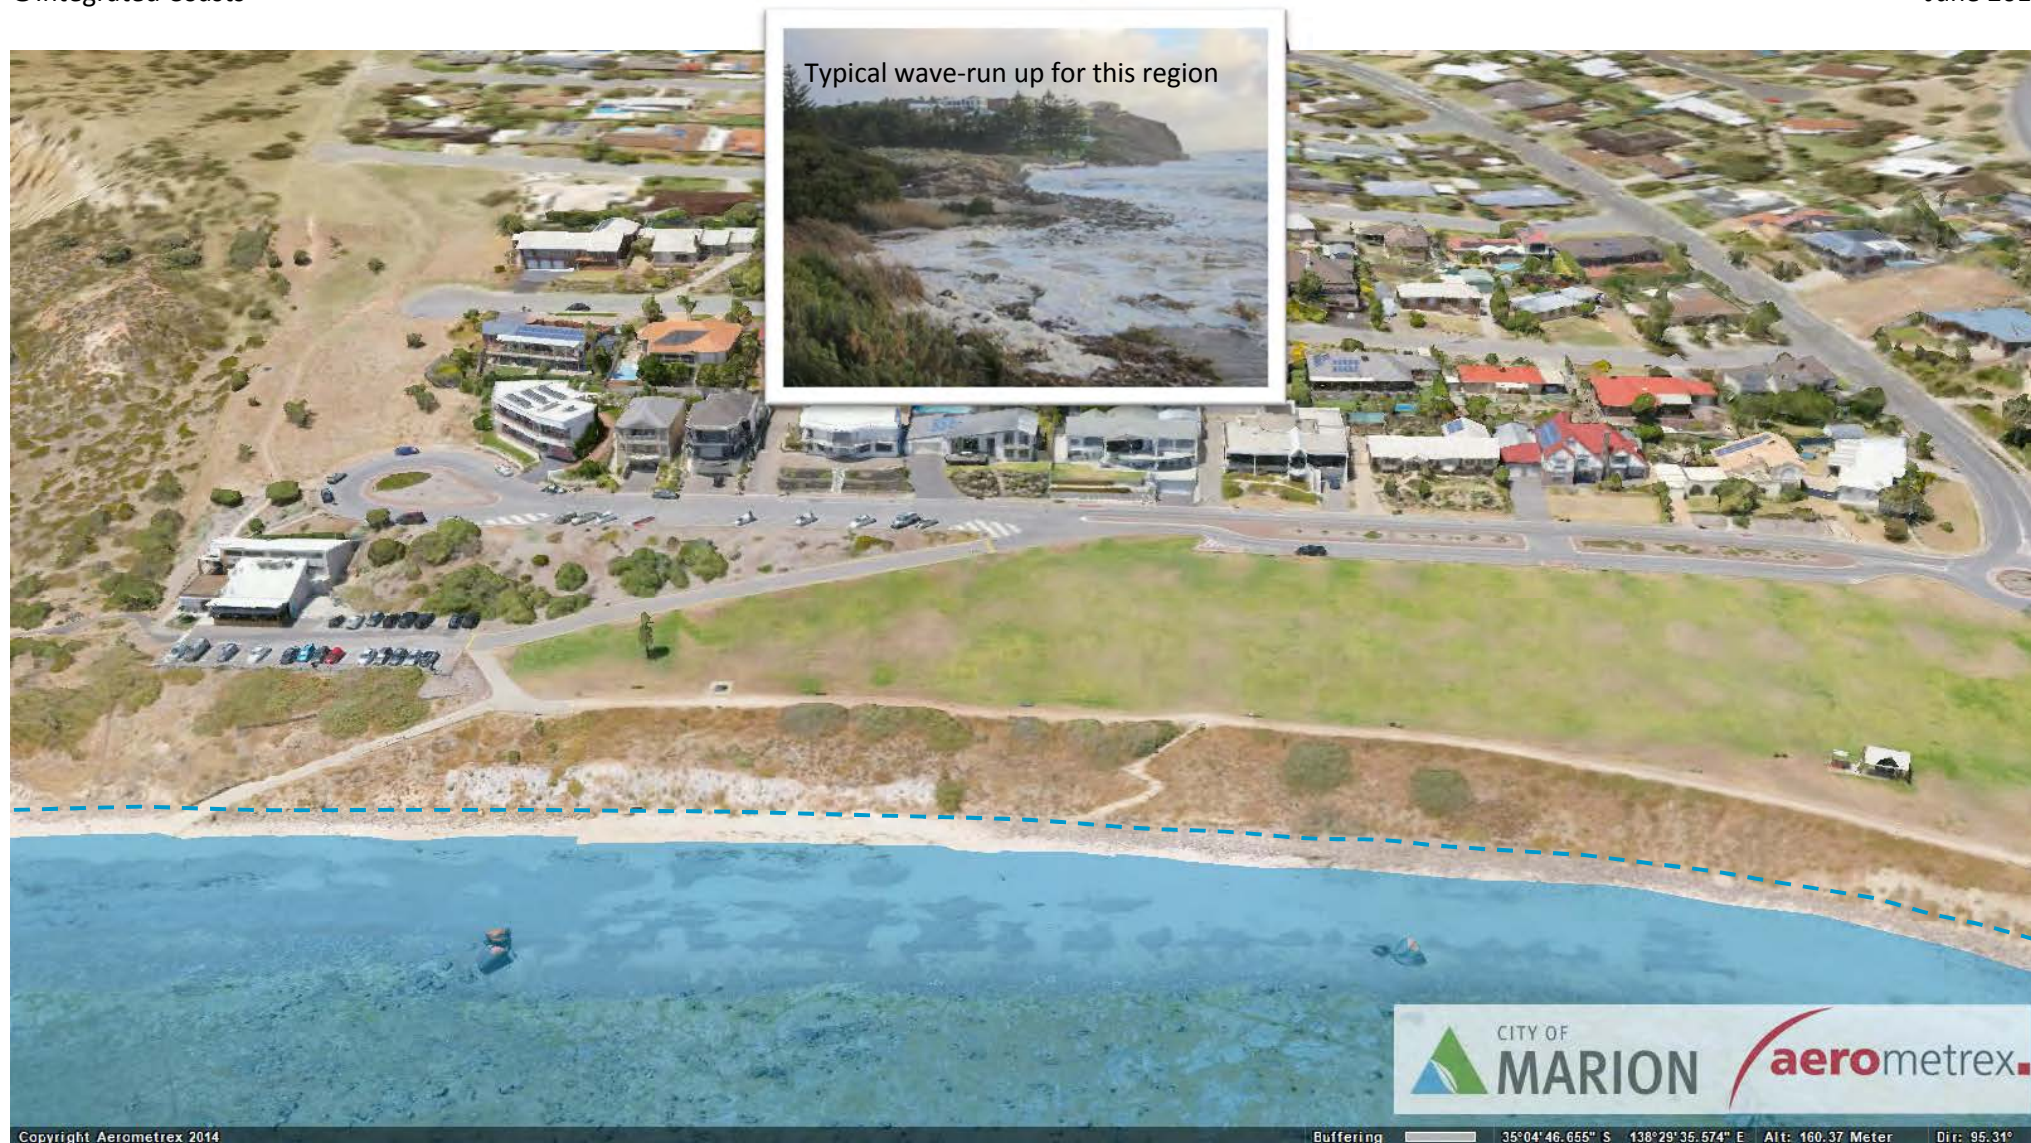
Steep embankment 3H:1V (HCCMS p 39)

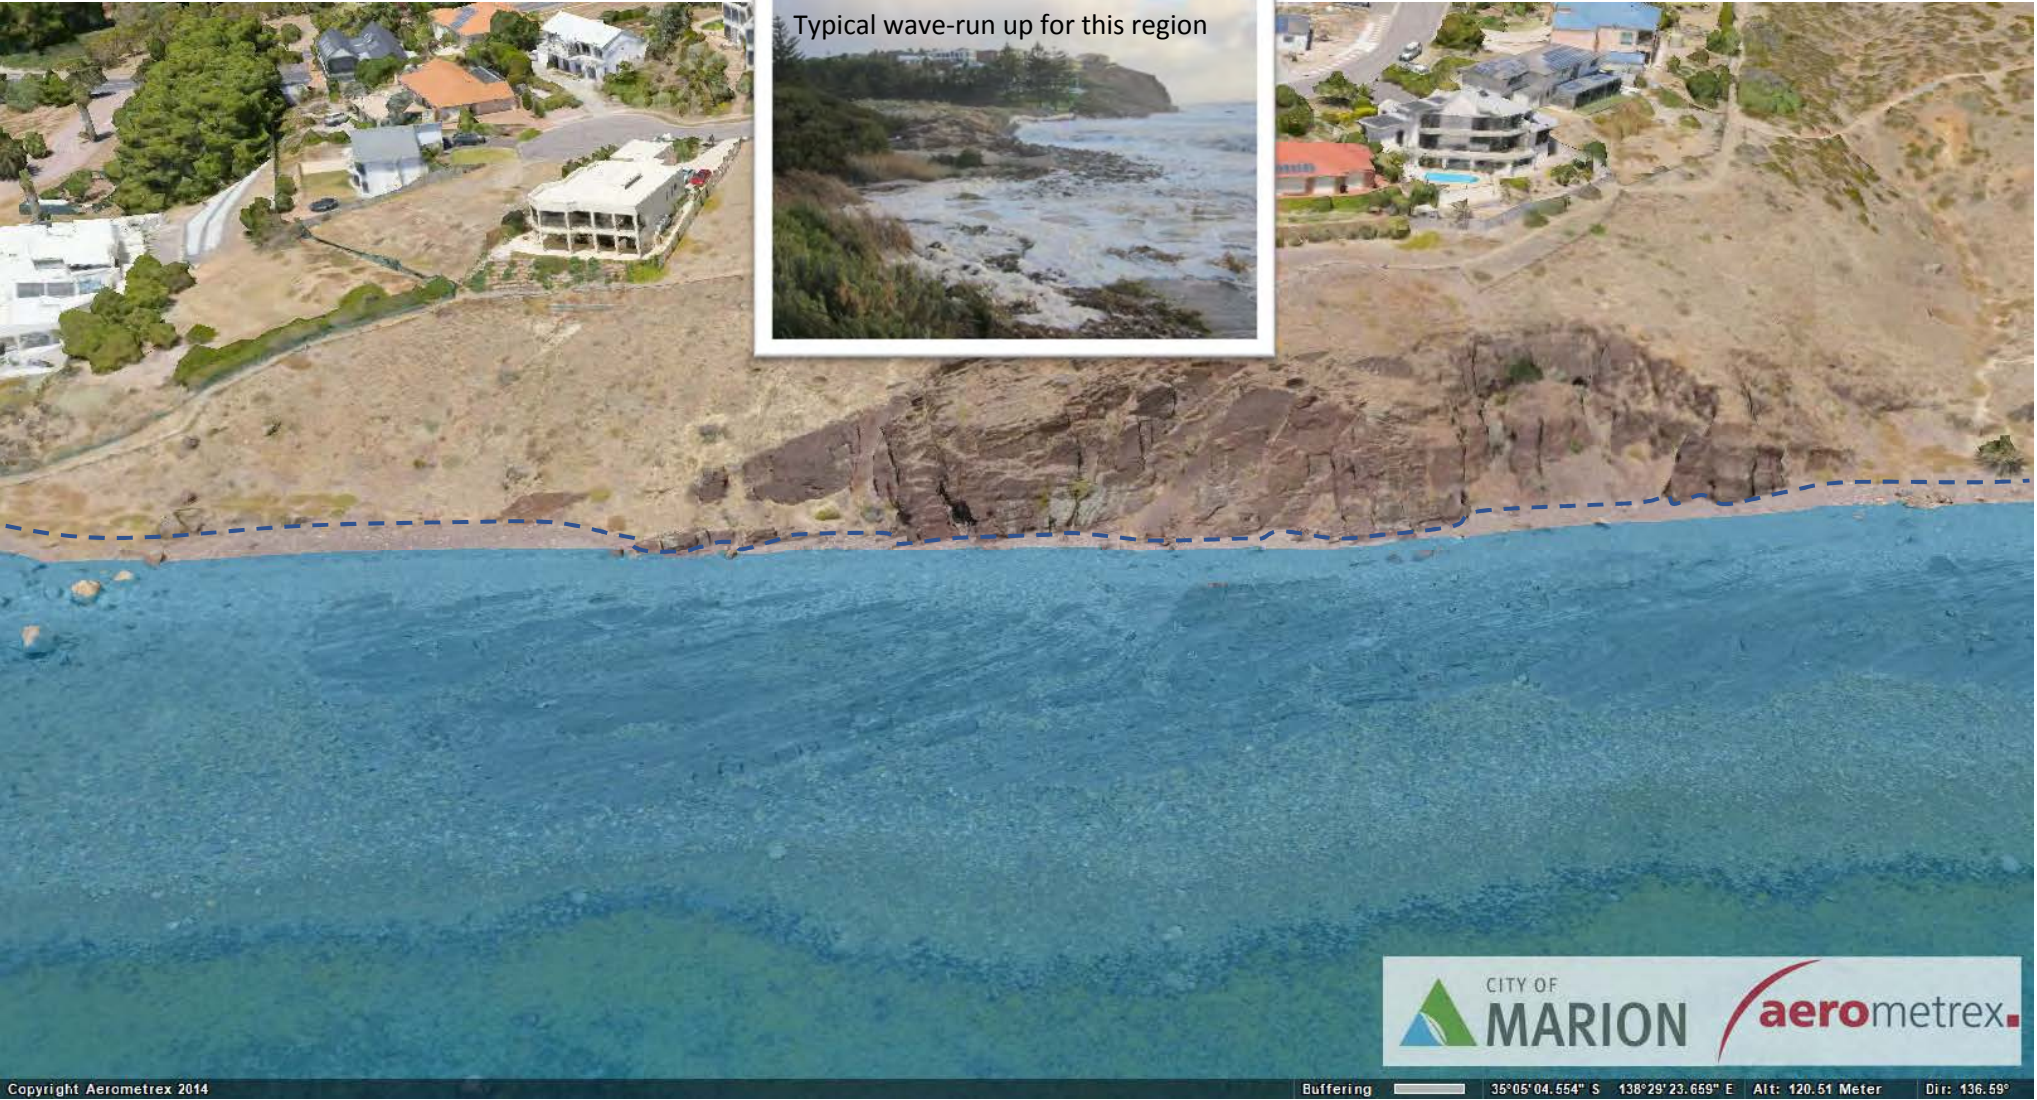
Cell 5: Southern Cliffs (5:1)

One house is close to the top of the escarpment, but the slope of the embankment is quite low. By 2100, it is likely the base of the cliff will be inundated more frequently, allowing direct wave action against the base of the cliffs. Routine monitoring of the cliff condition and stability should be undertaken (particularly the discharge of stormwater) HCCMS, P. 45
