City of Marion

DRAFT Coastal Climate Change Adaptation Plan

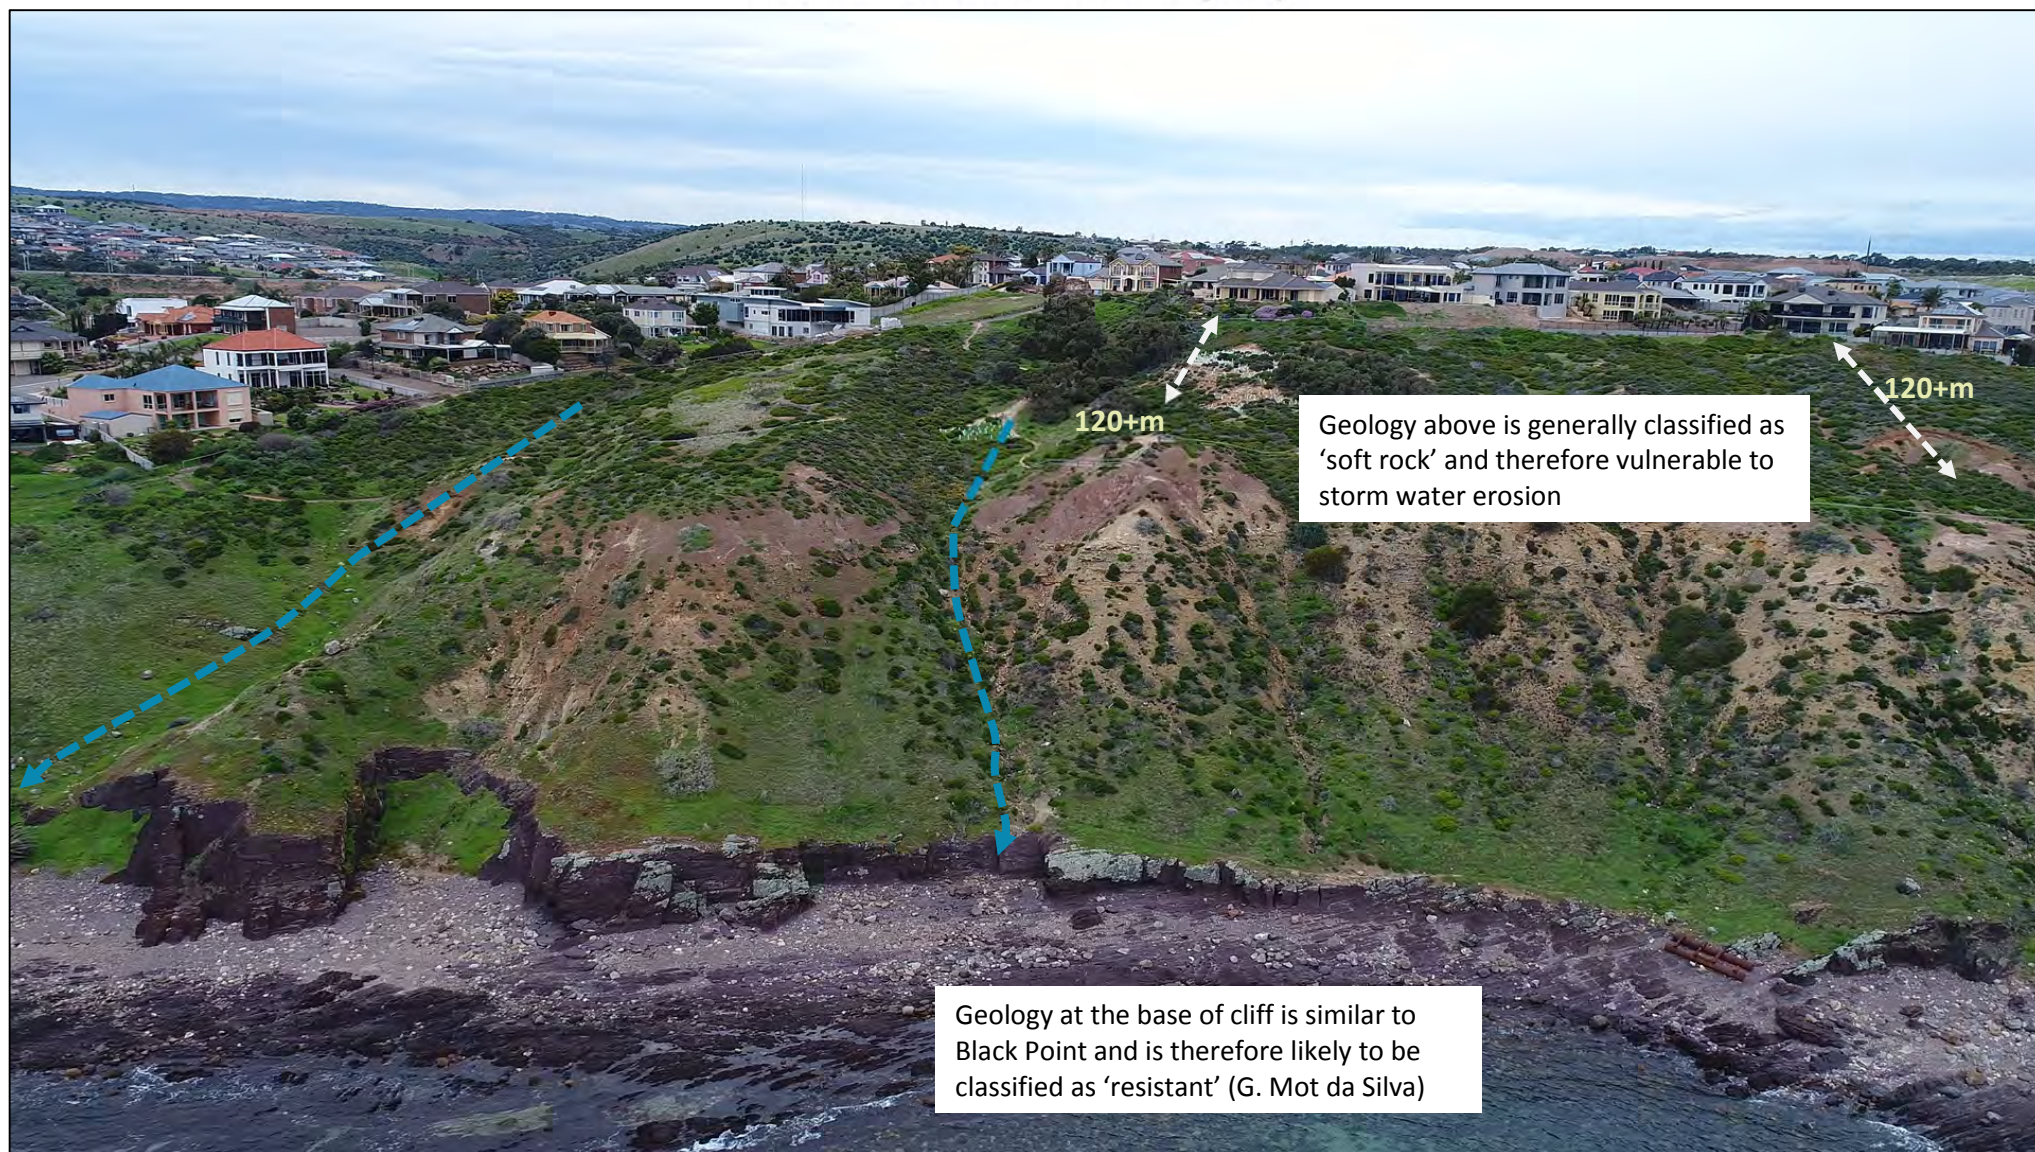
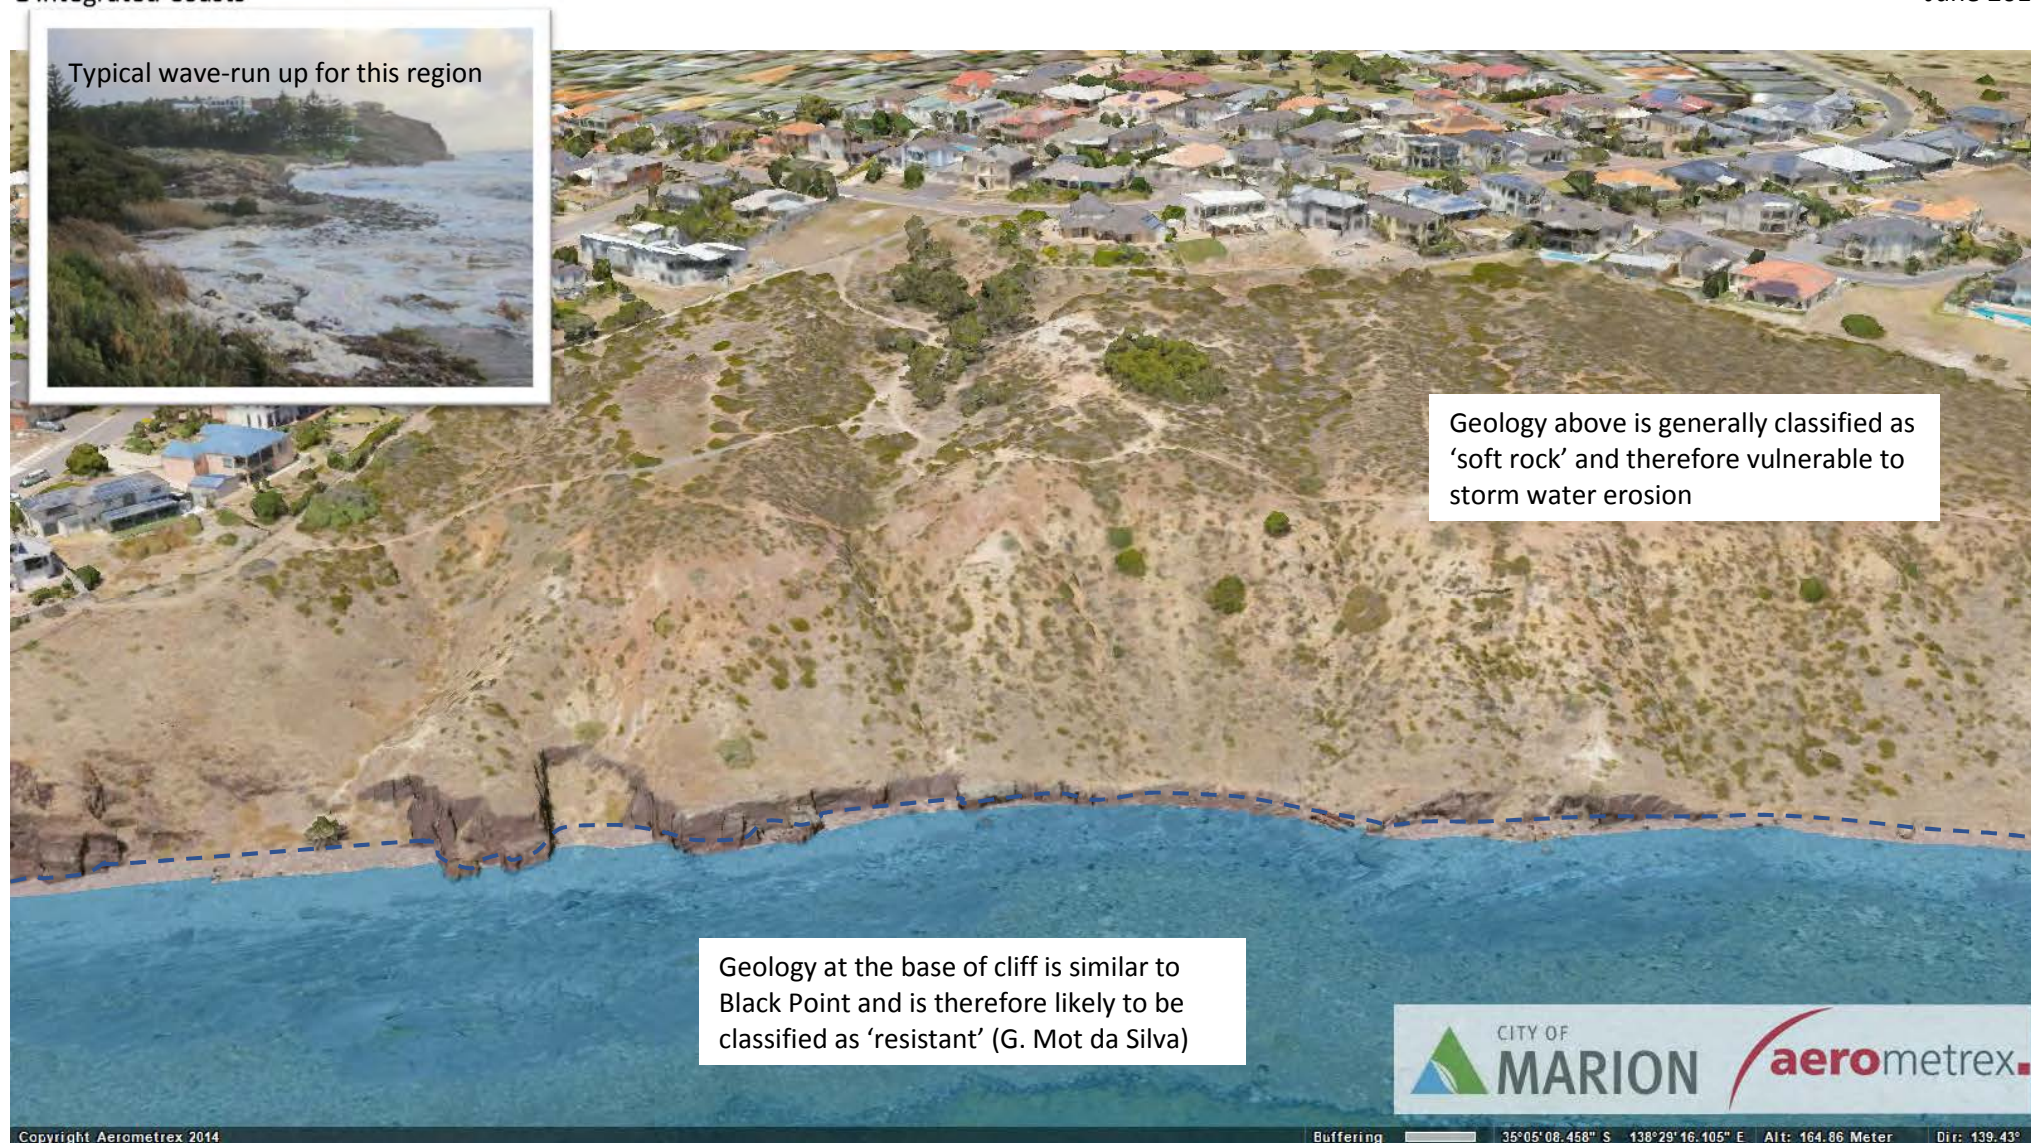
Cell 5: Southern Cliffs (5:2)

All private and public infrastructure is set well-back from cliffs. By 2100, it is likely the base of the cliff will be inundated more frequently, allowing direct wave action against the base of the cliffs. Routine monitoring of the cliff condition and stability should be undertaken (particularly the discharge of stormwater) HCCMS, P. 45
