City of Marion

# DRAFT Coastal Climate Change Adaptation Study

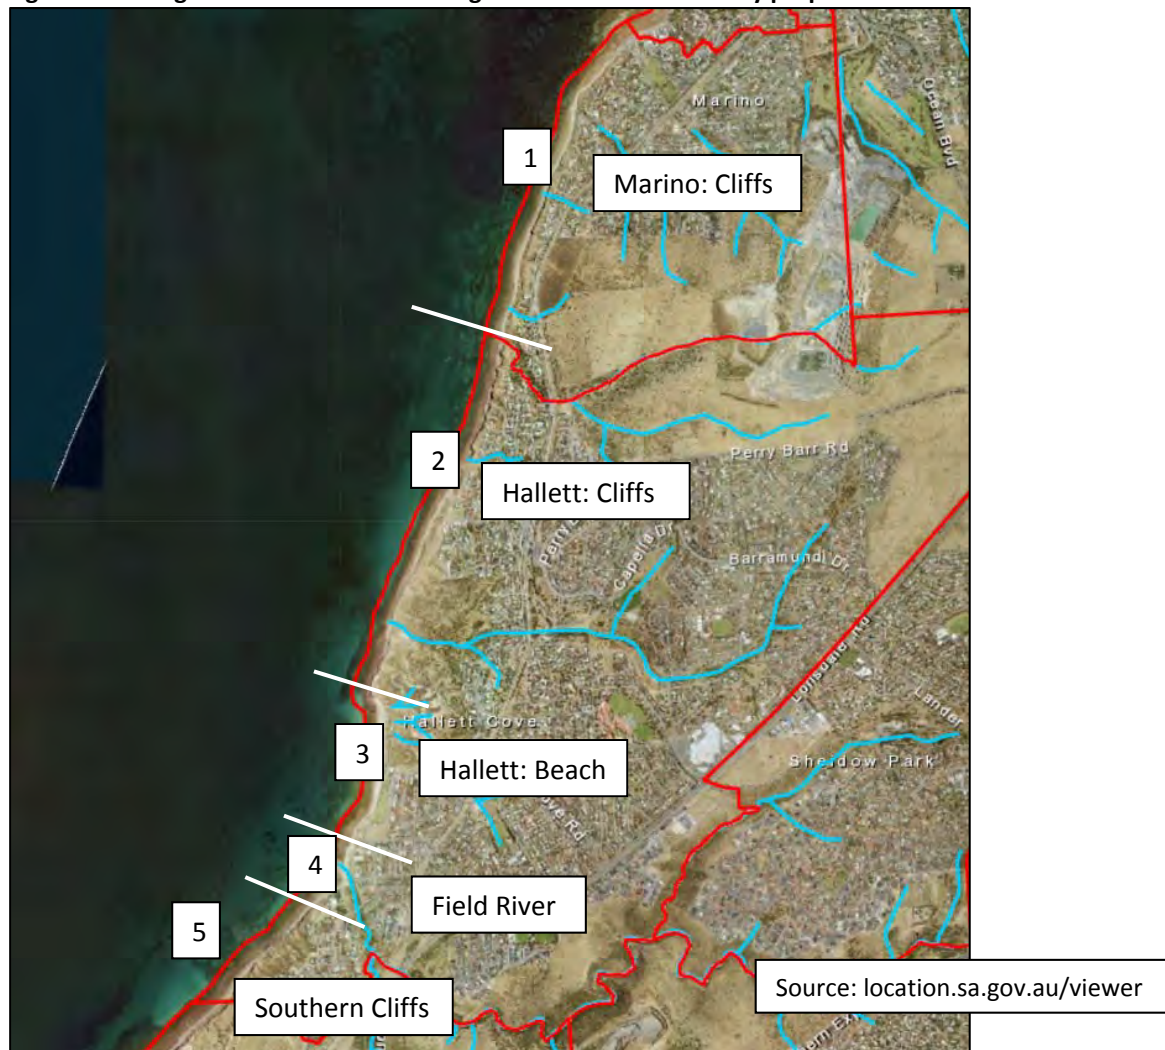
**Figure 5: Geological context and sectioning of the coastline for study purposes**

To facilitate the scoping study the City of Marion coastline is broken into study segments that reflect these geological assignments (Fig. 3). See also Figure 7 for assessment of geological features (p.13).

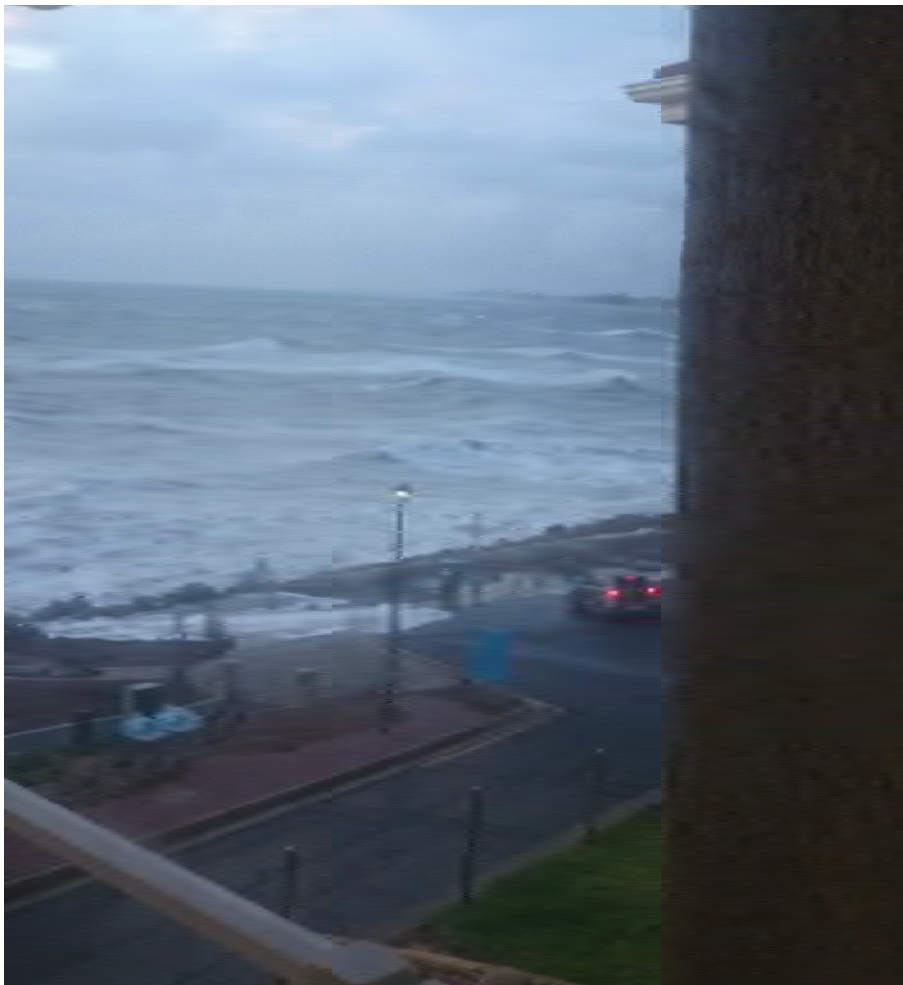
**Figure 9: Storm surge impact at The Esplanade, Marion (17:20, 9<sup>th</sup> May 2016)**

Photograph: Bill and Glenys Summersides of 4 Esplanade at 17.20

A more complete report of the event is found within the templates at Marino 1:1, along with the flood mapping of this event.

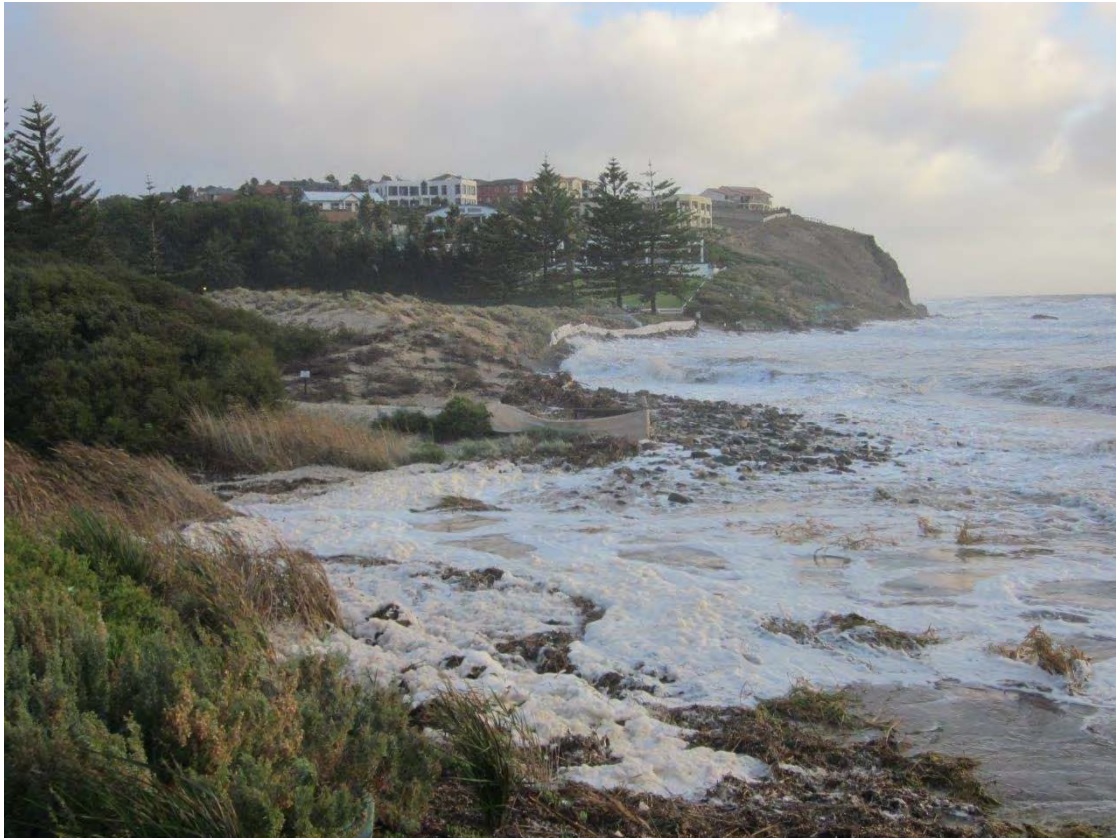
**Figure 10: Storm surge in Field River region (9<sup>th</sup> May 2016)**

Photograph: Bill and Glenys Summersides of 4 Esplanade at 17.50 (but the sky suggests it was earlier)

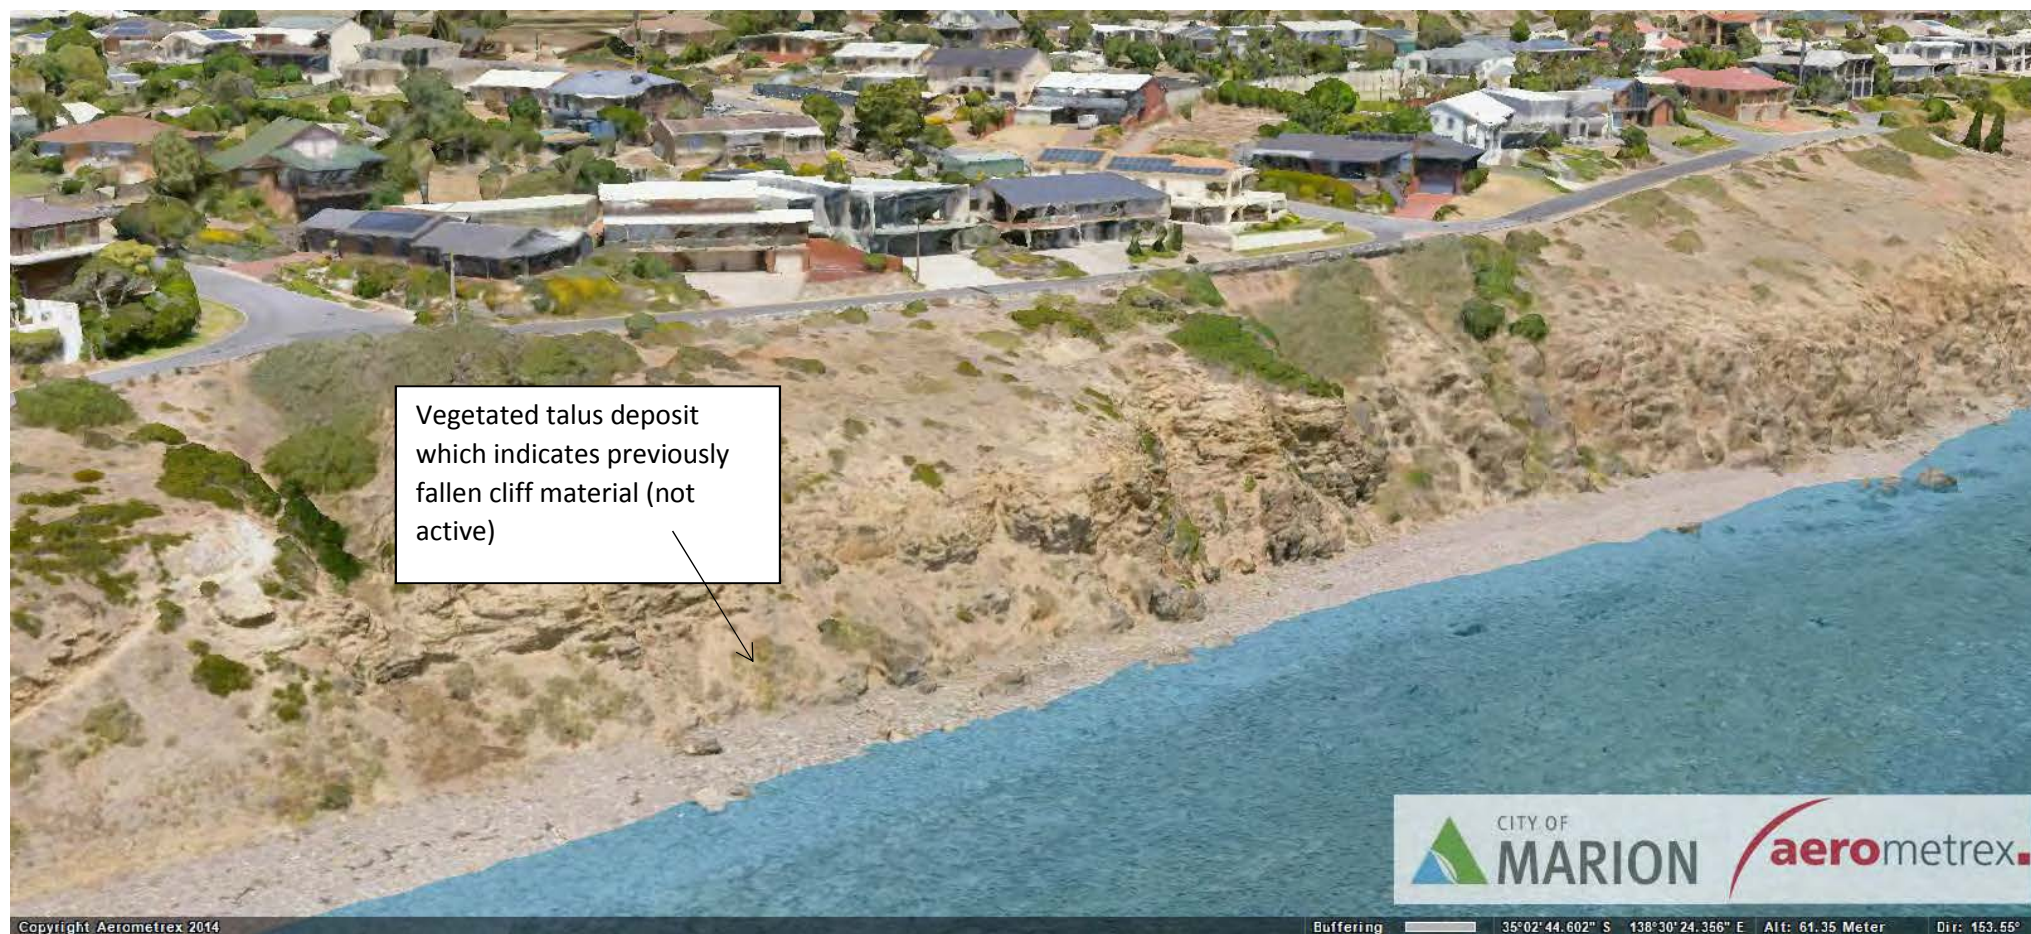
Event: Ongoing  
 Risk: Cliff erosion  
 Date: 12 May 2018

This cliff section has been mapped as part of the Neo-Proterozoic Marino Arkose formation, which is a resistant, lime-cemented sandstone rich in feldspar. Some slump material but cliff face mostly exposed. Narrow gravel beach, steeper and narrow intertidal width – hence more wave impact. The narrow intertidal rock platform also indicates less cliff recession over the last 7000 yrs in comparison to northerly sections. Sea-flood 2.7m will impact cliff toe, potential for significant erosion caused by wave run-up. In a 1-4 erosion resistance scale (1, highly vulnerable; 2, likely vulnerable; 3, likely resistant; 4, highly resistant) this section is 3, likely resistant.

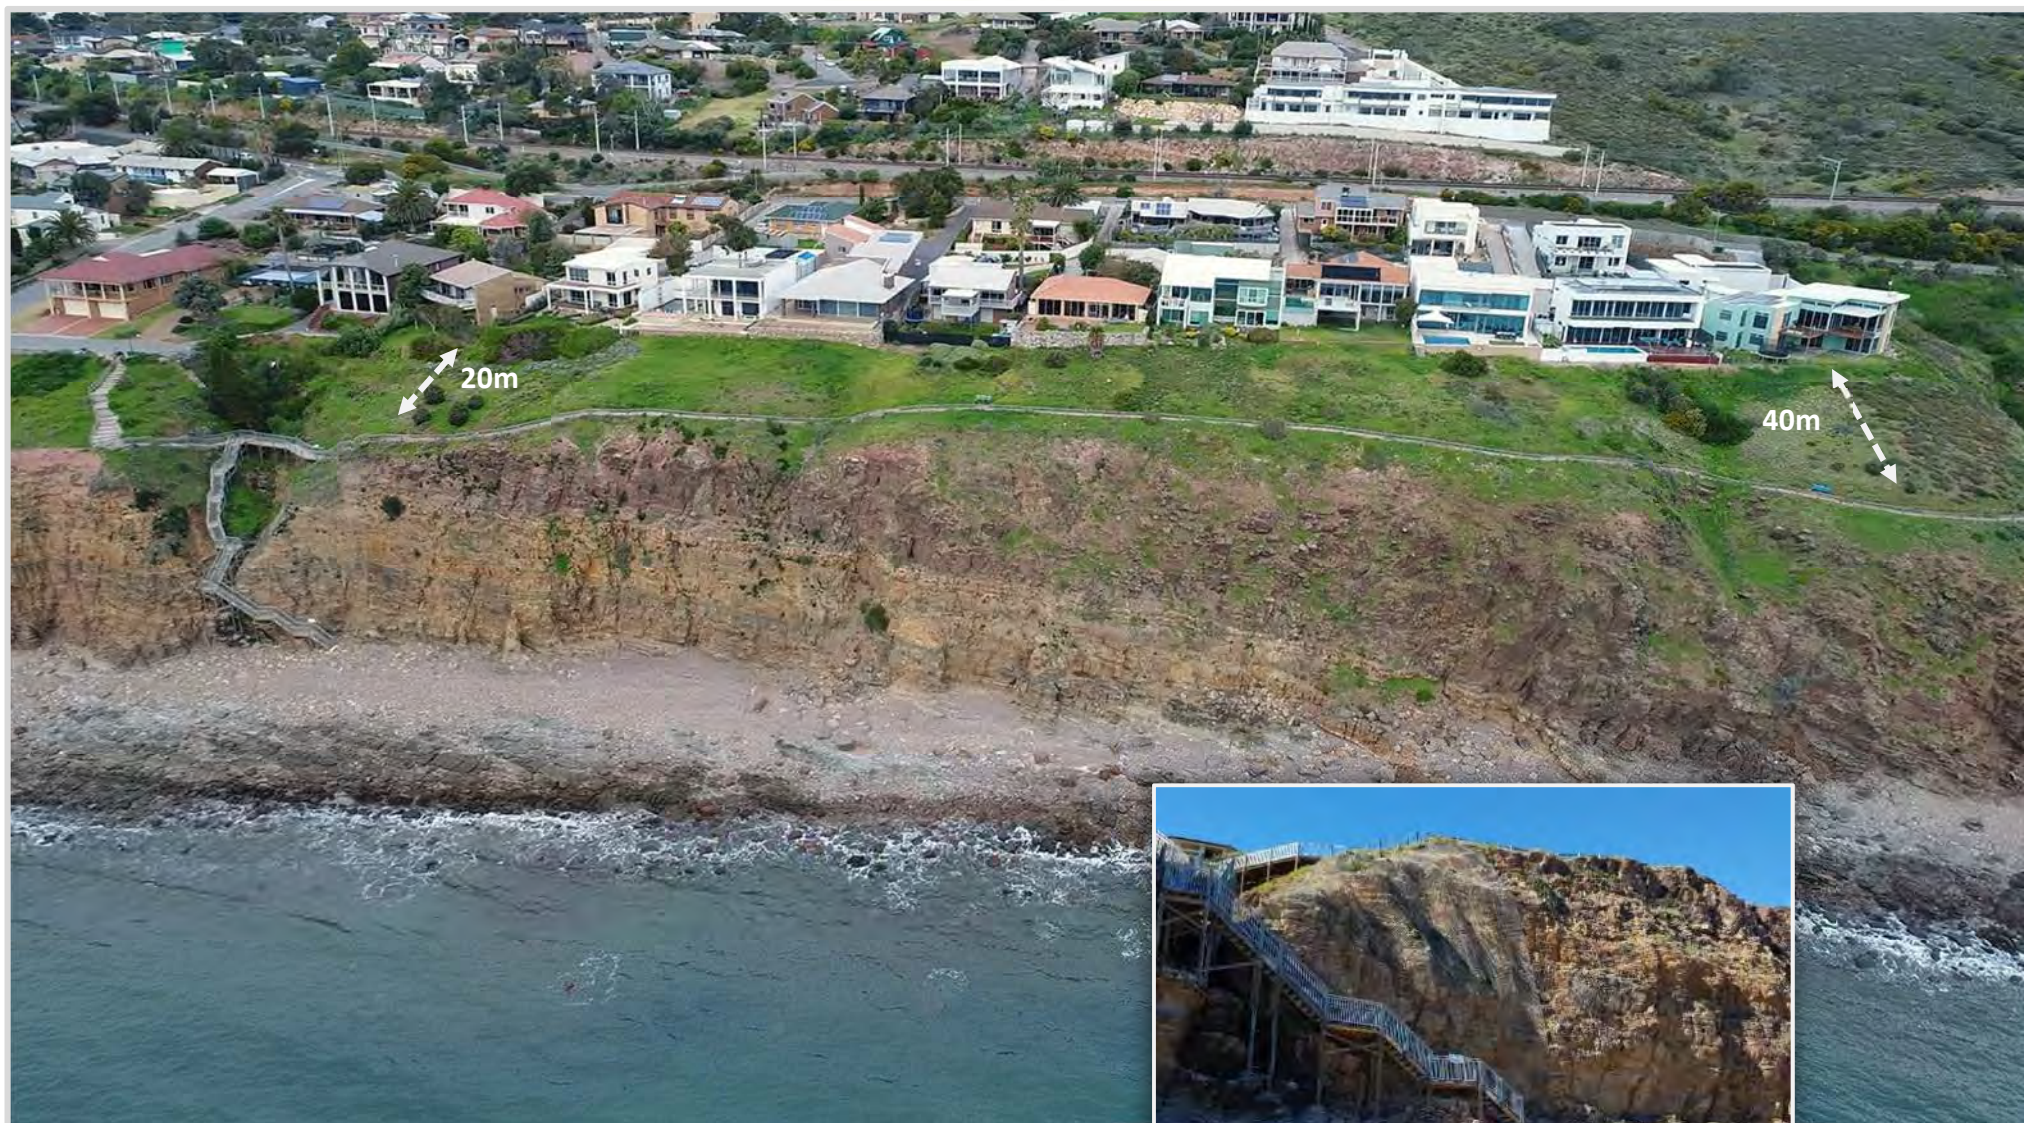
## Cell 1: Marino Cliffs (4)

Falling rocks hazard contained with wire netting. Beach access stairs may come under increasing impact from sea processes but improved design can cater for impacts when stairs are upgraded.

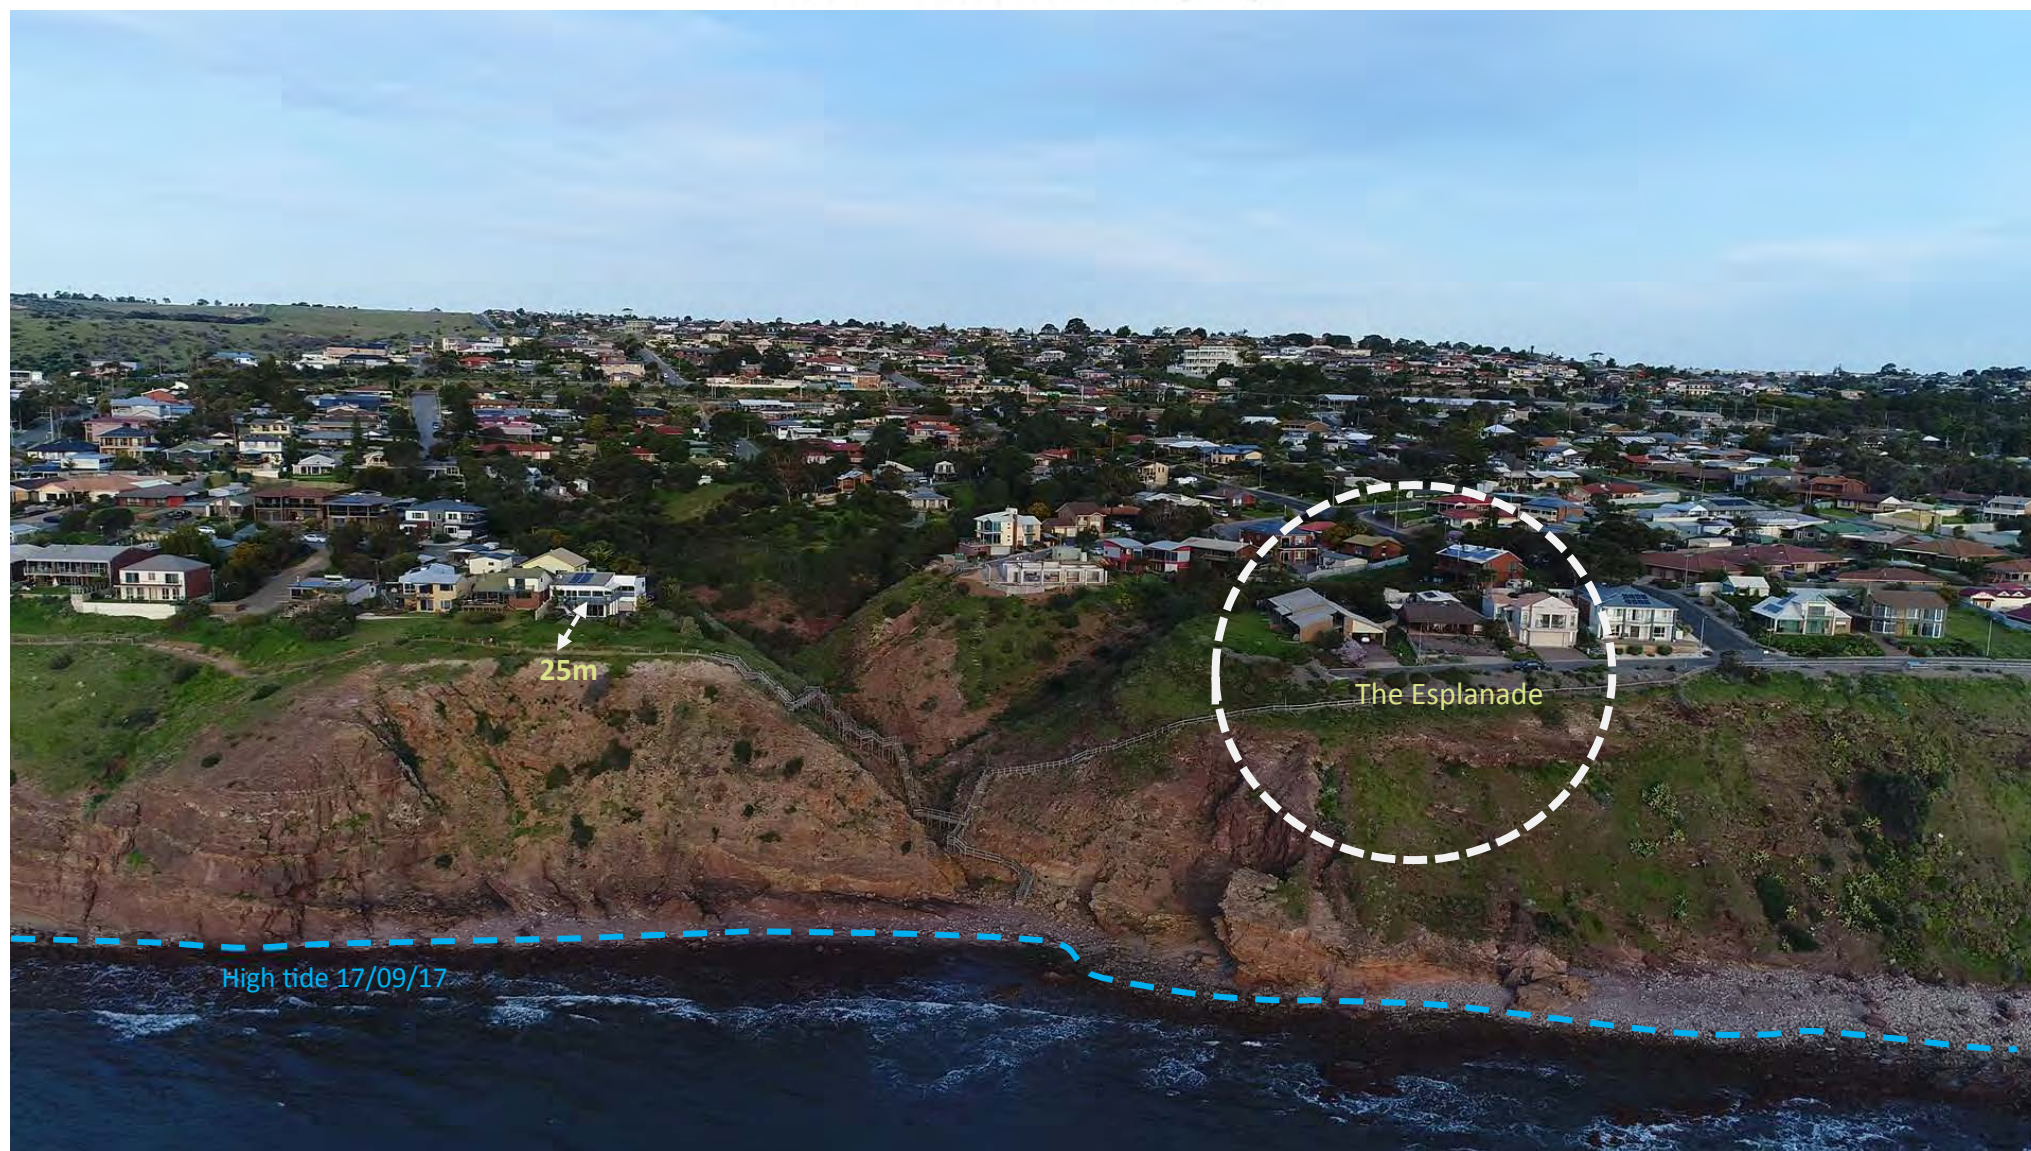
## Cell 2: Hallett Cliffs (2:4)

High tide was 2.03CD (high tides can be 2.30 to 2.50). It is likely that some sections of this cliff base is receiving constant wave action. The Esplanade Road is set back only a couple of metres from the top of the escarpment. Houses are set back about 15m. (See hotspot assessment below for The Esplanade)

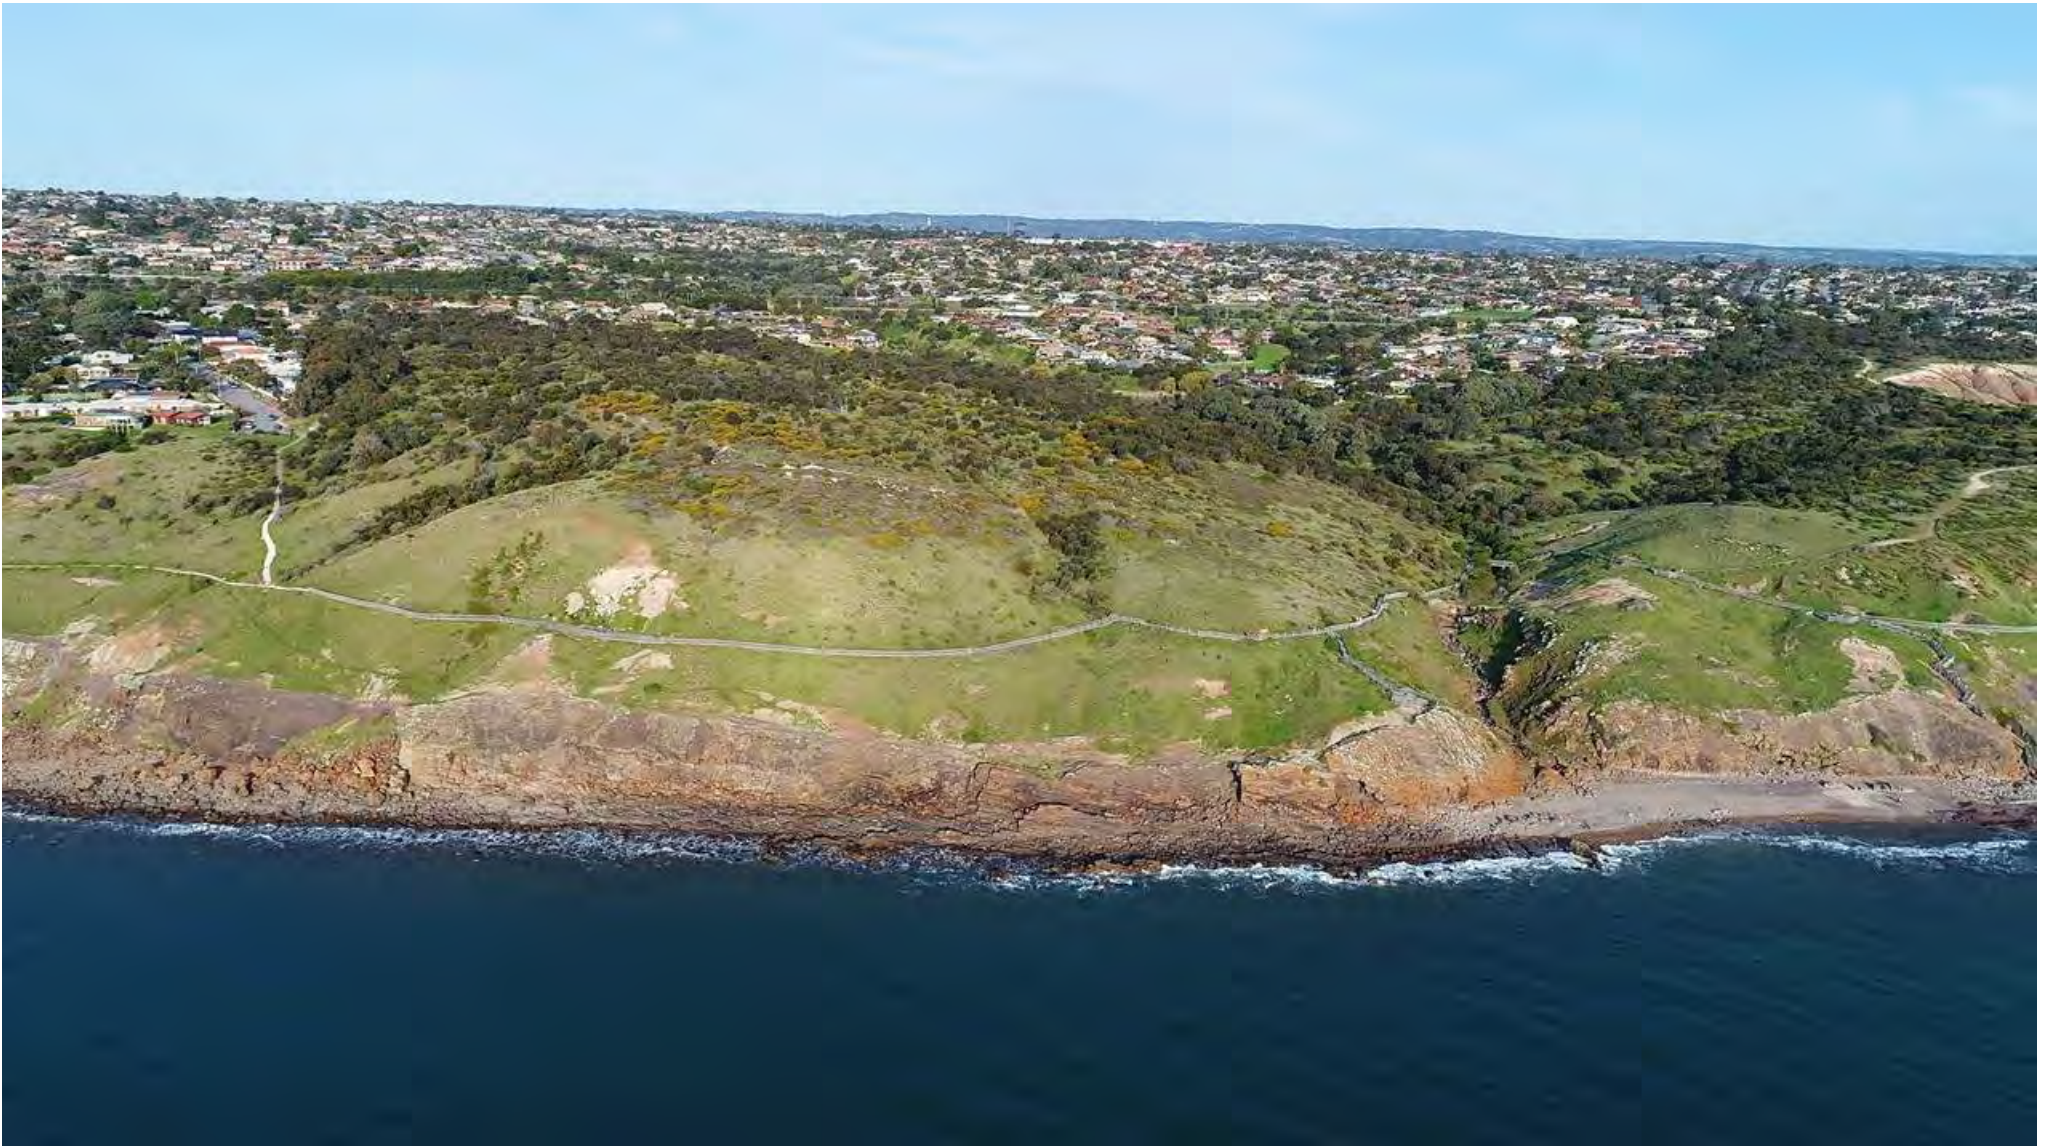
## Cell2: Hallett Cliffs (2:7)

Resistant Neo-Proterozoic Brachina Formation (red and green siltstone and sandstone) on the bottom of the cliff. The top is friable composed of Permian Cape Jarvis sediments, underlying Pliocene Hallet Cove sandstone and Pleistocene alluvial deposits. Erosion is mostly subaerial rather than wave-driven, although there is significant rockfall material resting on cliff toe. In a 1-4 erosion resistance scale (1, highly vulnerable; 2, likely vulnerable; 3, likely resistant; 4, highly resistant) this section is 2 overall, likely vulnerable, especially to stormwater flow and other subaerial factors removing material from the top of the cliff. The bottom of the cliff is however likely resistant.

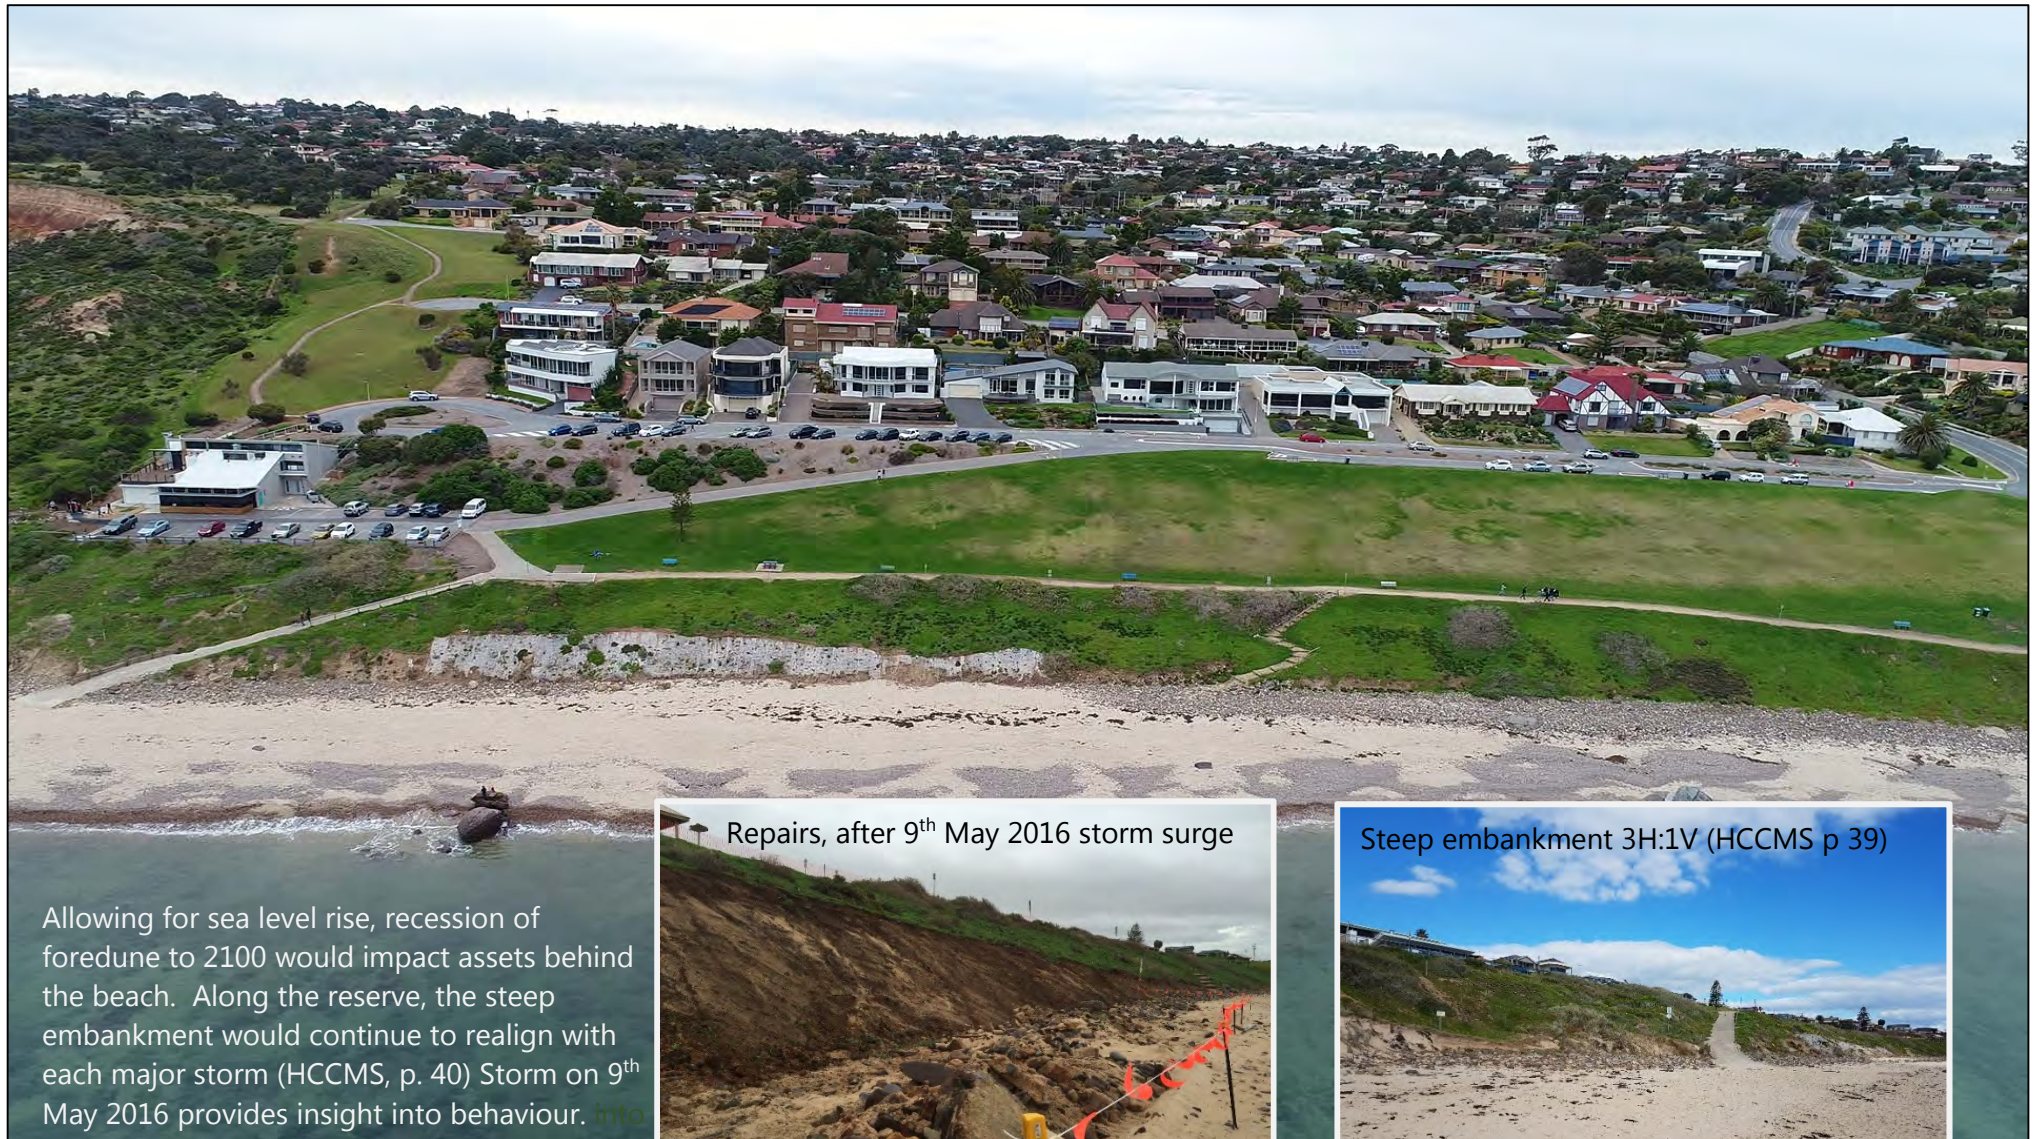
Allowing for sea level rise, recession of foredune to 2100 would impact assets behind the beach. Along the reserve, the steep embankment would continue to realign with each major storm (HCCMS, p. 40) Storm on 9<sup>th</sup> May 2016 provides insight into behaviour. [into](#)

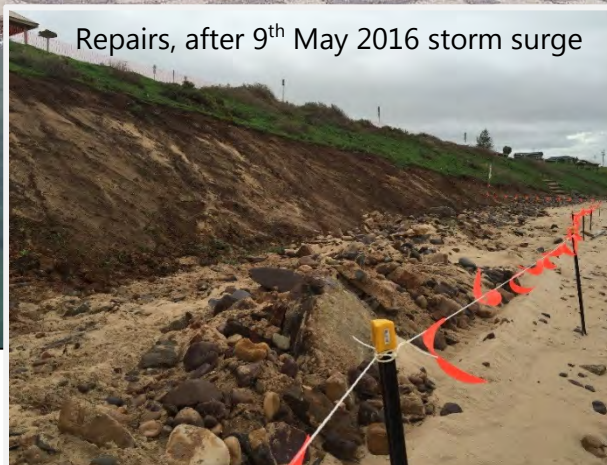
Repairs, after 9<sup>th</sup> May 2016 storm surge

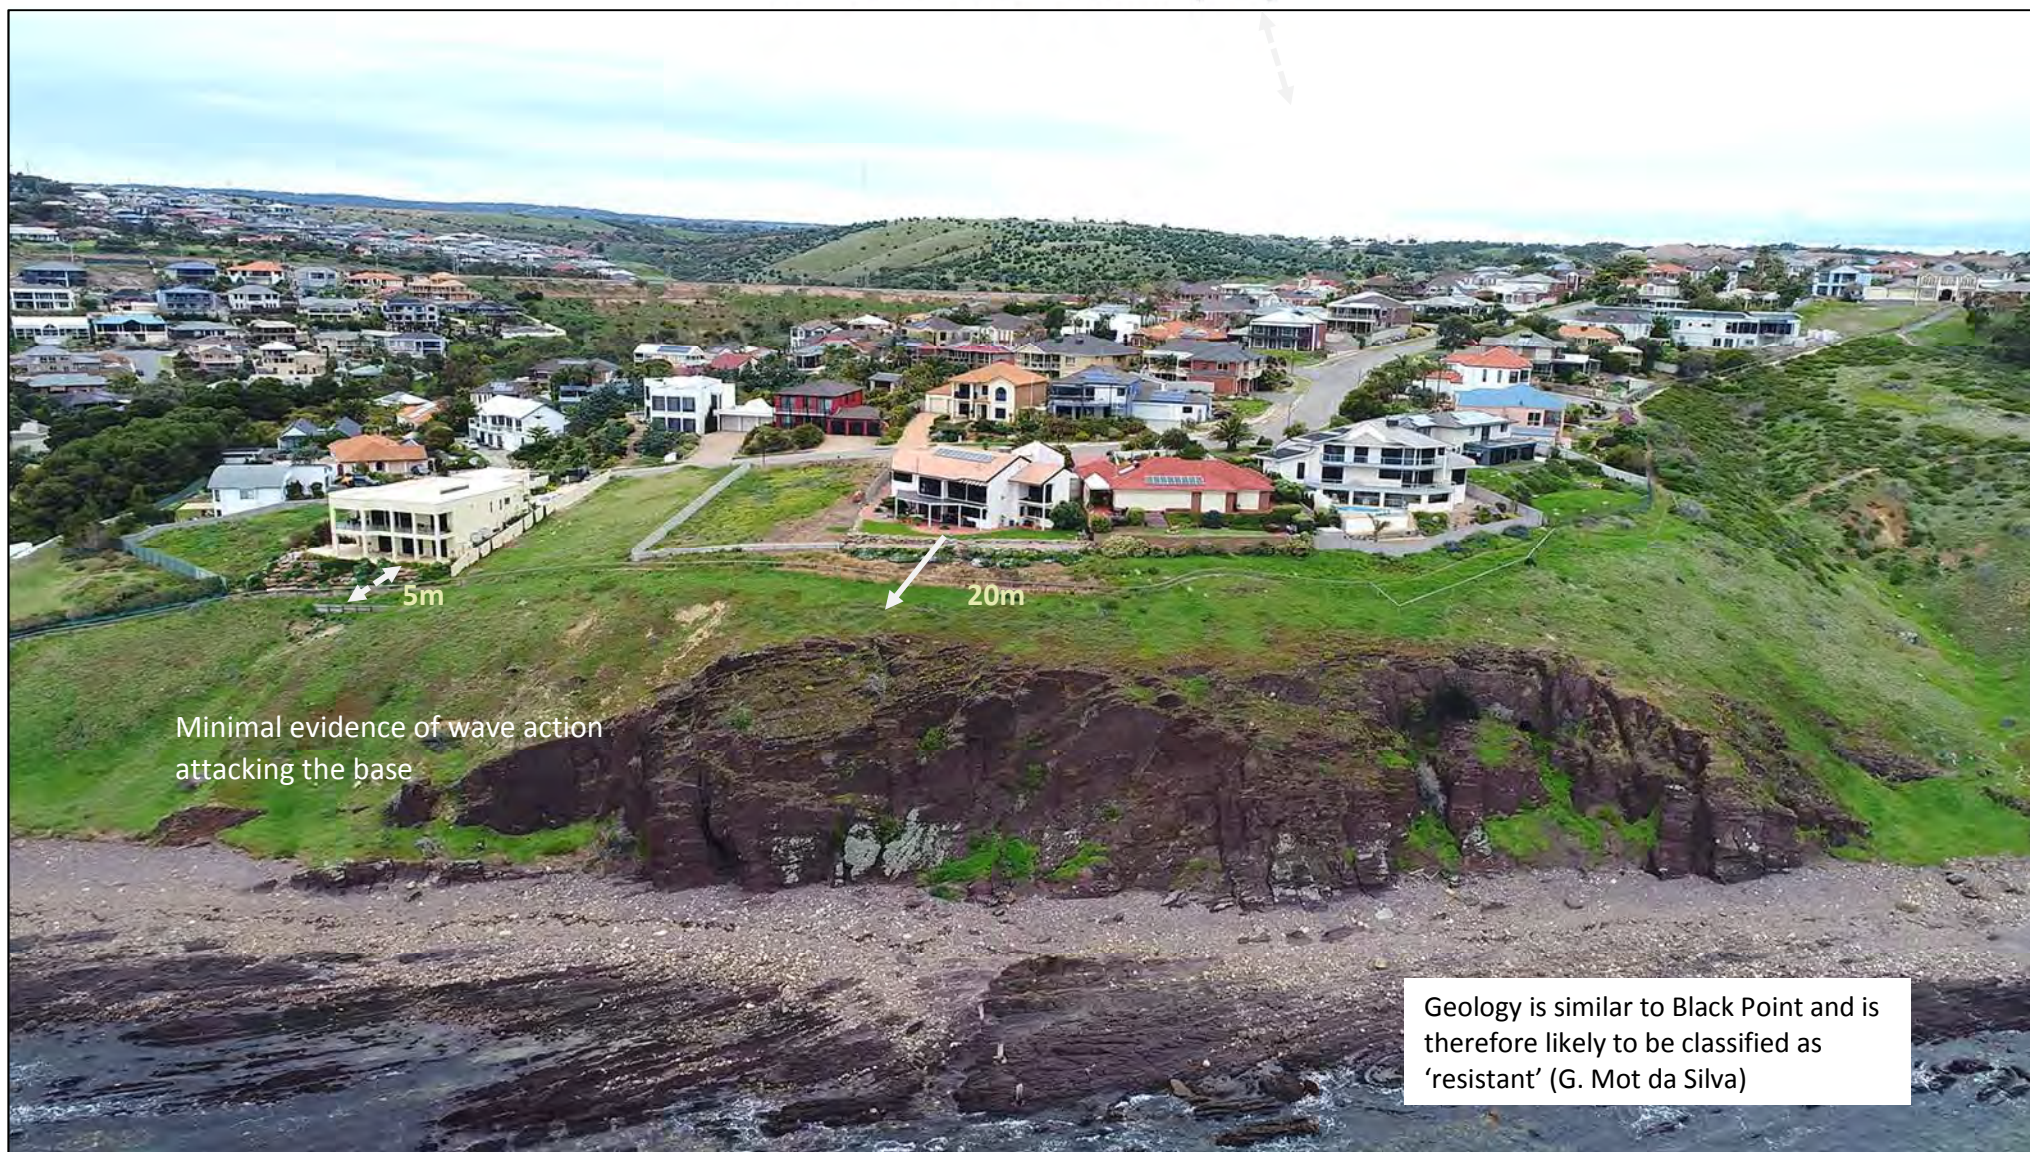
## Cell 5: Southern Cliffs (5:1)

One house is close to the top of the escarpment, but the slope of the embankment is quite low. By 2100, it is likely the base of the cliff will be inundated more frequently, allowing direct wave action against the base of the cliffs. Routine monitoring of the cliff condition and stability should be undertaken (particularly the discharge of stormwater) HCCMS, P. 45

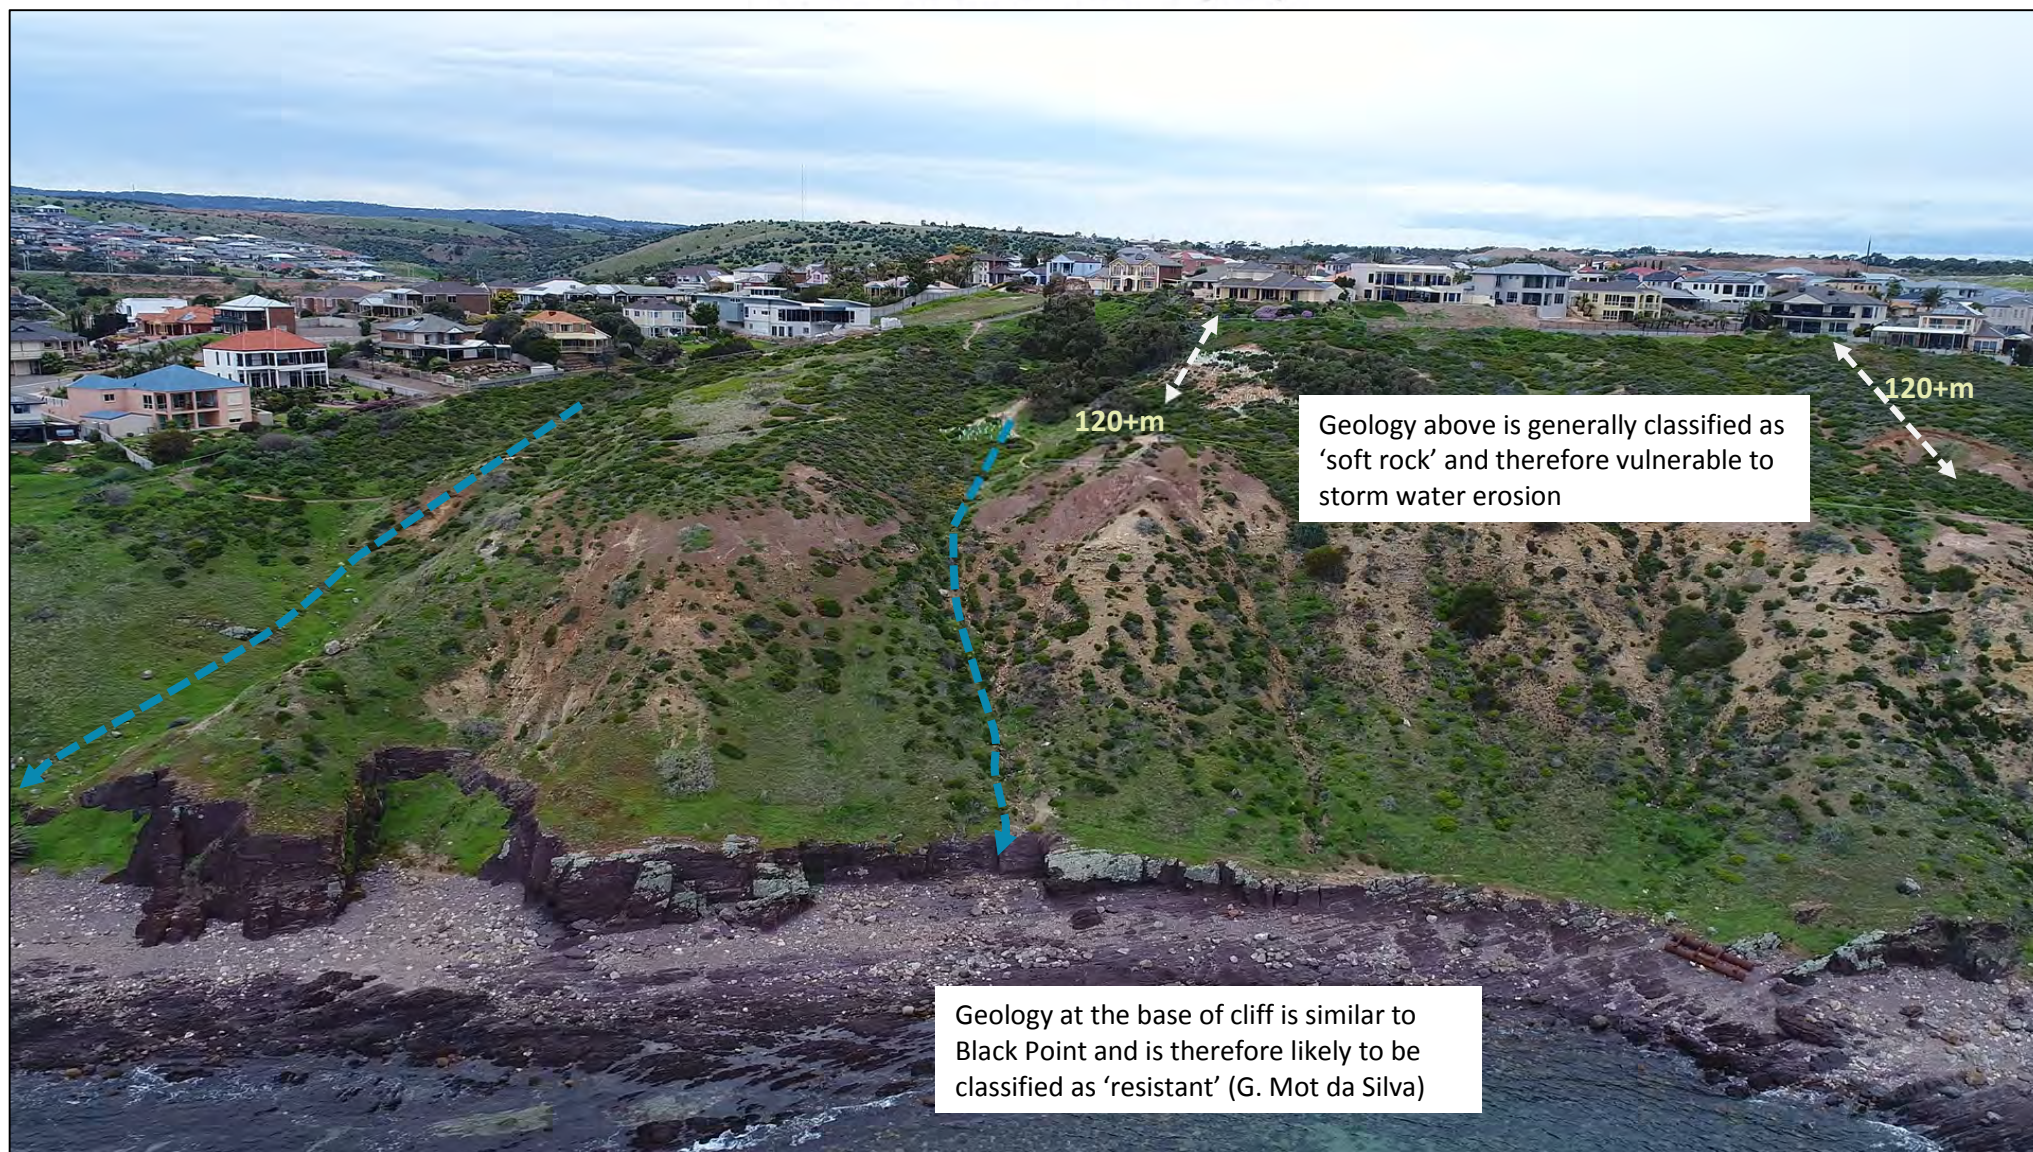
## Cell 5: Southern Cliffs (5:2)

All private and public infrastructure is set well-back from cliffs. By 2100, it is likely the base of the cliff will be inundated more frequently, allowing direct wave action against the base of the cliffs. Routine monitoring of the cliff condition and stability should be undertaken (particularly the discharge of stormwater) HCCMS, P. 45
